# FEASIBILITY STUDY

## TOWN OF DEDHAM POLICE STATION Dedham, MA

# **Site & Building Assessment**

Town of Dedham Police Station

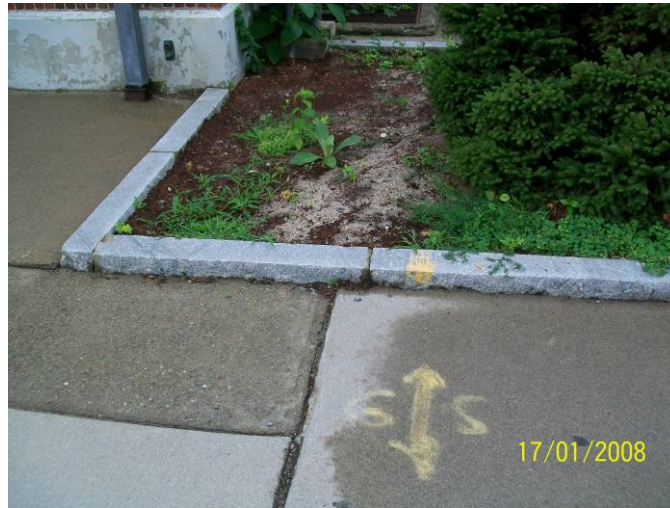
Neither the record plans nor the Dedham's GIS indicated a gas service to the main building. During the site walk on July 21<sup>st</sup>, pavement markings were observed to indicate that a gas service does exist and is located at the northwest corner of the site. HVAC Assessment indicates gas fired boiler and Plumbing Assessment indicates gas meter outside the building. Since record drawings were not found, further investigation would need to occur to determine the exact location gas service enters into the building.

Possible gas service

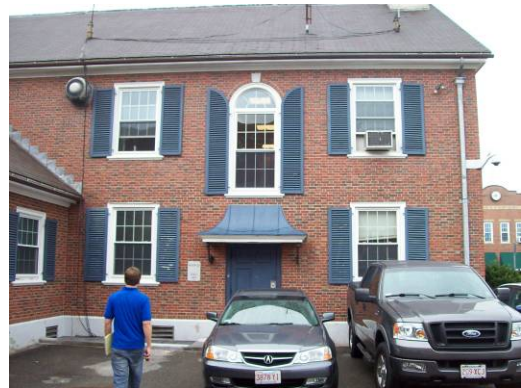
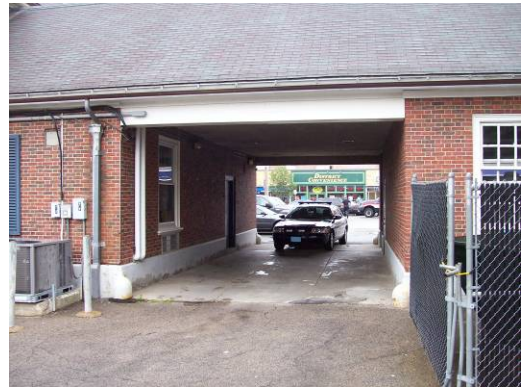
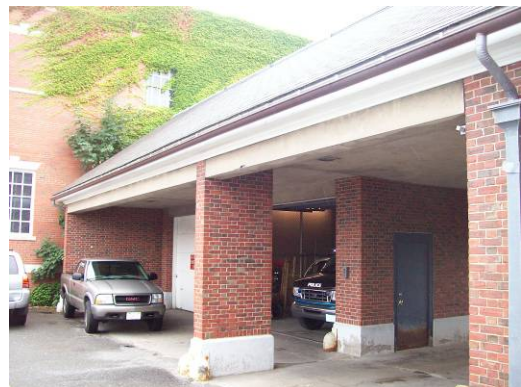
The exterior metal doors are in poor to fair condition. Some doors are rusting from the bottom. Drawings indicate that the doors are in-filled with mineral wool insulation. This type of door has a very low R-value. Existing doors are non-security exterior door types.

- Replace exterior doors for greater security and energy efficiency.

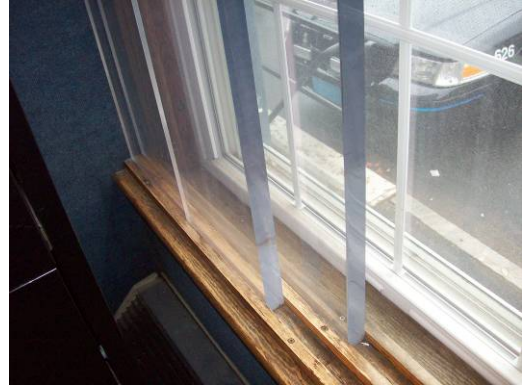
The existing exterior windows are double hung wood windows with wood shutters which are in fair condition. Drawings indicate single pane, non-insulated glazing at the windows. Exterior windows at dispatch contain an interior pane of bullet resistant glazing. Other secure areas do not have bullet resistant glazing.

- Replace windows with aluminum clad wood windows, specifying low-e with argon or high R tripane glass for greater efficiency. Install additional bullet-proof glass as needed.

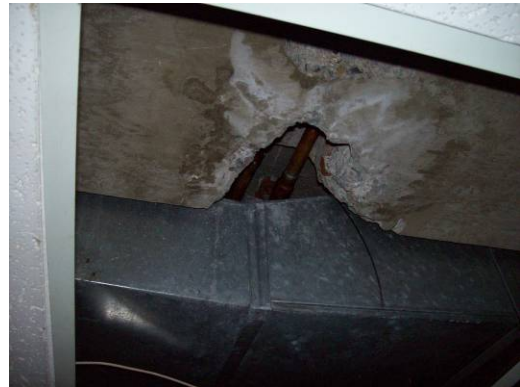
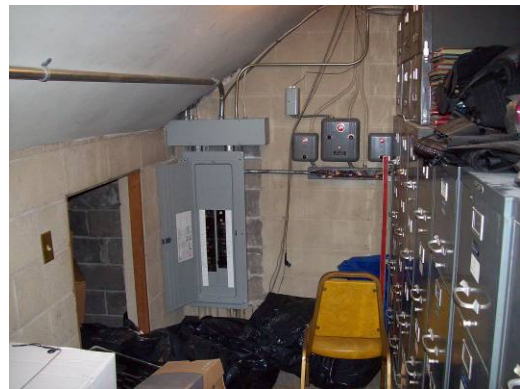
- The boiler room lacks a second means of egress
- The electrical room is also serving as an office. The room should only be used for electrical purposes and the office should be relocated.
- A concrete beam has been chipped away due to a recent plumbing installation. This may affect the structural strength of the beam. Refer to Structural Assessment.
- Corridors are restricted due to storage of various items, including lockers. Corridor spaces are too narrow with excess storage occurring in the walking space.
- Stairs do not meet current accessibility/egress requirements with guard heights below code requirements, stair risers taller than requirements, treads narrower than requirements, and guard openings wider than requirements.
- Stairs are missing a second handrail as required by code.

- Relocate offices out of electrical room and provide adequate cooling and ventilation.
- Maintain clear egress paths with adequate width in case of an emergency.
- Modify guards and handrails to comply with code requirements.

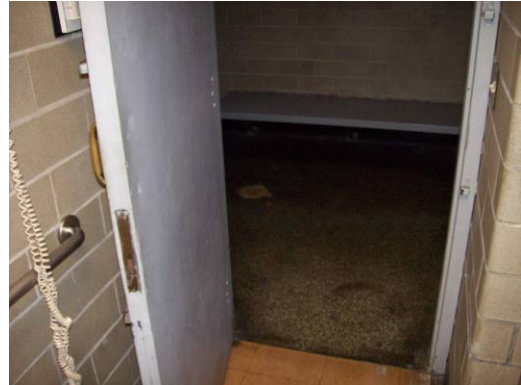
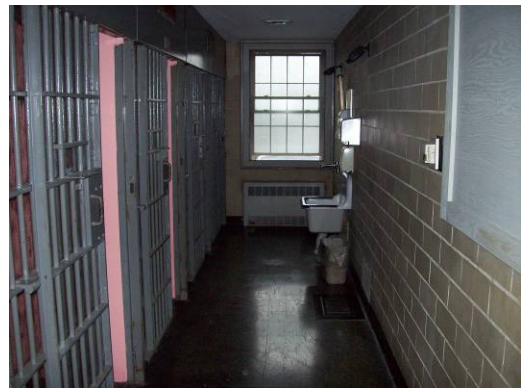
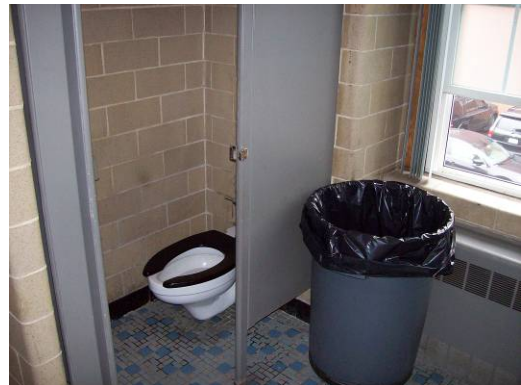
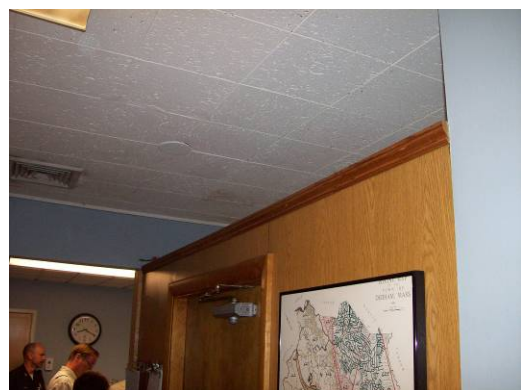
- Security is compromised at the entry vestibule with a large opening above the door.
- Bullet resistant glazing is used at the entry lobby, but the exterior window to the reception area is vulnerable.
- Bullet resistant glazing at exterior windows is open to allow for additional ventilation, but compromises security.

- Provide barriers to separate areas.
- Relocate items that can be used as weapons to areas not accessible by prisoners.
- Consider a security system in the building or at minimum, doors with some safety measures in places to protect staff/public areas from prisoner holding areas.

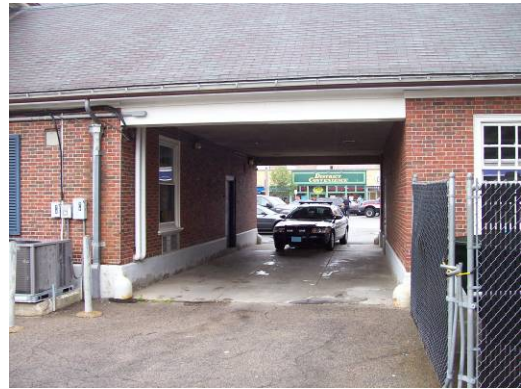
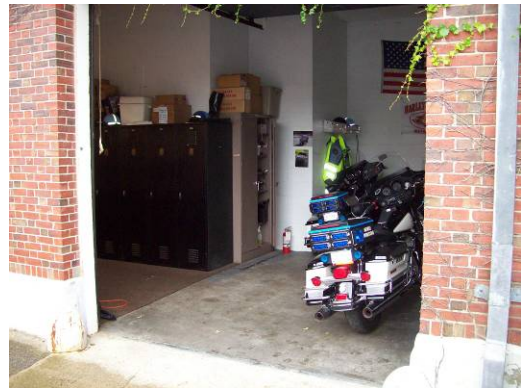
- Prisoner booking and processing serves as a corridor and contains items that could be used as weapons. The desk is not durable and the computer is compromised.
- Steps are integral to the prisoner booking area and offer a hazard to officers transferring a prisoner to/from the Sally port.
- The corridor in the Women's Cells is less than 5' and contains general storage. This creates a security and safety liability.
- Administration area is open to the prisoner processing space and not conveniently located to the rest of the staff. This office is vulnerable to the Sally port as well, with direct unprotected window access.
- Fingerprint area is not durable and is located within the Women's Cell area. This does not allow proper separation of Male/Female/Juvenile prisoners, and the equipment is vulnerable.
- The Sally port is open and not secure.

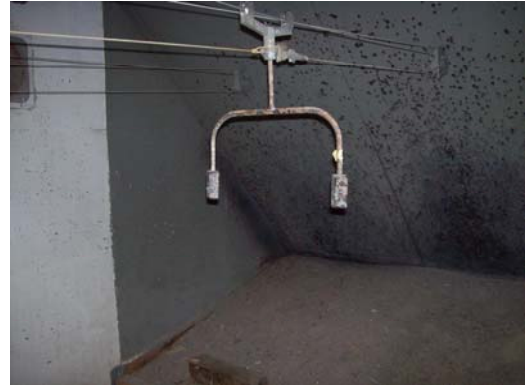
- The firing range requires abatement/cleaning and the HVAC is inadequate for the intended use. Refer to the Hazardous Materials Assessment for additional information
- The bullet trap and baffles appear to require renovation
- Target systems are aged and should be updated

- Renovate firing range on site for police use. If it is decided to use the Medfield outdoor firing range, renovate the firing range area to provide spaces listed in this assessment as insufficient in size or lacking on site, such as soft and hard interview rooms, kitchenette, locker/restroom areas, additional office space, storage space, etc.

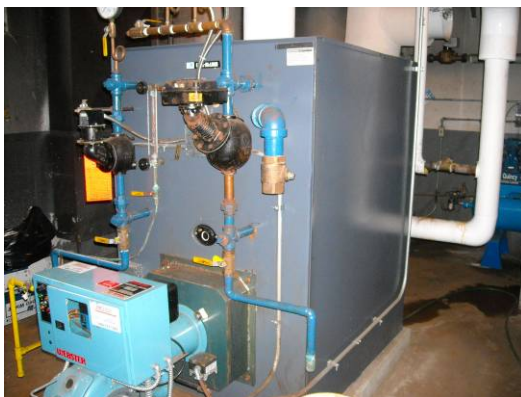
*Steam Boiler*

Heating for the building is provided by a low pressure steam boiler located in the basement boiler room. The boiler is a Weil McLain Model 688 gas-fired low pressure steam boiler. The boiler appears to have been installed within the past 10 years and appears to be in fair condition. The boiler provides low pressure steam to air handling unit steam heating coils (two units are active/, and two units are abandoned in place), and terminal heating radiation units (convectors and baseboard) located throughout the building.

The condensate receiver and boiler feed unit serving the boiler are in poor condition and in need of replacement.

The main steam and condensate piping appears to be old and in poor condition. Many segments of the piping are un-insulated. It also appears that the original piping insulation located at elbows have been removed (as the insulation for these fittings may have contained asbestos). Sections of the branch steam and condensate piping appear to have been recently replaced as part of a heating system repair project.

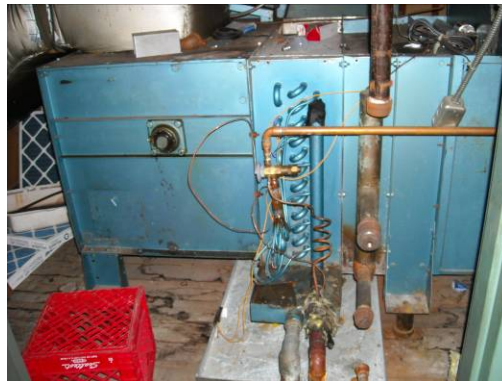
*Attic – AHU (Serves Second Floor)*

The second floor of the building is providing with heating, ventilation and air conditioning from an indoor air handling unit located in the attic of the building. This unit is also a modular indoor air handling unit which appears to be original vintage circa 1962 as manufactured by the Dunham Bush Co. The unit has steam heating, DX cooling and supply fan sections. The unit is old and in poor condition. The unit's associated air cooled condensing unit is installed outdoors at grade adjacent to the building. Insulated, galvanized sheet metal ductwork is routed from the unit in the attic to the second floor. The majority of the ductwork appears to be original vintage and in poor condition.

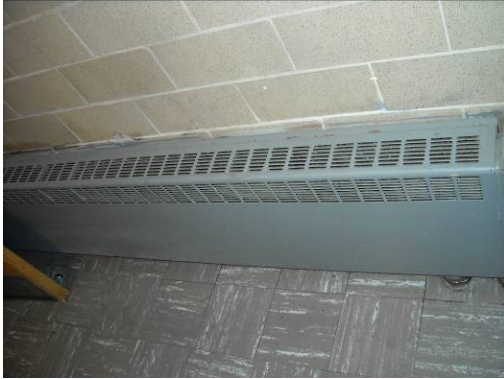
*Steam Fin Tube Radiation Heating*

The majority of the rooms in the building also have heating provided by either steam convectors or steam fin tube radiation. The Chief's office has supplemental electric baseboard heating installed. The majority of the steam terminal heating equipment appears to be original vintage and in poor condition.

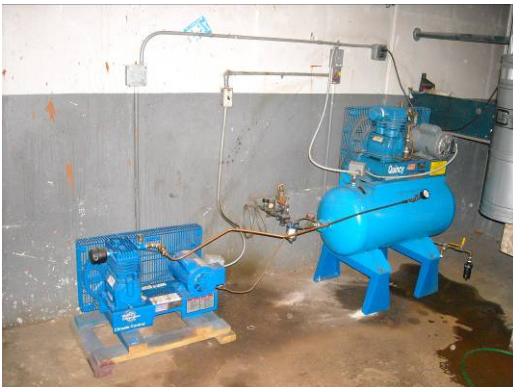
*ATC Compressor*

The majority of the building's automatic temperature control systems are pneumatic type. The control system's compressor is located in the basement boiler room and appears to be in fair condition. During recent HVAC system upgrades it appears that some HVAC system controls have been replaced with stand alone analog electric type controls.

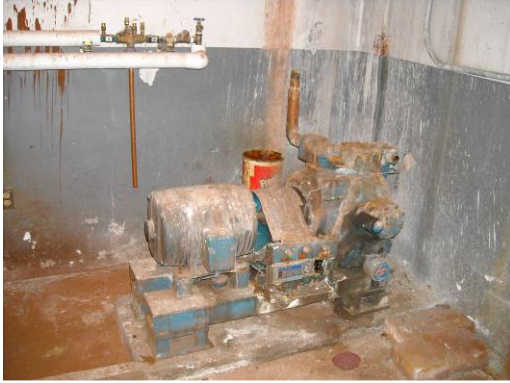
*Compressor (Abandoned in Place)*

As part of past HVAC system repair and replacement projects it appears that some original HVAC systems and equipment have been abandoned in place. One example of this is a set of Compressors that are located in the basement Boiler Room which previously served the First and Second Floor Air Handling unit systems before the Outdoor air cooled condensing units shown above were installed.

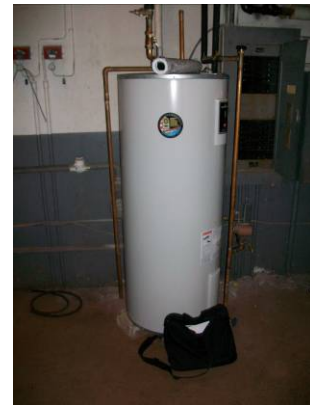
The copper piping where exposed shows signs of corrosion and due to its age is not suitable for re use in a major renovation.

The pipe covering needs to be evaluated for the presence of asbestos.

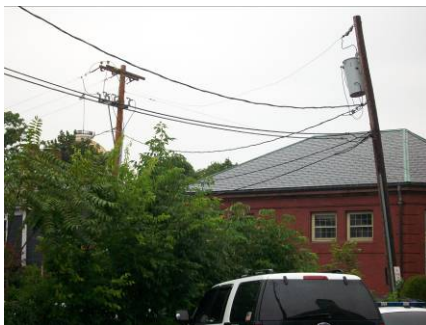
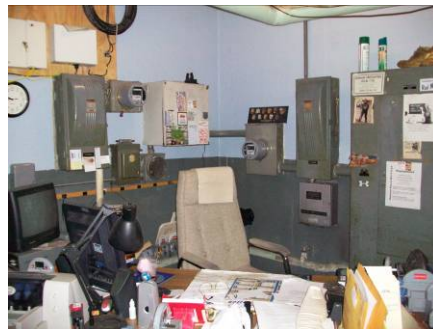
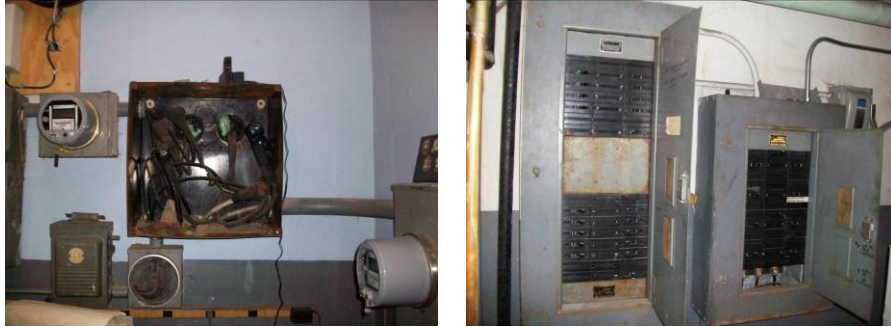
There are other remote panels, including split bus panels, in similar poor condition.

These services cannot be expanded and would require replacement.

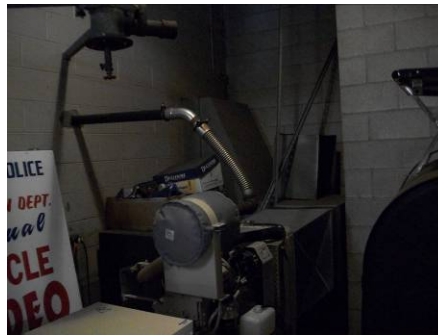
The emergency power system consists of a 30kw, 120/240V, 1Ø, 3 wire diesel generator located in the motorcycle garage building within a fenced area. The generator set was manufactured by Katolight #SD30FGJ4T2 and is fueled by a remote 275 gallon residential type fuel tank also within the fenced area. The unit has (1) 100 ampere breaker. The automatic transfer switch is a ASCO #D00300020104F10C rated at 104 amperes, 120/240, 1Ø, 3 wire. This space is not a two hour rated room and therefore is in violation of current codes.

This generator/ATS would not be suitable for reuse.

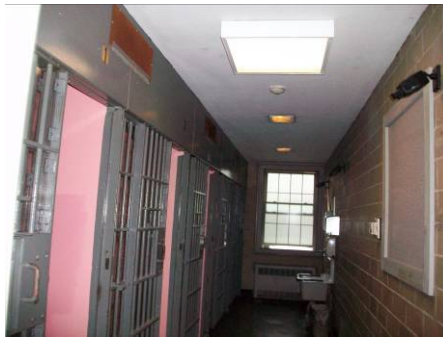
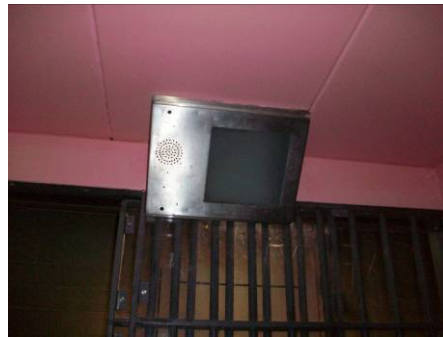
Cellblock has surface 2x2 troffers in hallways and 8" SQ recessed incandescent fixtures. Cells have corner mounted incandescent security rated fixture with integral speaker housing. Cell lighting is locally controlled in respective hallway.

Cellblock fixtures are old and provide inadequate light and would not be suitable for reuse.

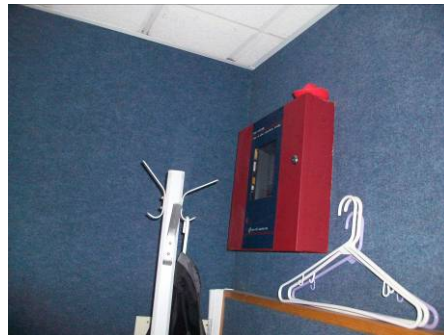
Stairs have no smokes. Cellblock hallway has heat detectors.

There are no smoke detectors or carbon monoxide detectors in cell areas.
