## **Town of Dedham, MA**

### **2013 Year One Inflow Investigation**

March 2014

**Town of Dedham, Massachusetts**  
**Weston & Sampson Project No. 2130225.A**

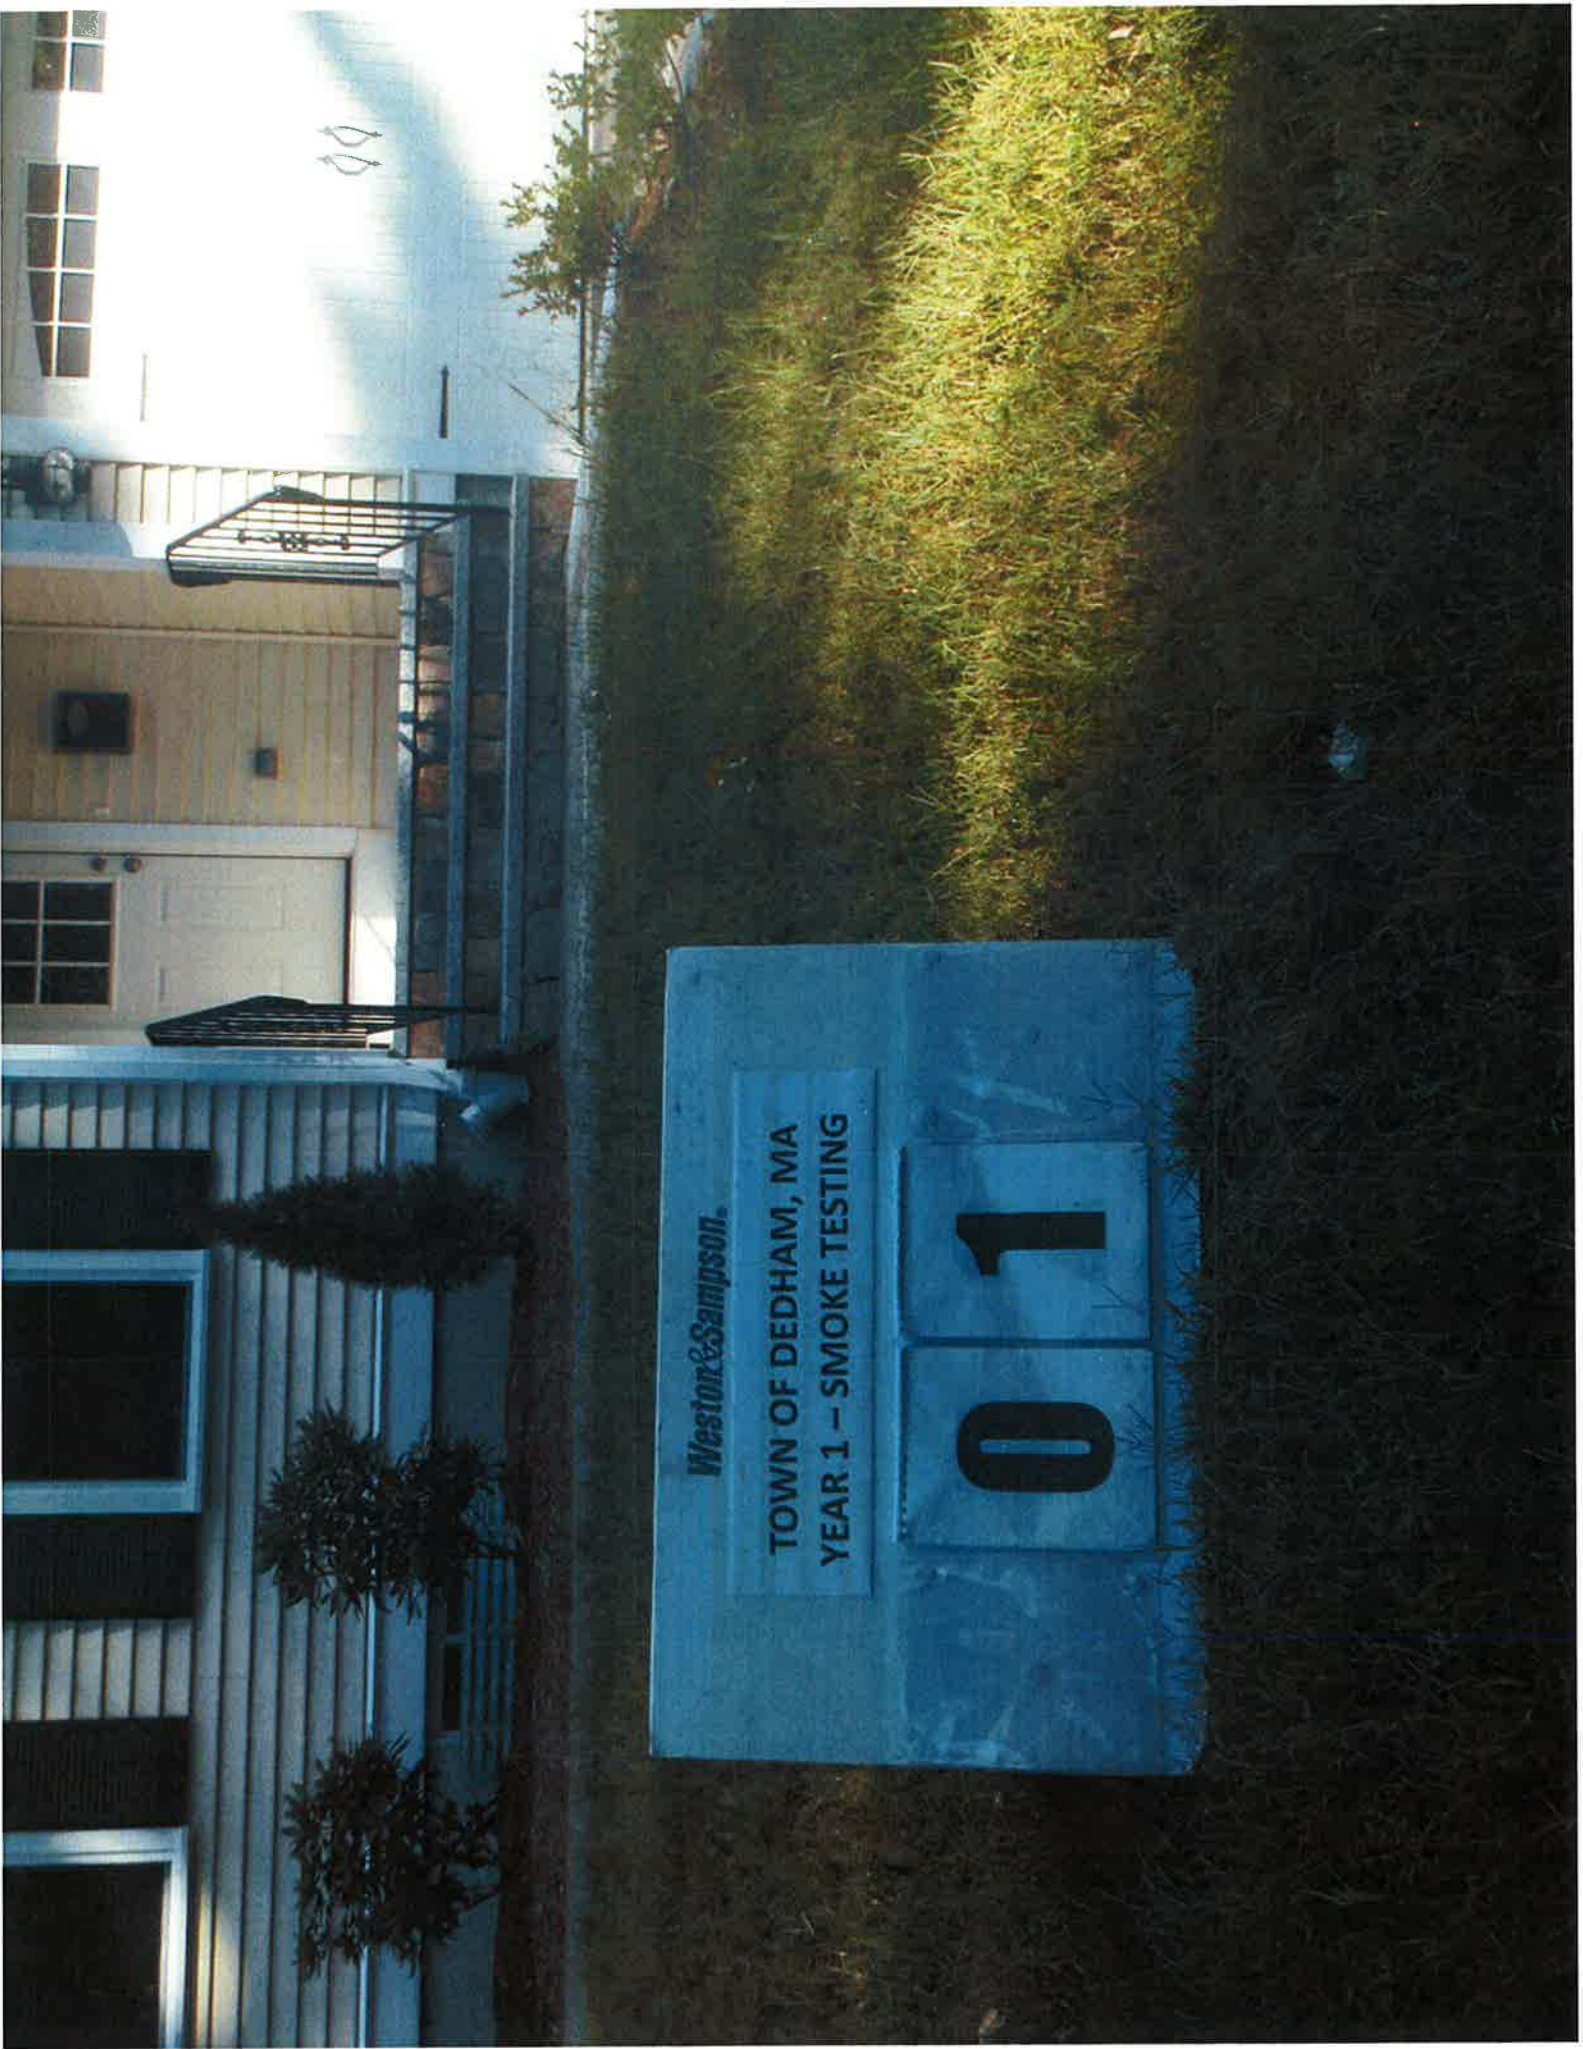
01

DEFECT	DESCRIPTION	Drainage Area	Surface Type	Severity			Picture No.(s)
				Major	Mod	Minor	
1	Defective Cleanout Cap	5' x 5'	Grass			X	1

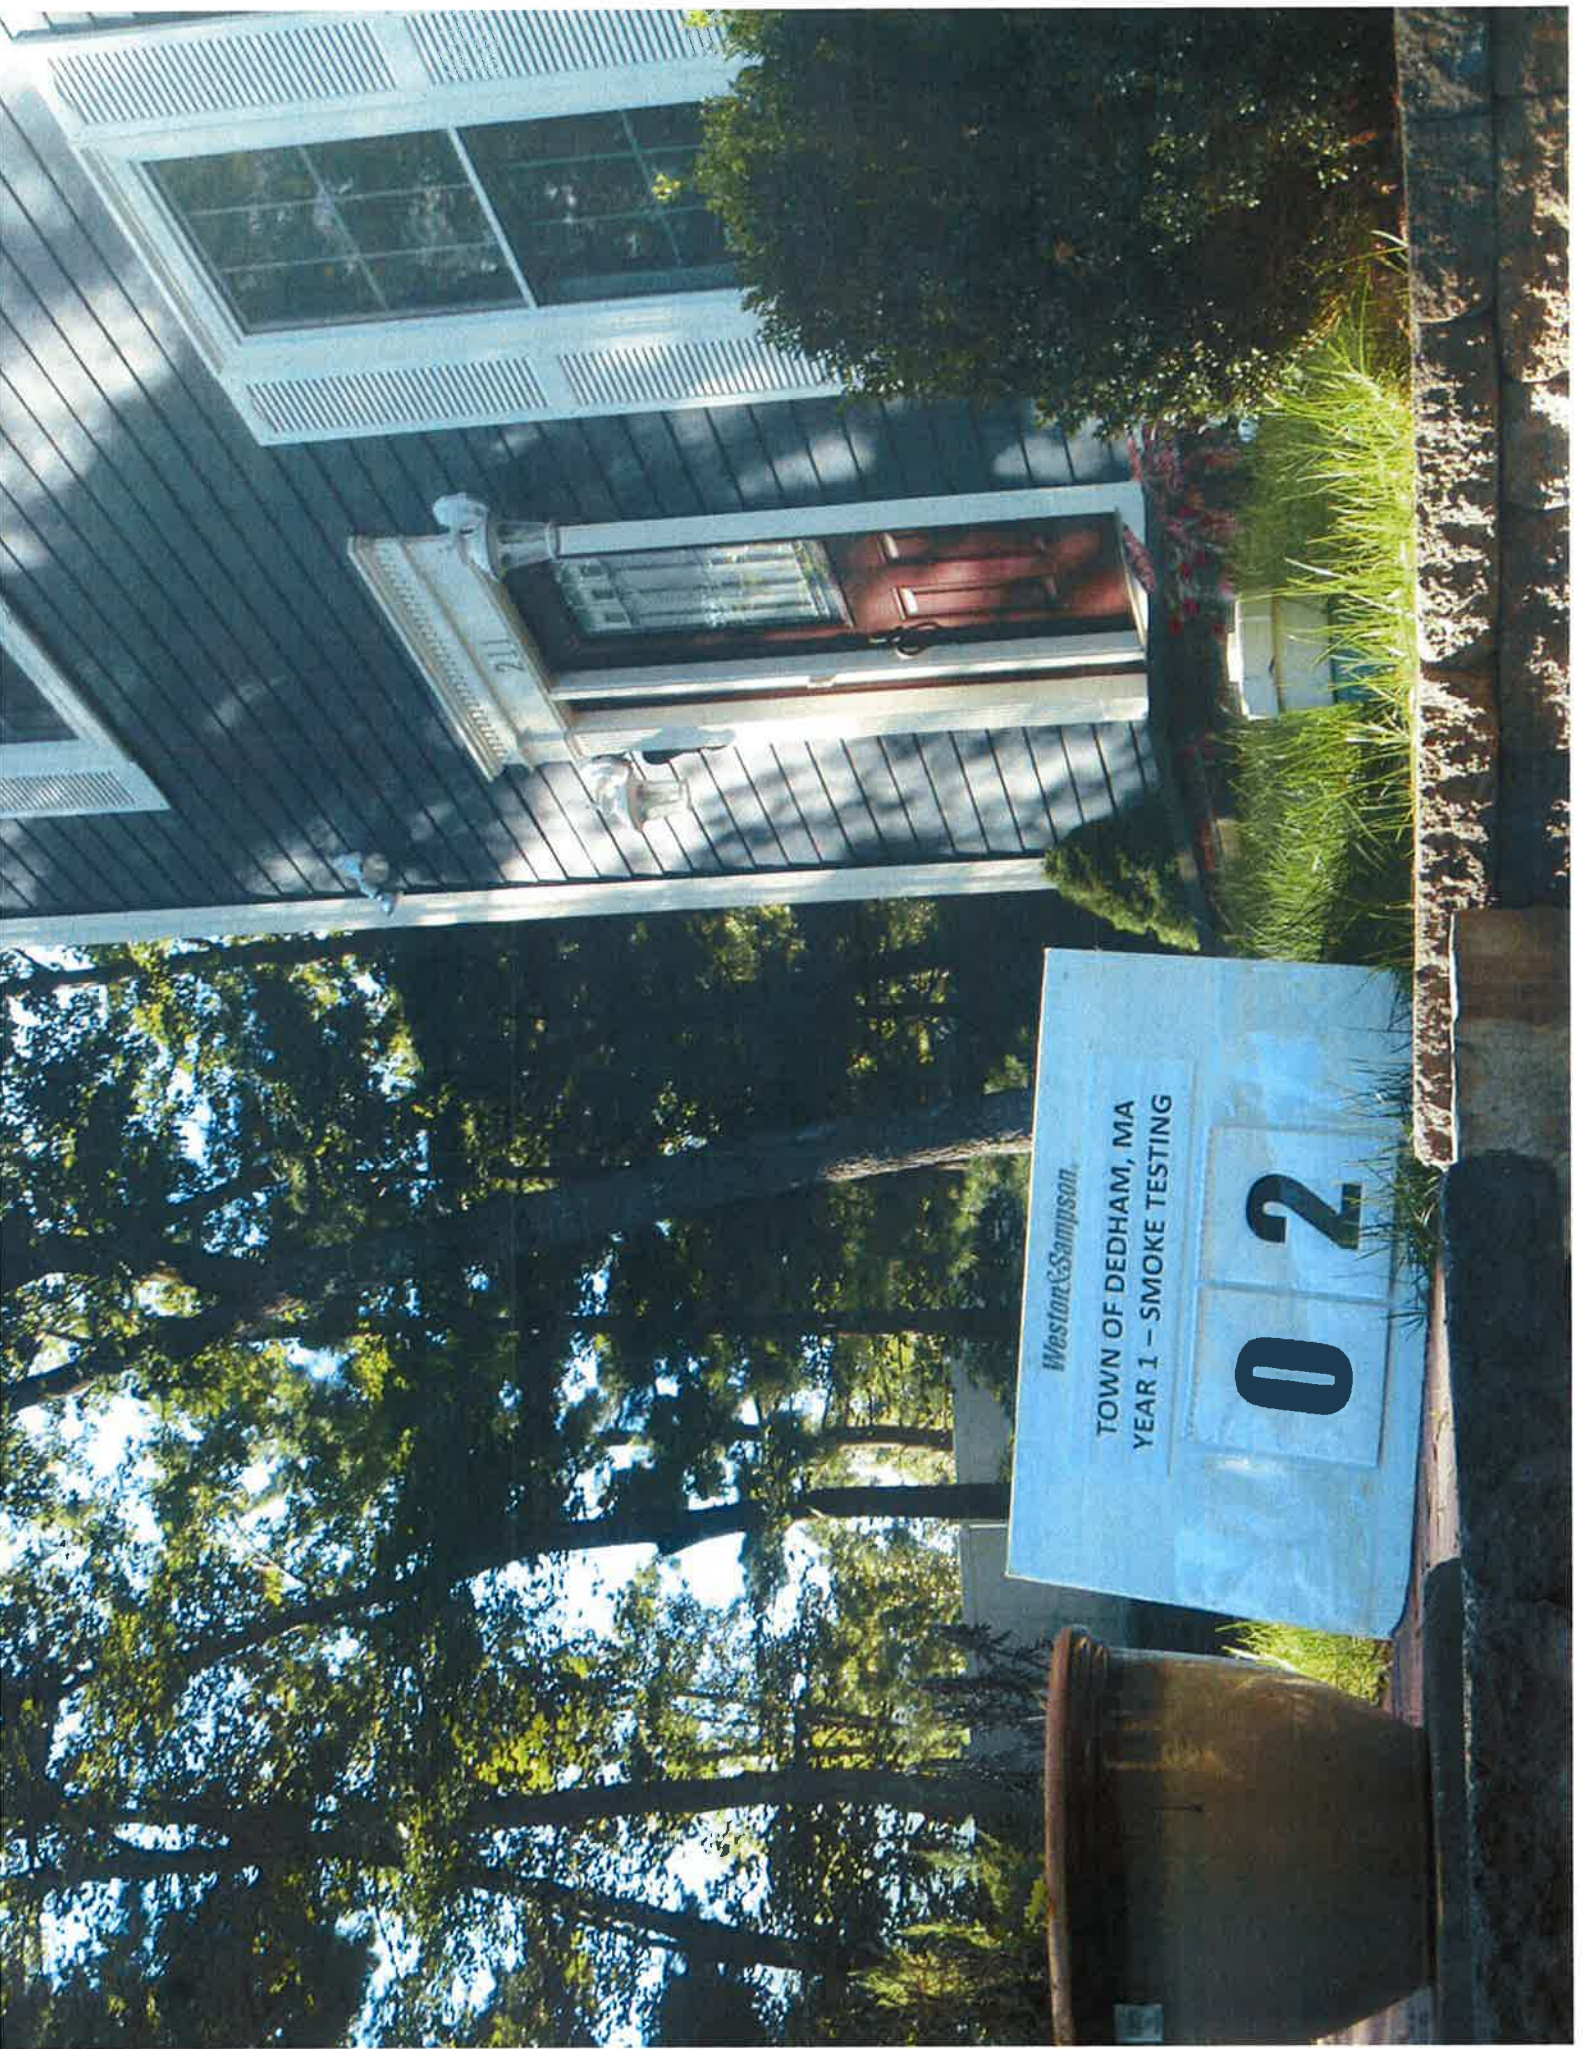
02

DEFECT	DESCRIPTION	Drainage Area	Surface Type	Severity			Picture No.(s)
				Major	Mod	Minor	
2	Defective Cleanout Cap	0	Above Grade			X	2

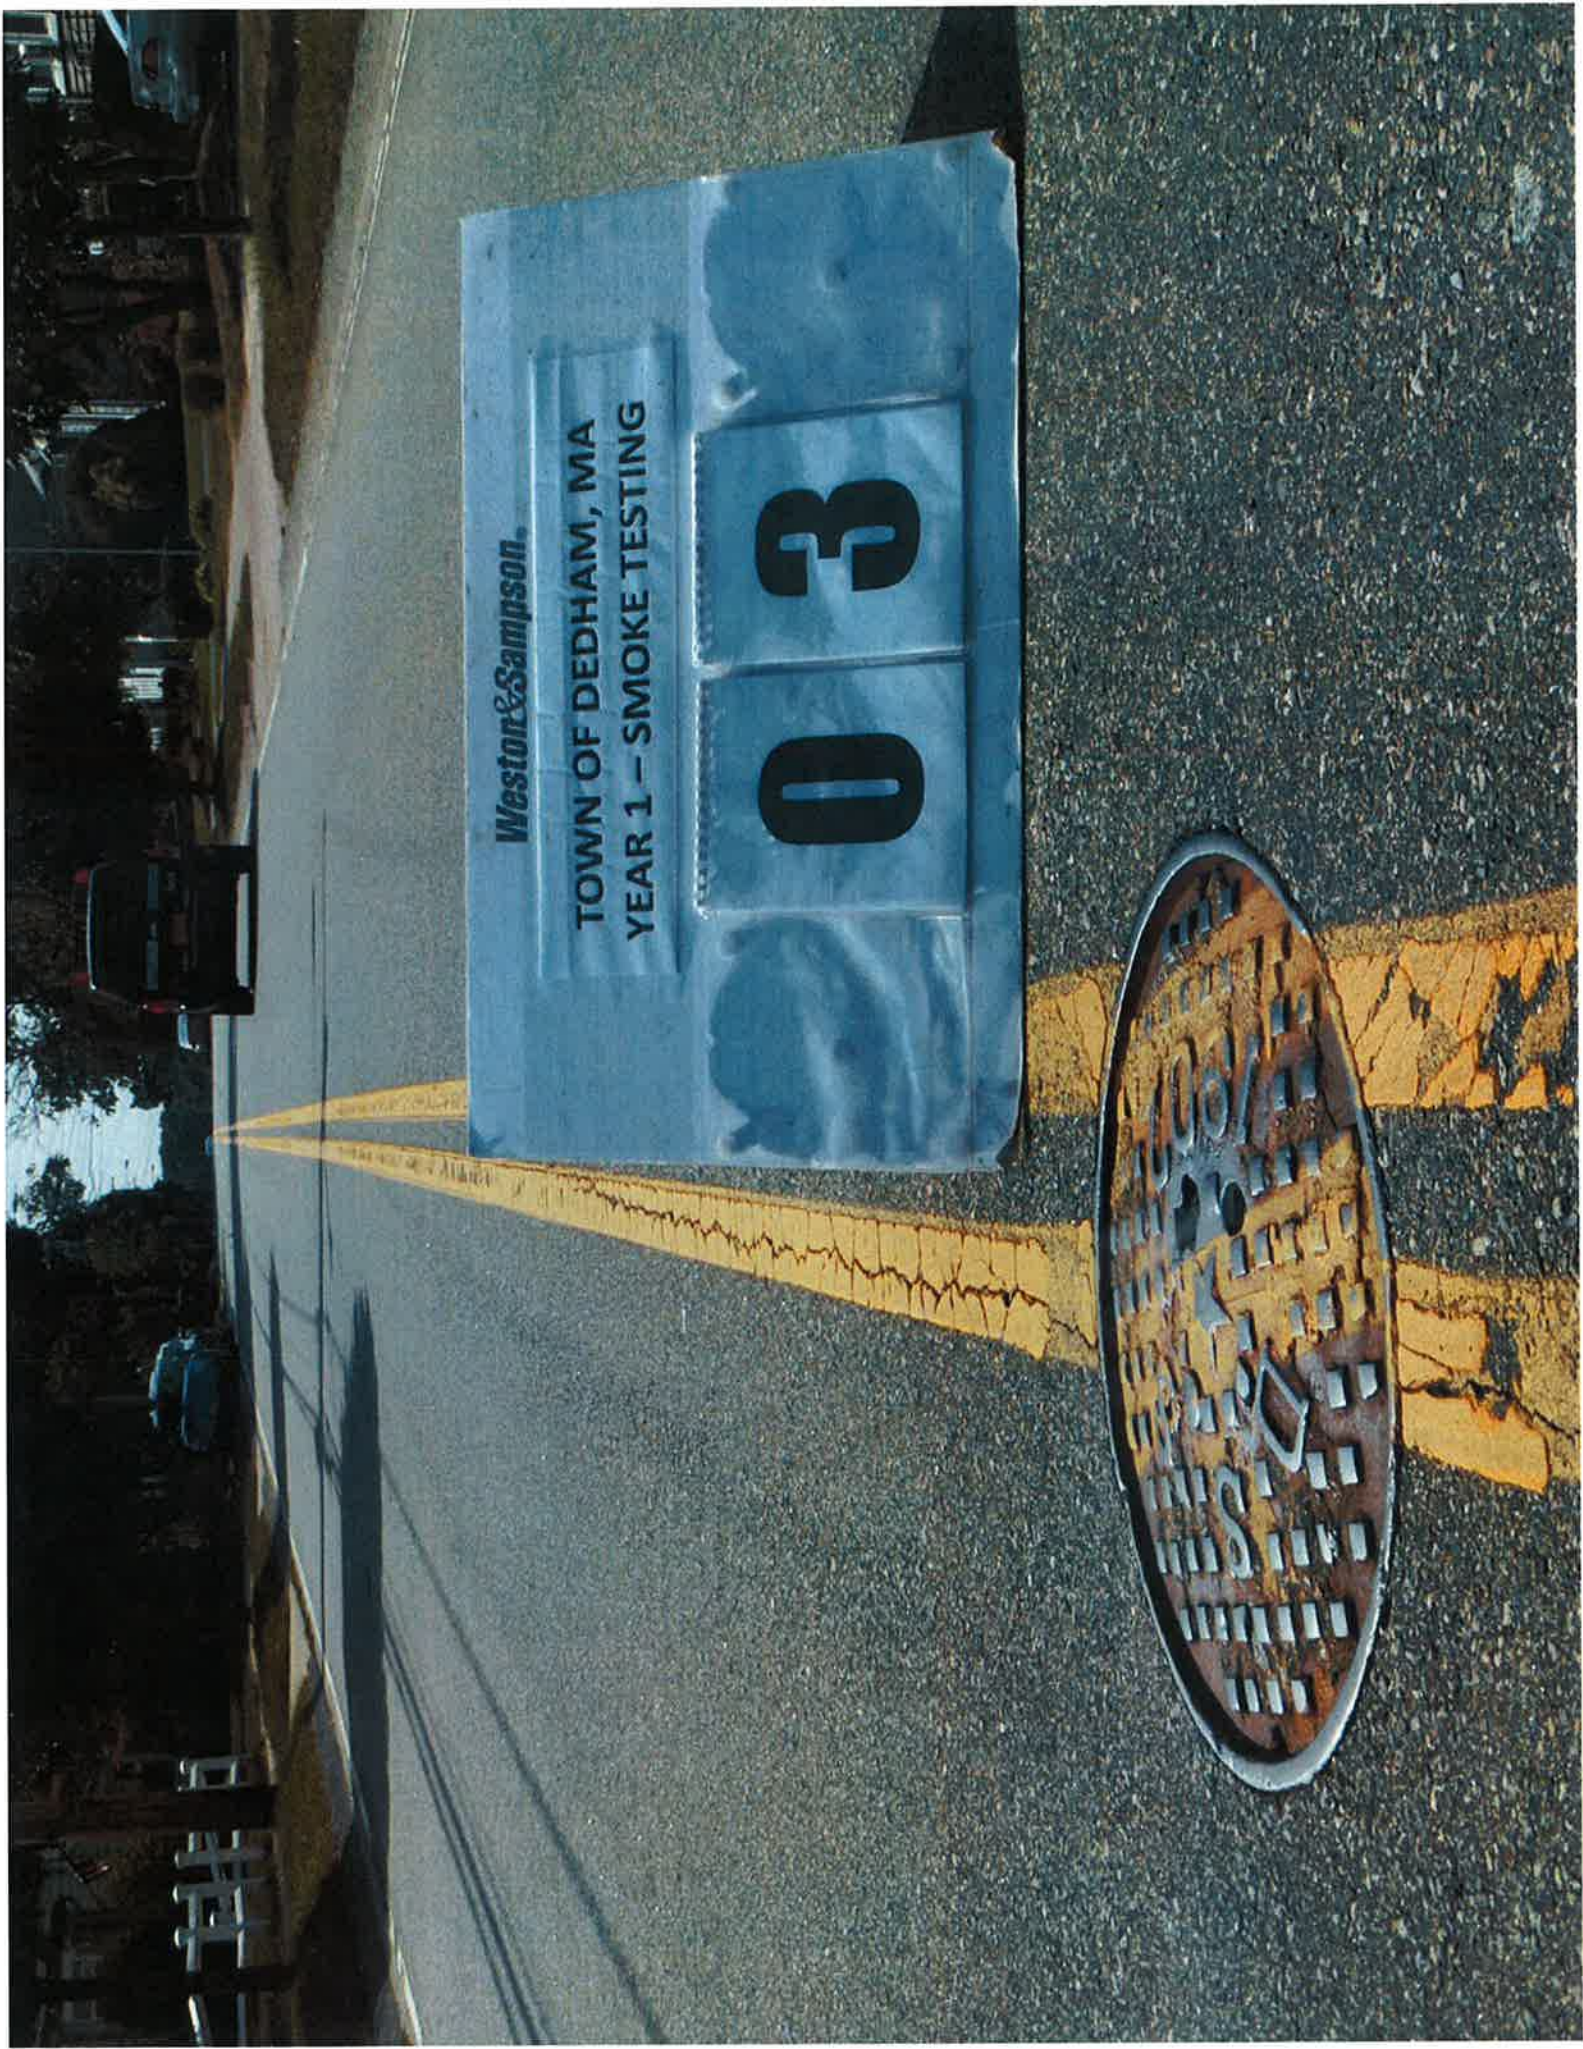
03

DEFECT	DESCRIPTION	Drainage Area	Surface Type	Severity			Picture No.(s)
				Major	Mod	Minor	
3	MH RR-120 - Holes in Cover	10' x 5'	Asphalt			X	3

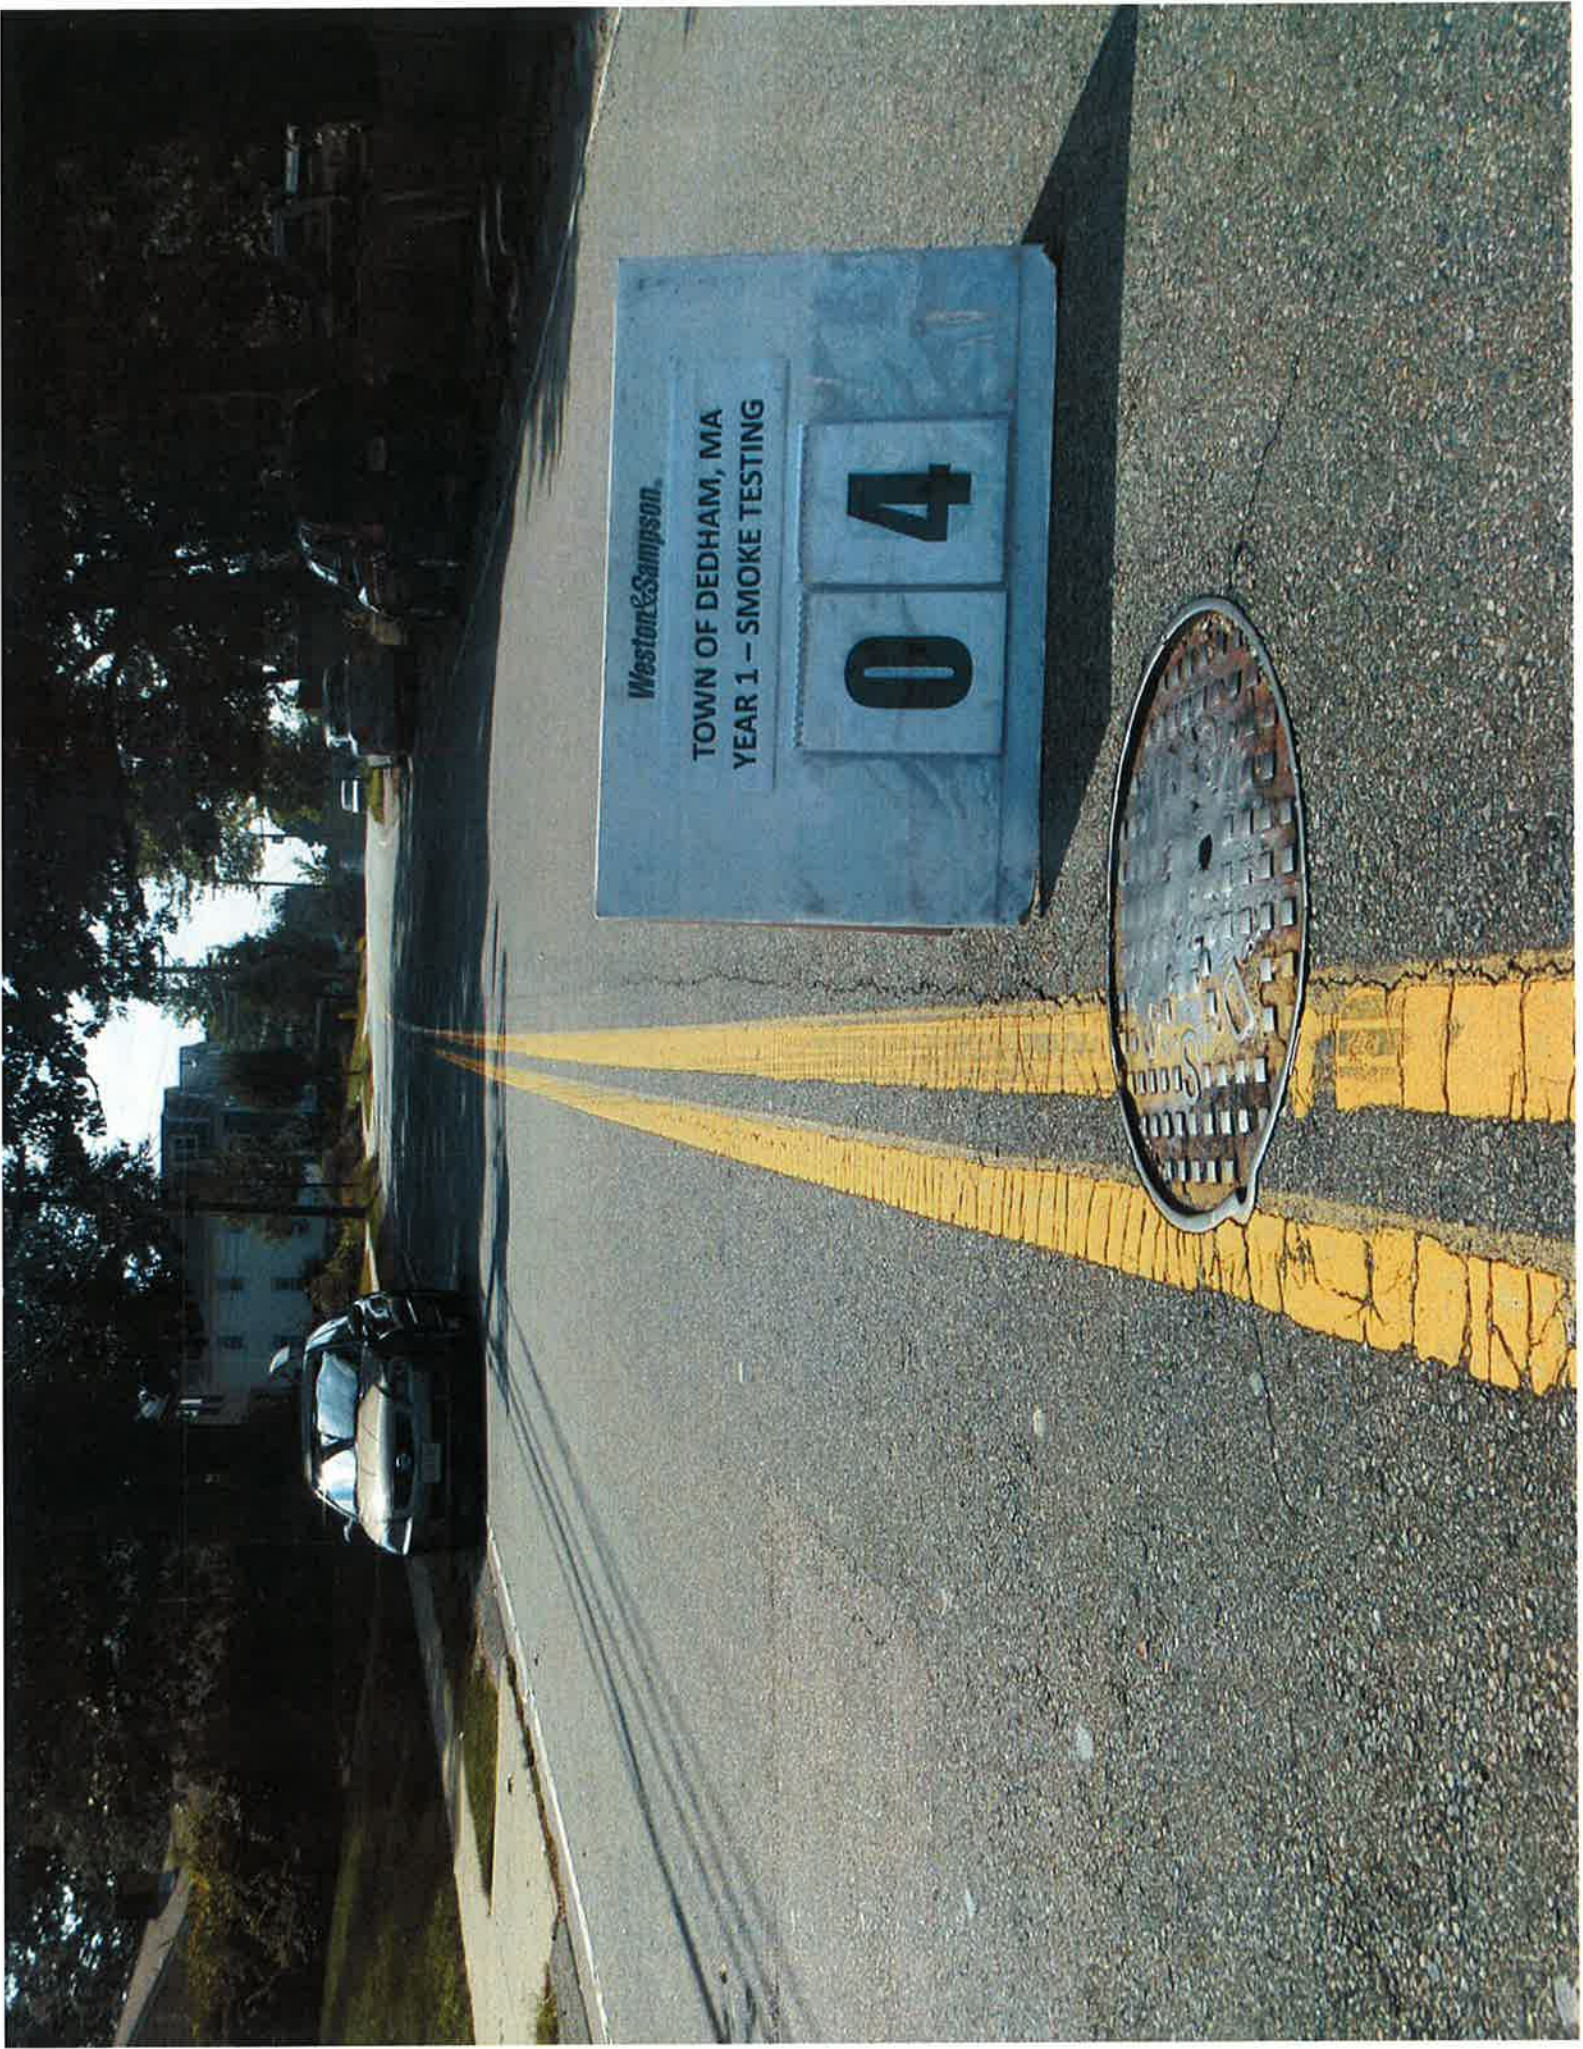
0	4
---	---

DEFECT	DESCRIPTION	Drainage Area	Surface Type	Severity			Picture No.(s)
				Major	Mod	Minor	
4	MH RR-90 - Holes in Cover	30' x 5'	Asphalt			X	4

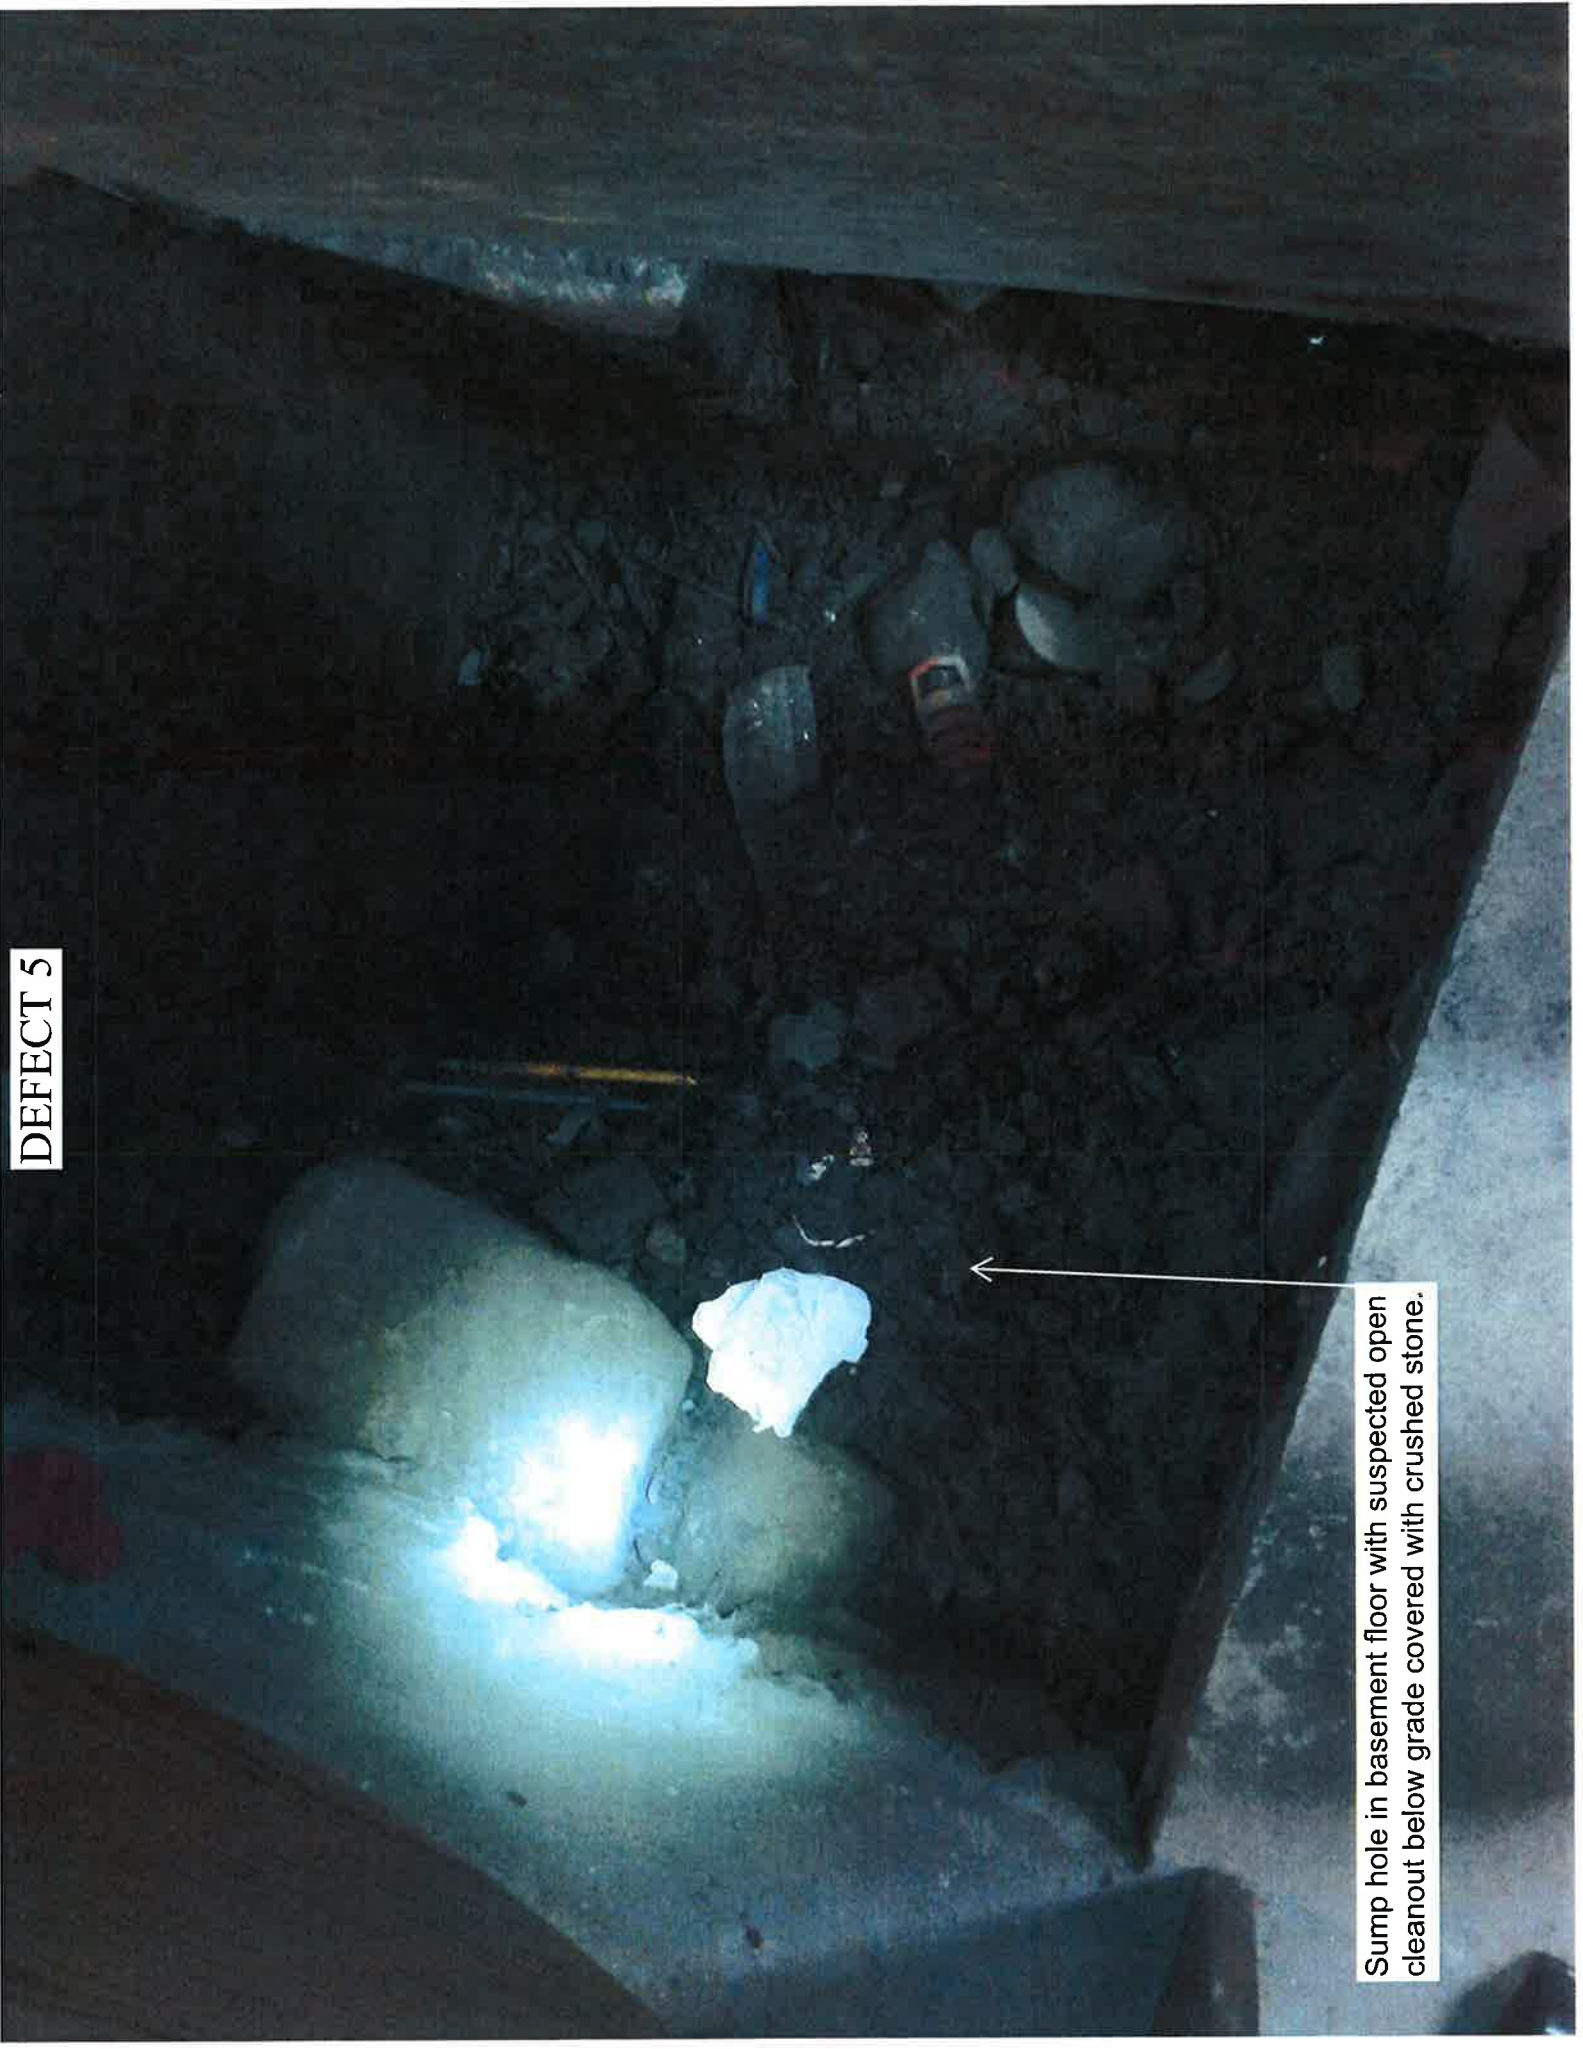
**DEFECT 5**

DEFECT	DESCRIPTION	Drainage Area	Surface Type	Severity			Picture No.(s)
				Major	Mod	Minor	
5	Sump hole in basement floor with suspected open cleanout below grade covered with crushed stone.	1020	Concrete		X		5

Sump hole in basement floor with suspected open cleanout below grade covered with crushed stone.

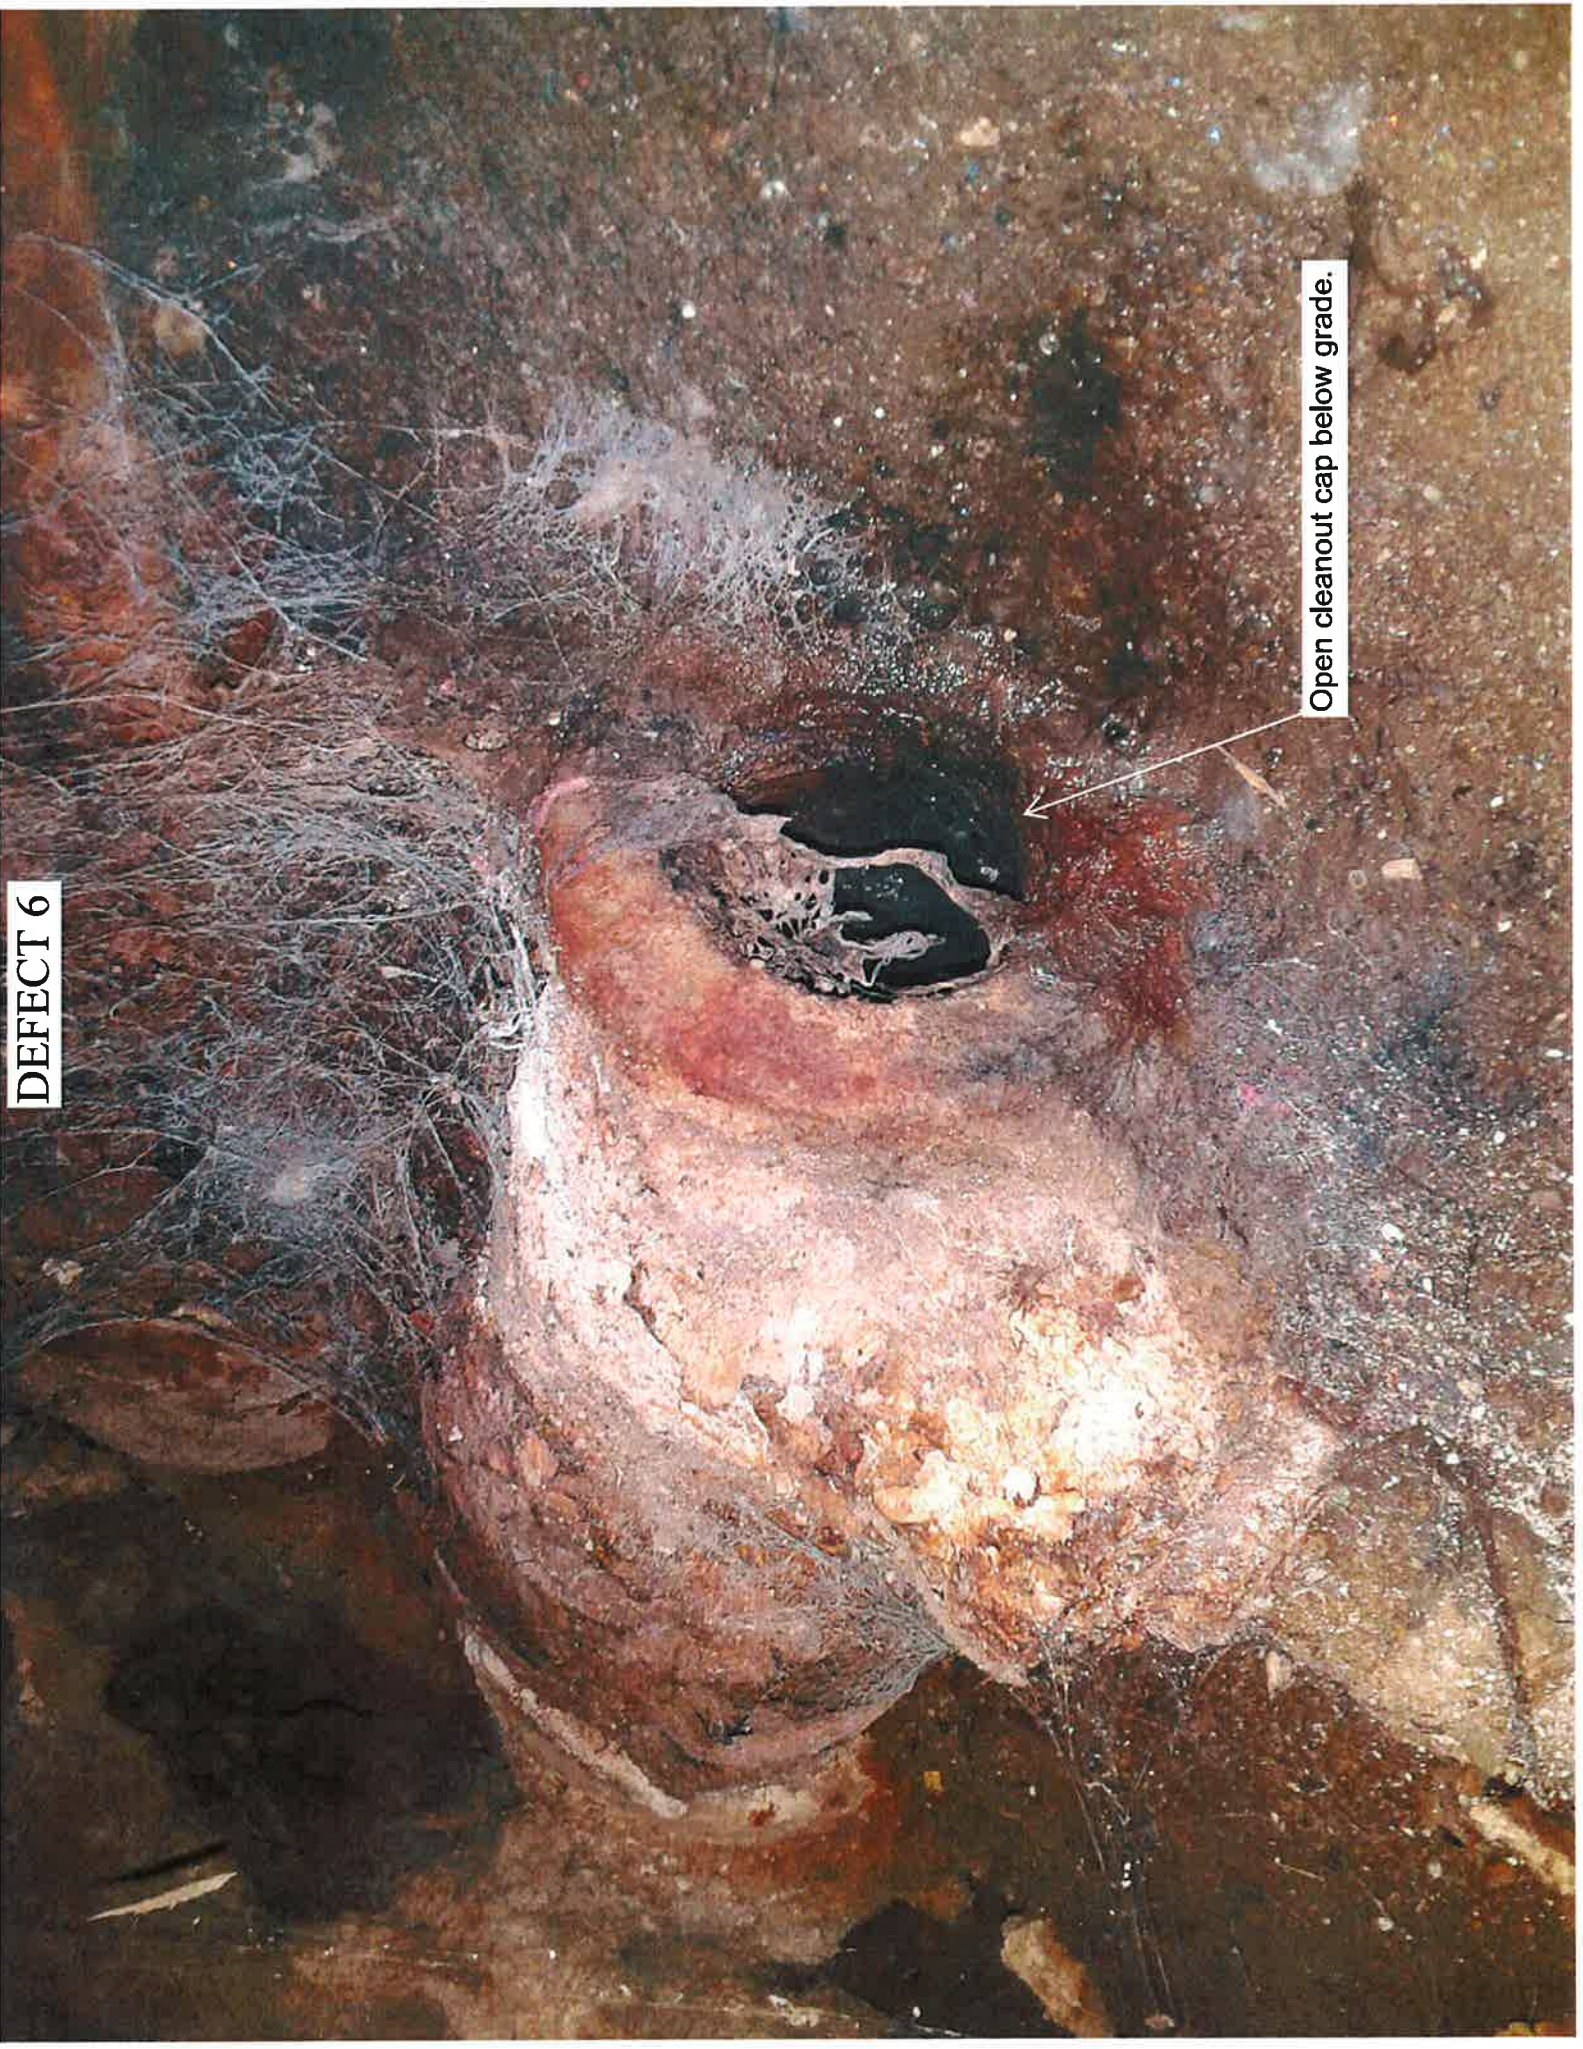
DEFECT 6

DEFECT	DESCRIPTION	Drainage Area	Surface Type	Severity			Picture No.(s)
				Major	Mod	Minor	
6	Open cleanout cap below grade.	1,330	Concrete		X		6

Open cleanout cap below grade.

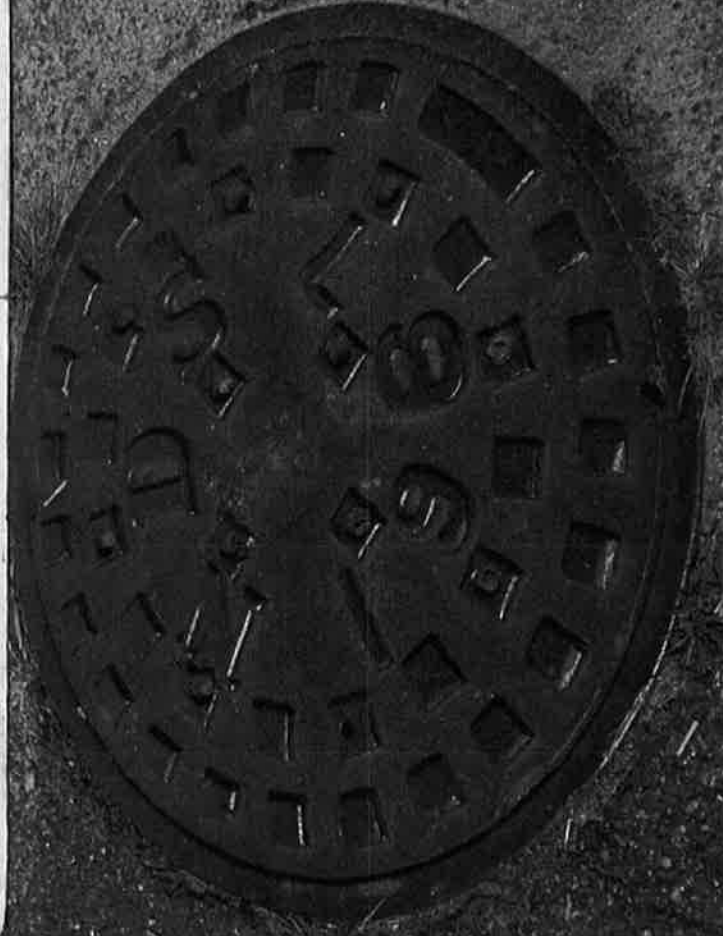
09

DEFECT	DESCRIPTION	Drainage Area	Surface Type	Severity			Picture No.(s)
				Major	Mod	Minor	
9	Manhole QQ-500 with vent holes.	50	Asphalt			X	9
