## **Town of Dedham, MA**

### **2013 Year One Inflow Investigation**

March 2014

**Town of Dedham, Massachusetts**  
**Weston & Sampson Project No. 2130225.A**

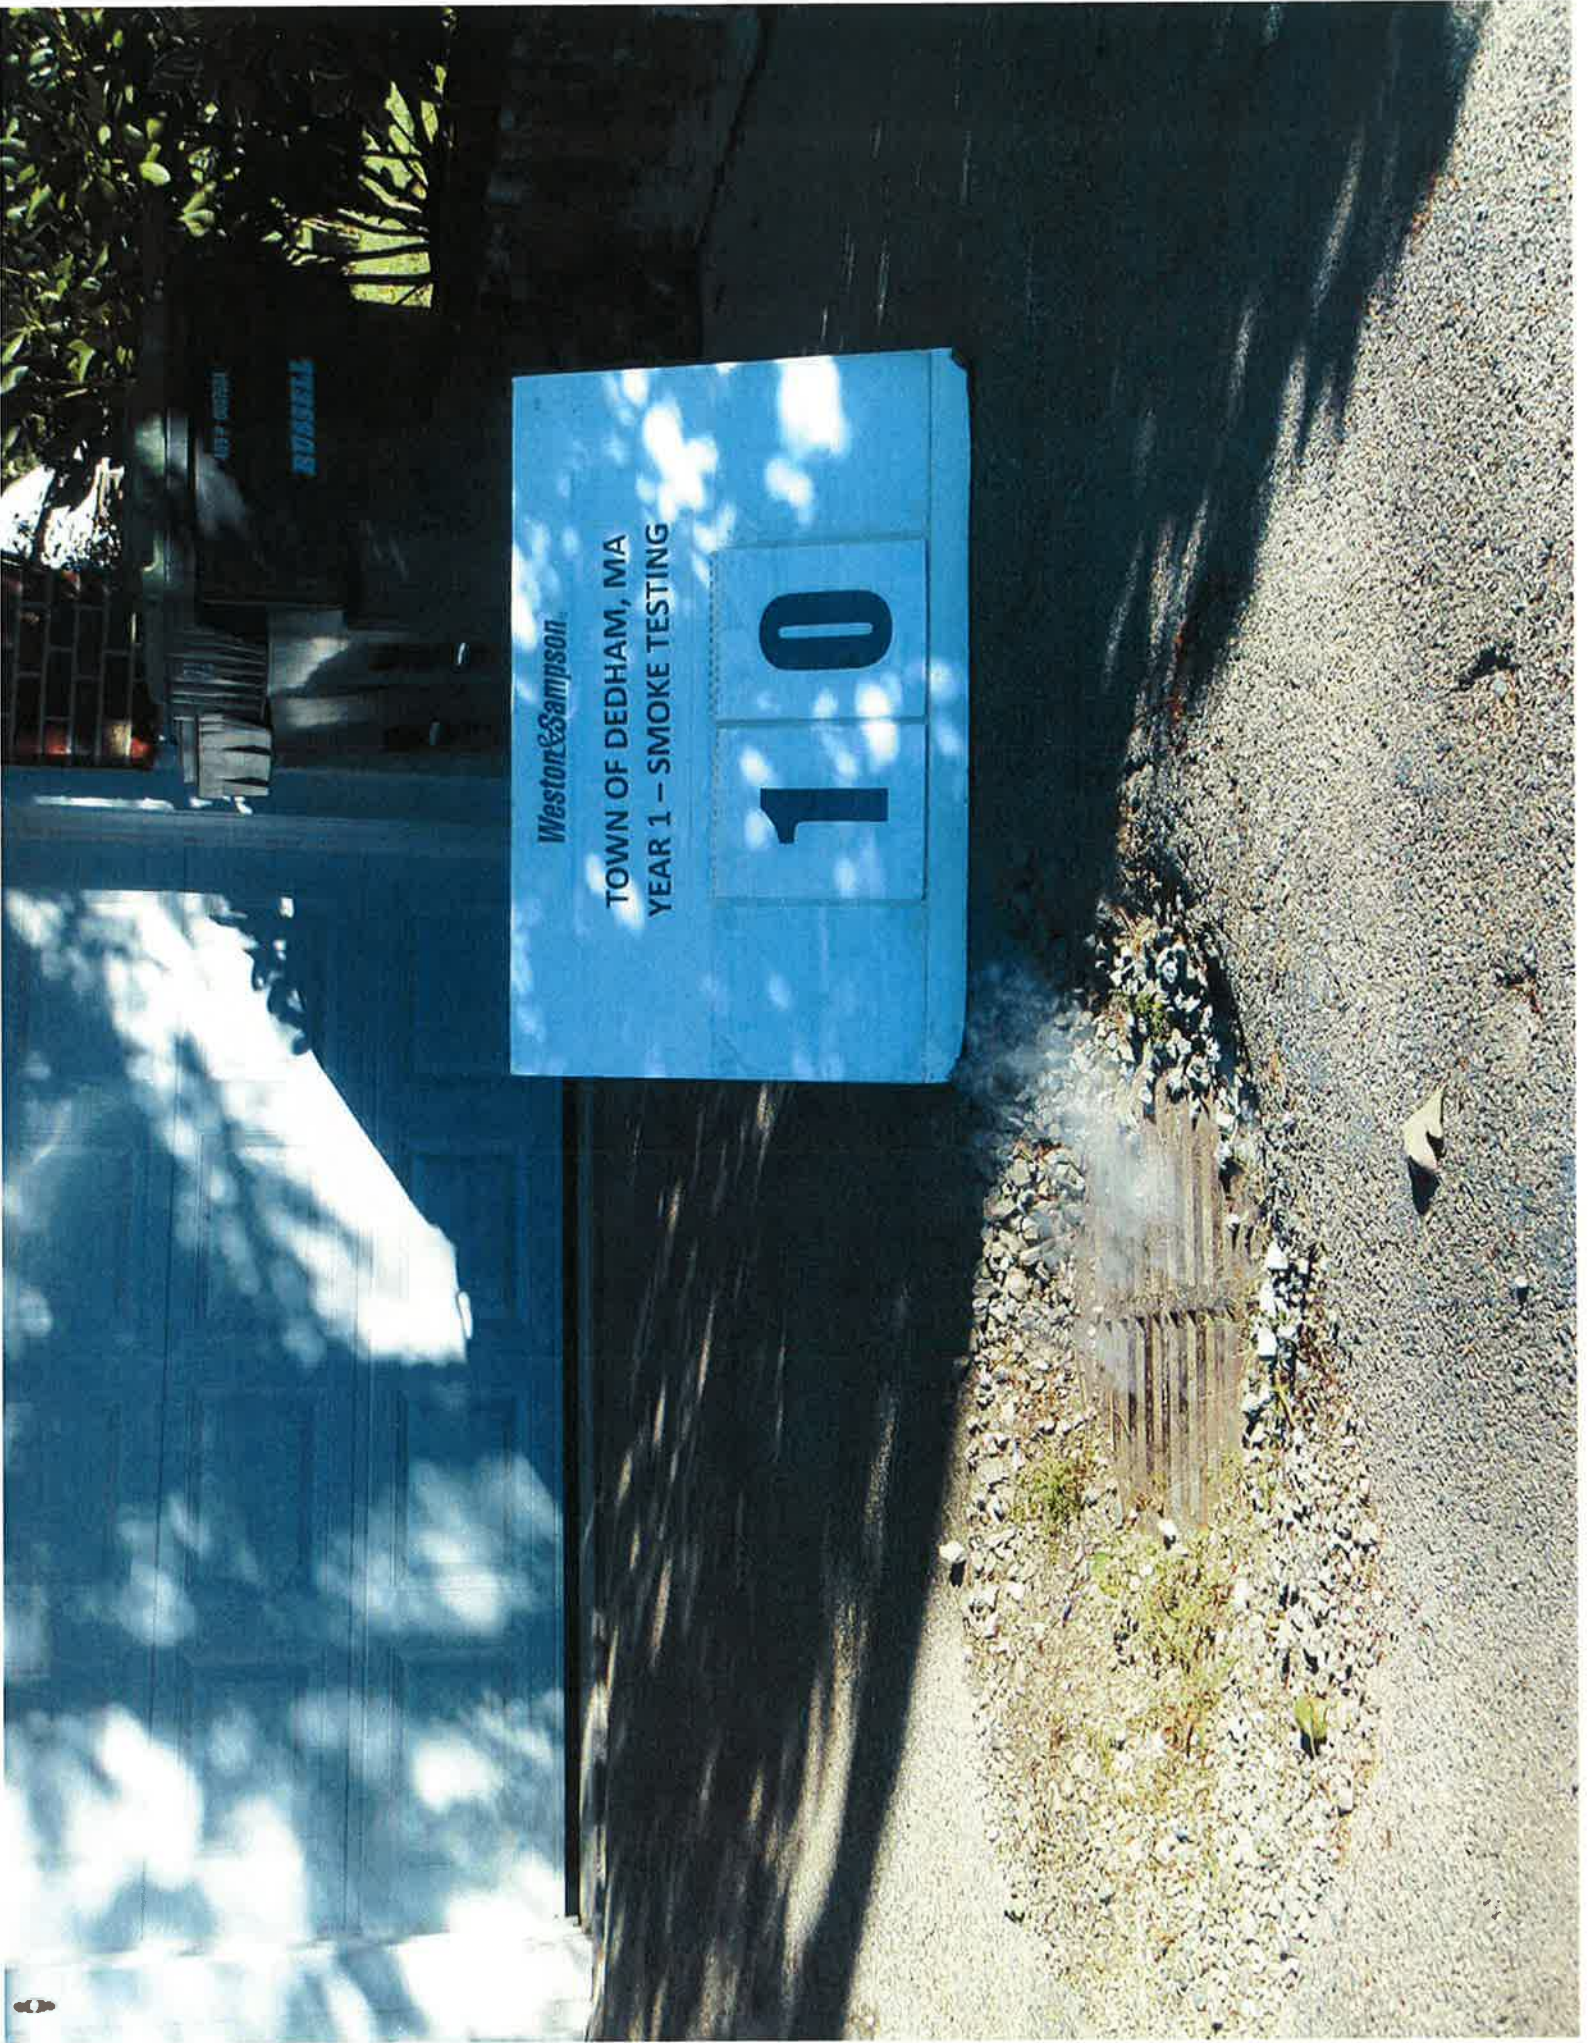
DEFECT	DESCRIPTION	Drainage Area	Surface Type	Severity			Picture No.(s)
				Major	Mod	Minor	
10	Driveway Drain.	748	Asphalt	X			10
11	Driveway Drain.	2381	Asphalt	X			11

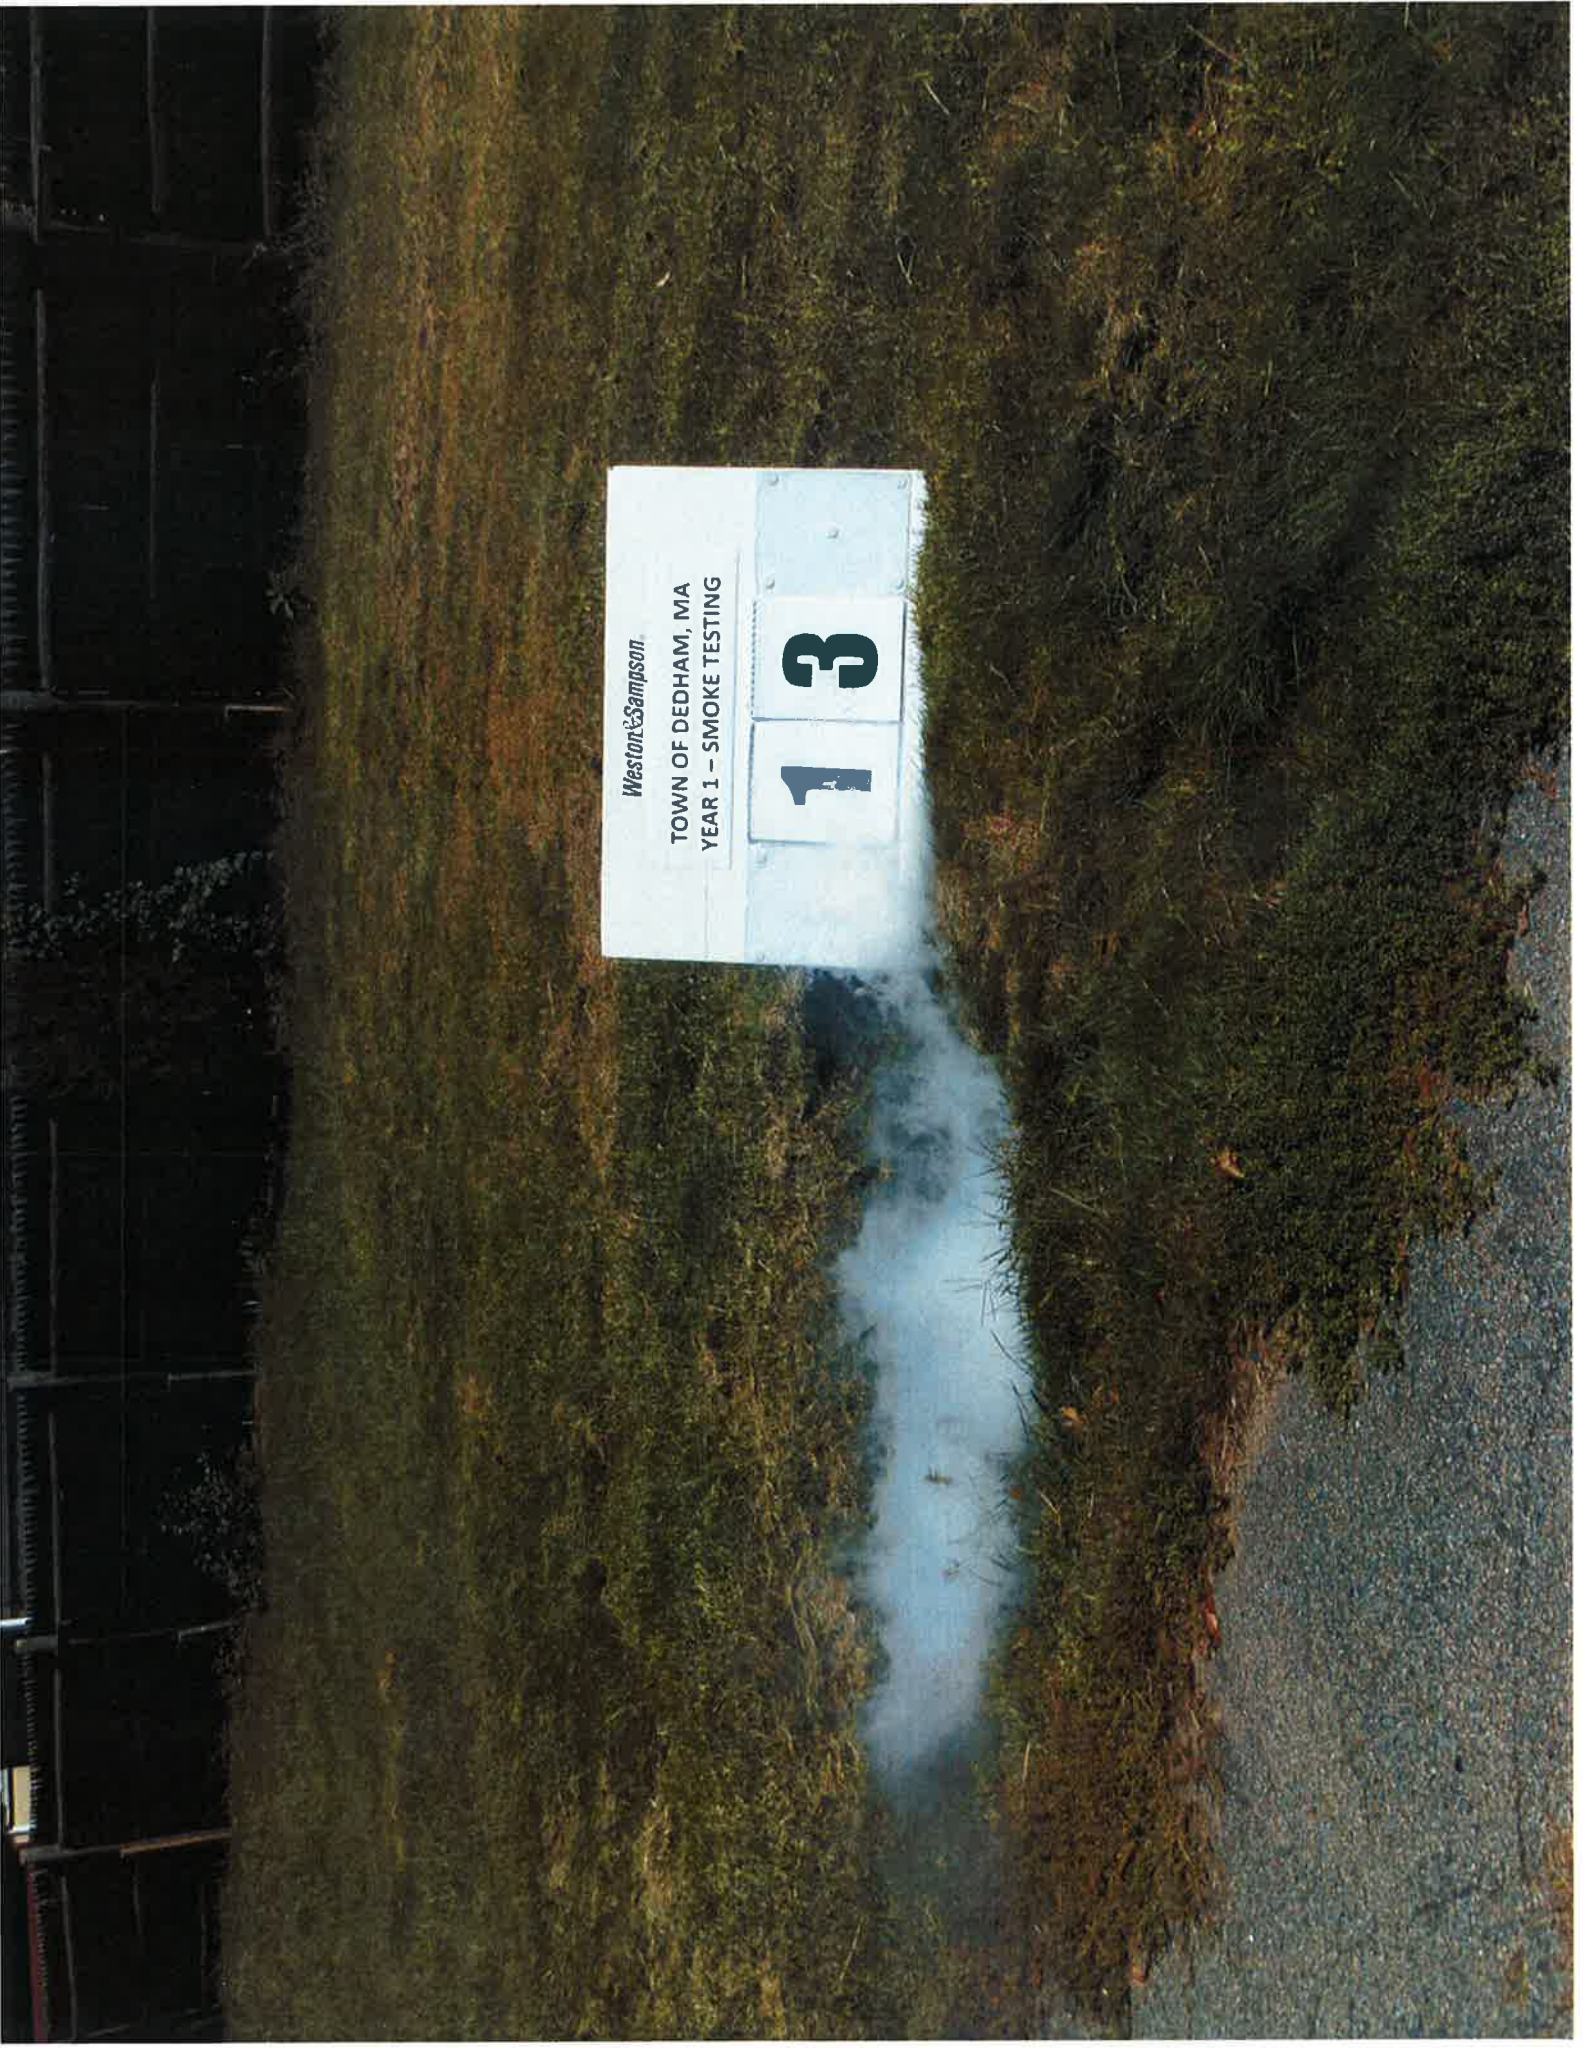
DEFECT	DESCRIPTION	Drainage Area	Surface Type	Severity			Picture No.(s)
				Major	Mod	Minor	
13	Broken Service Connection.	100	Grass		X		13

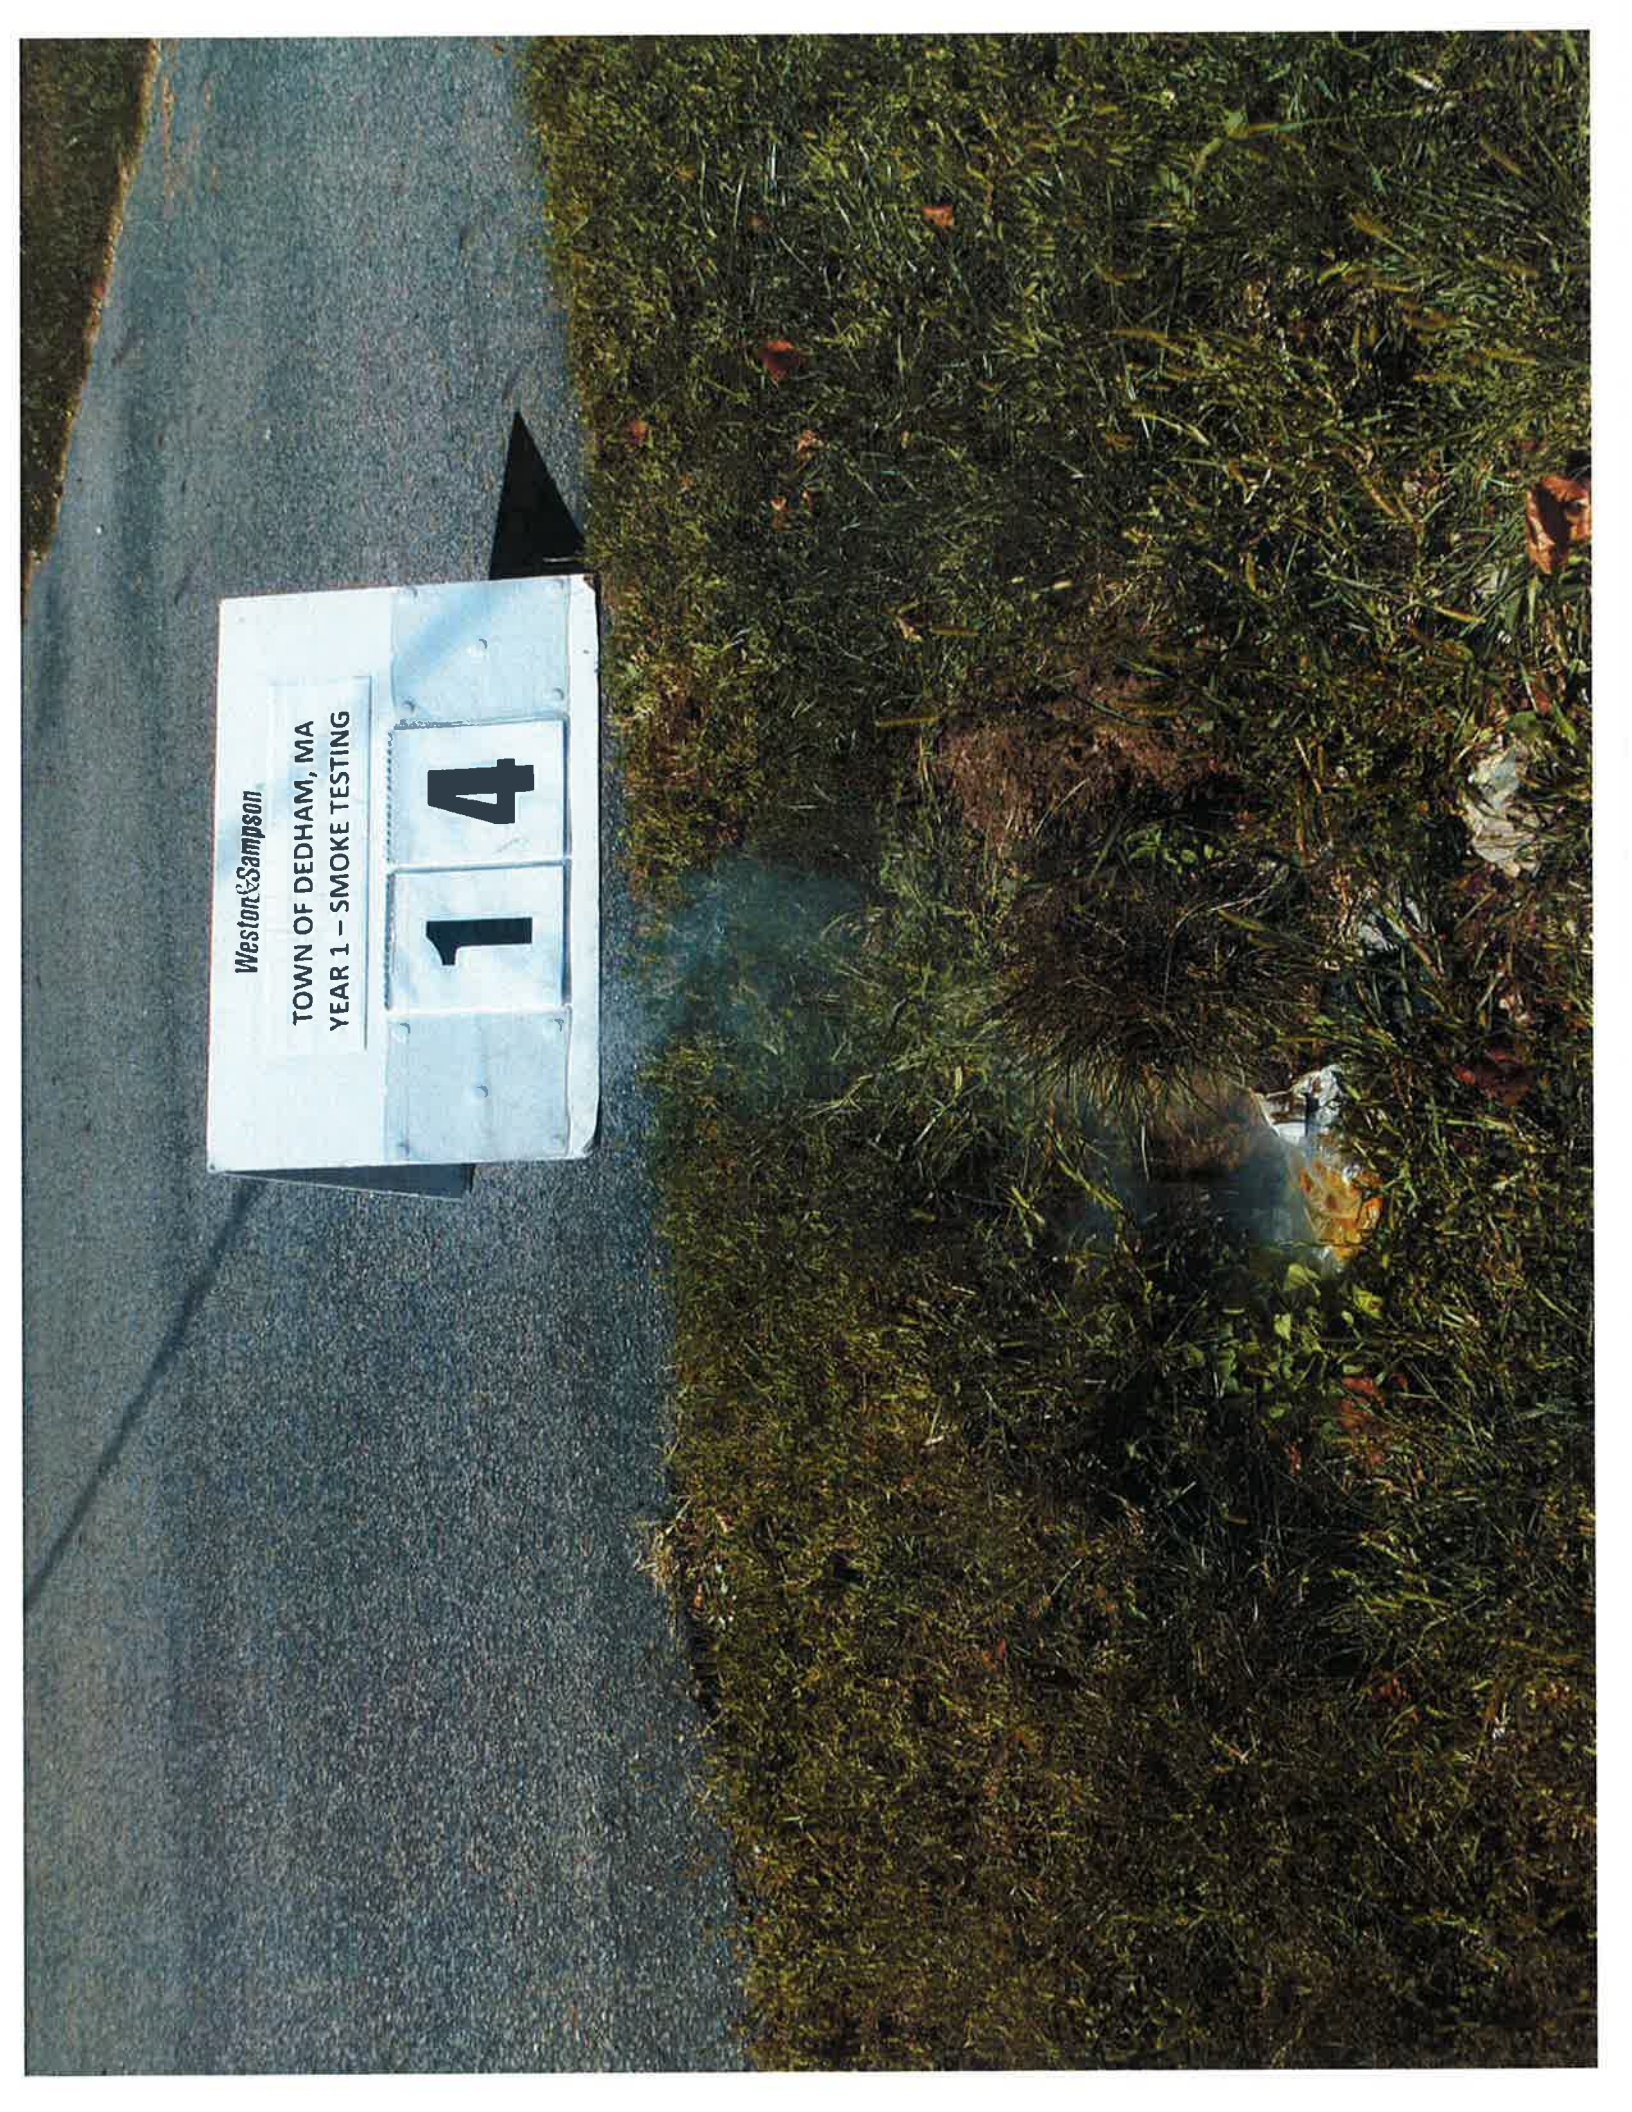
1	4
---	---

DEFECT	DESCRIPTION	Drainage Area	Surface Type	Severity			Picture No.(s)
				Major	Mod	Minor	
14	Broken Service Connection.	576	Asphalt		X		14

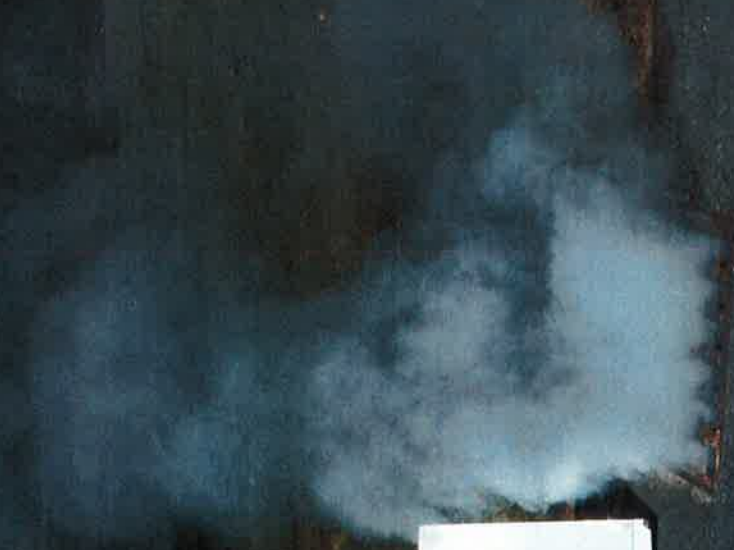
**DEFECT 17**  
**(Photo 2)**

Catch Basin directly connected to sewer 5.5' deep by 4' wide to invert of overflow pipe.

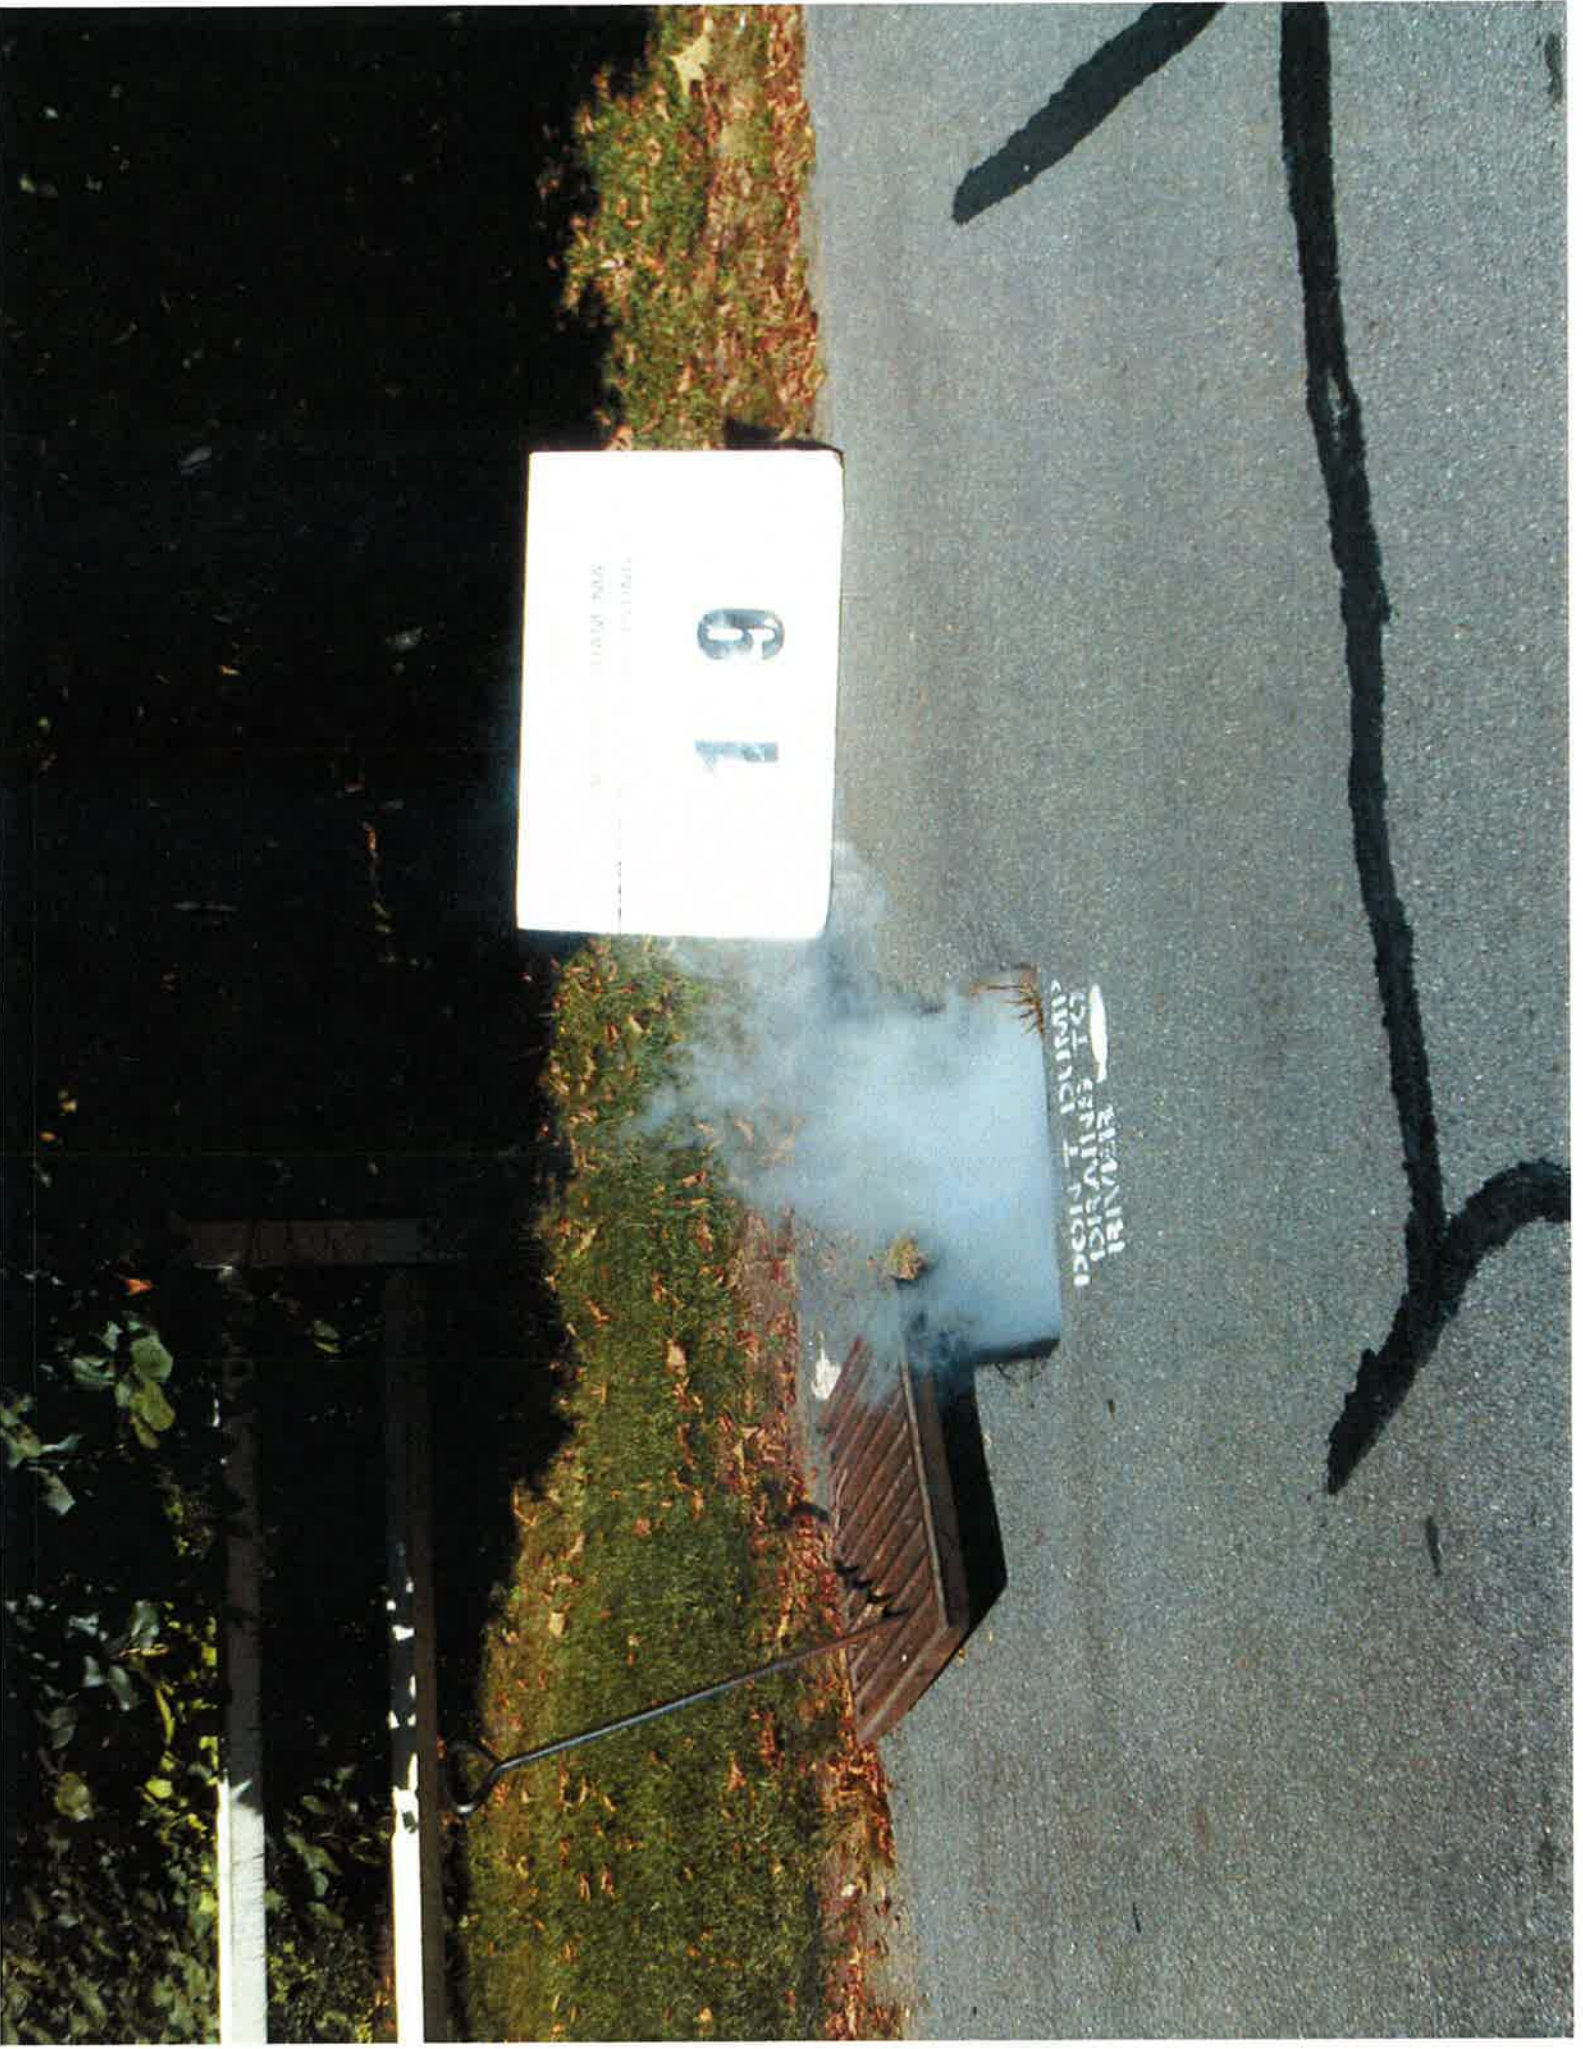
DEFECT	DESCRIPTION	Drainage Area	Surface Type	Severity			Picture No.(s)
				Major	Mod	Minor	
19	Catch Basin Indirectly connected to sewer. Smoke leaking in from brick walls.	480	Asphalt		X		19

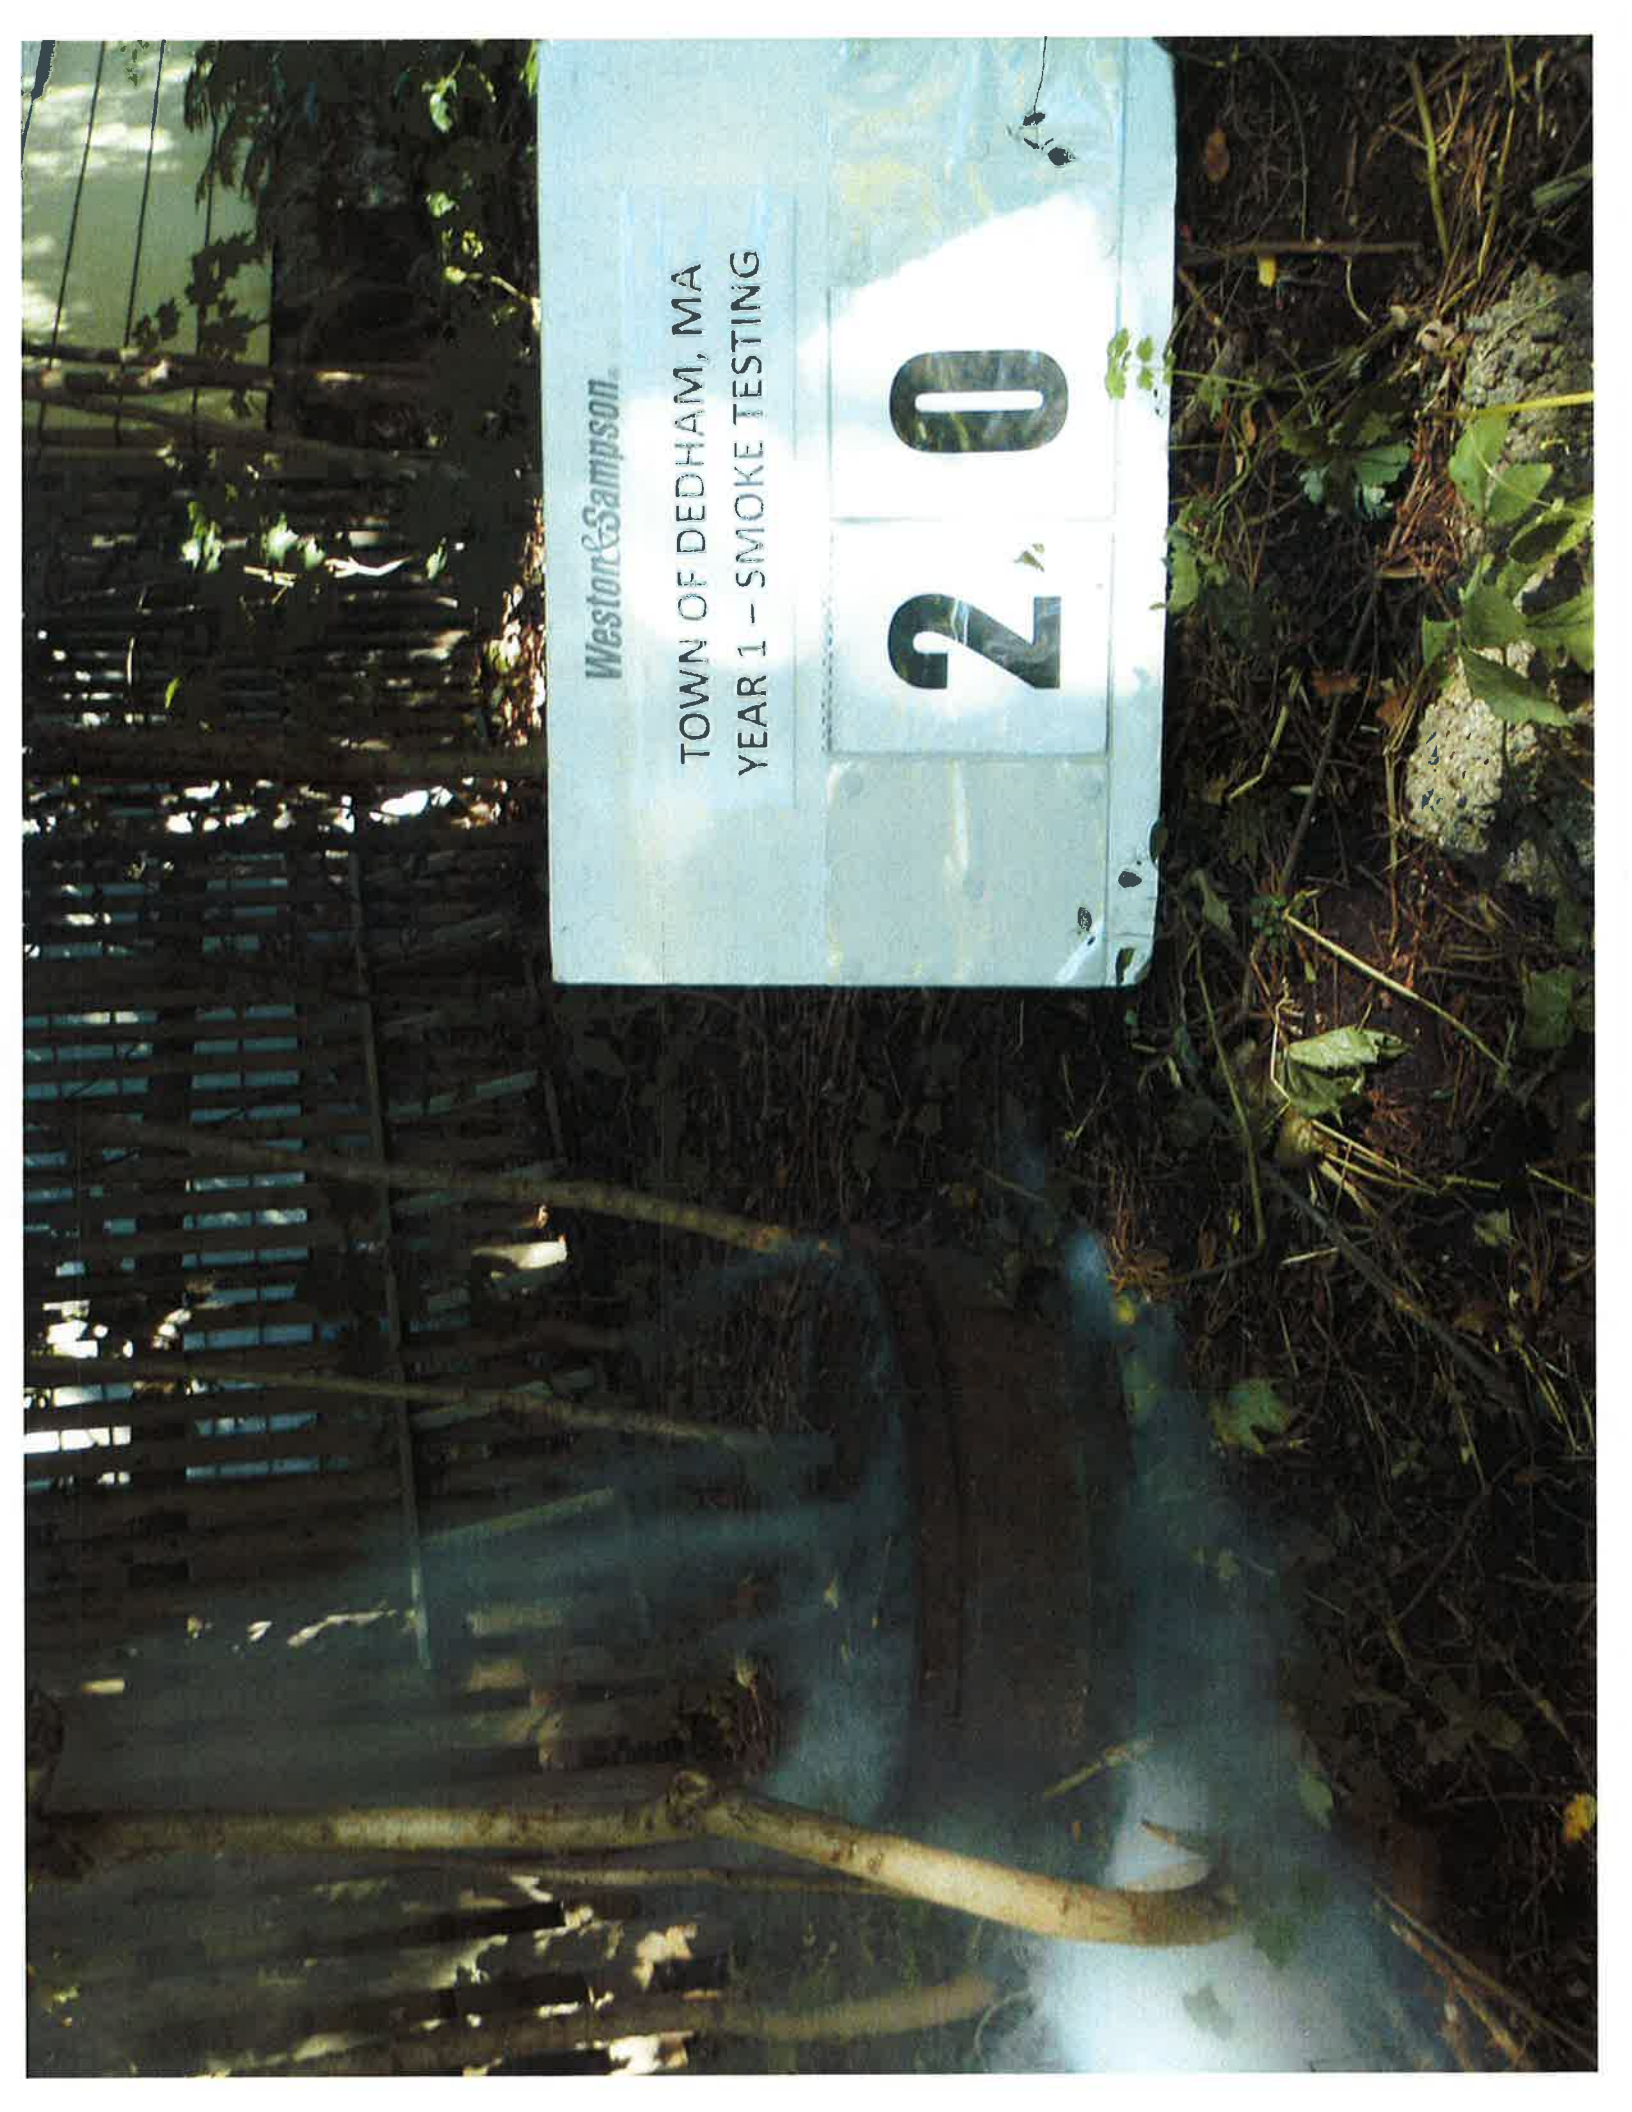
DEFECT	DESCRIPTION	Drainage Area	Surface Type	Severity			Picture No.(s)
				Major	Mod	Minor	
20	MH GG 170 with loose frame and vent holes in cover.		Grass		X		20
21	MH GG 160 with loose frame and vent holes in cover.		Grass		X		21

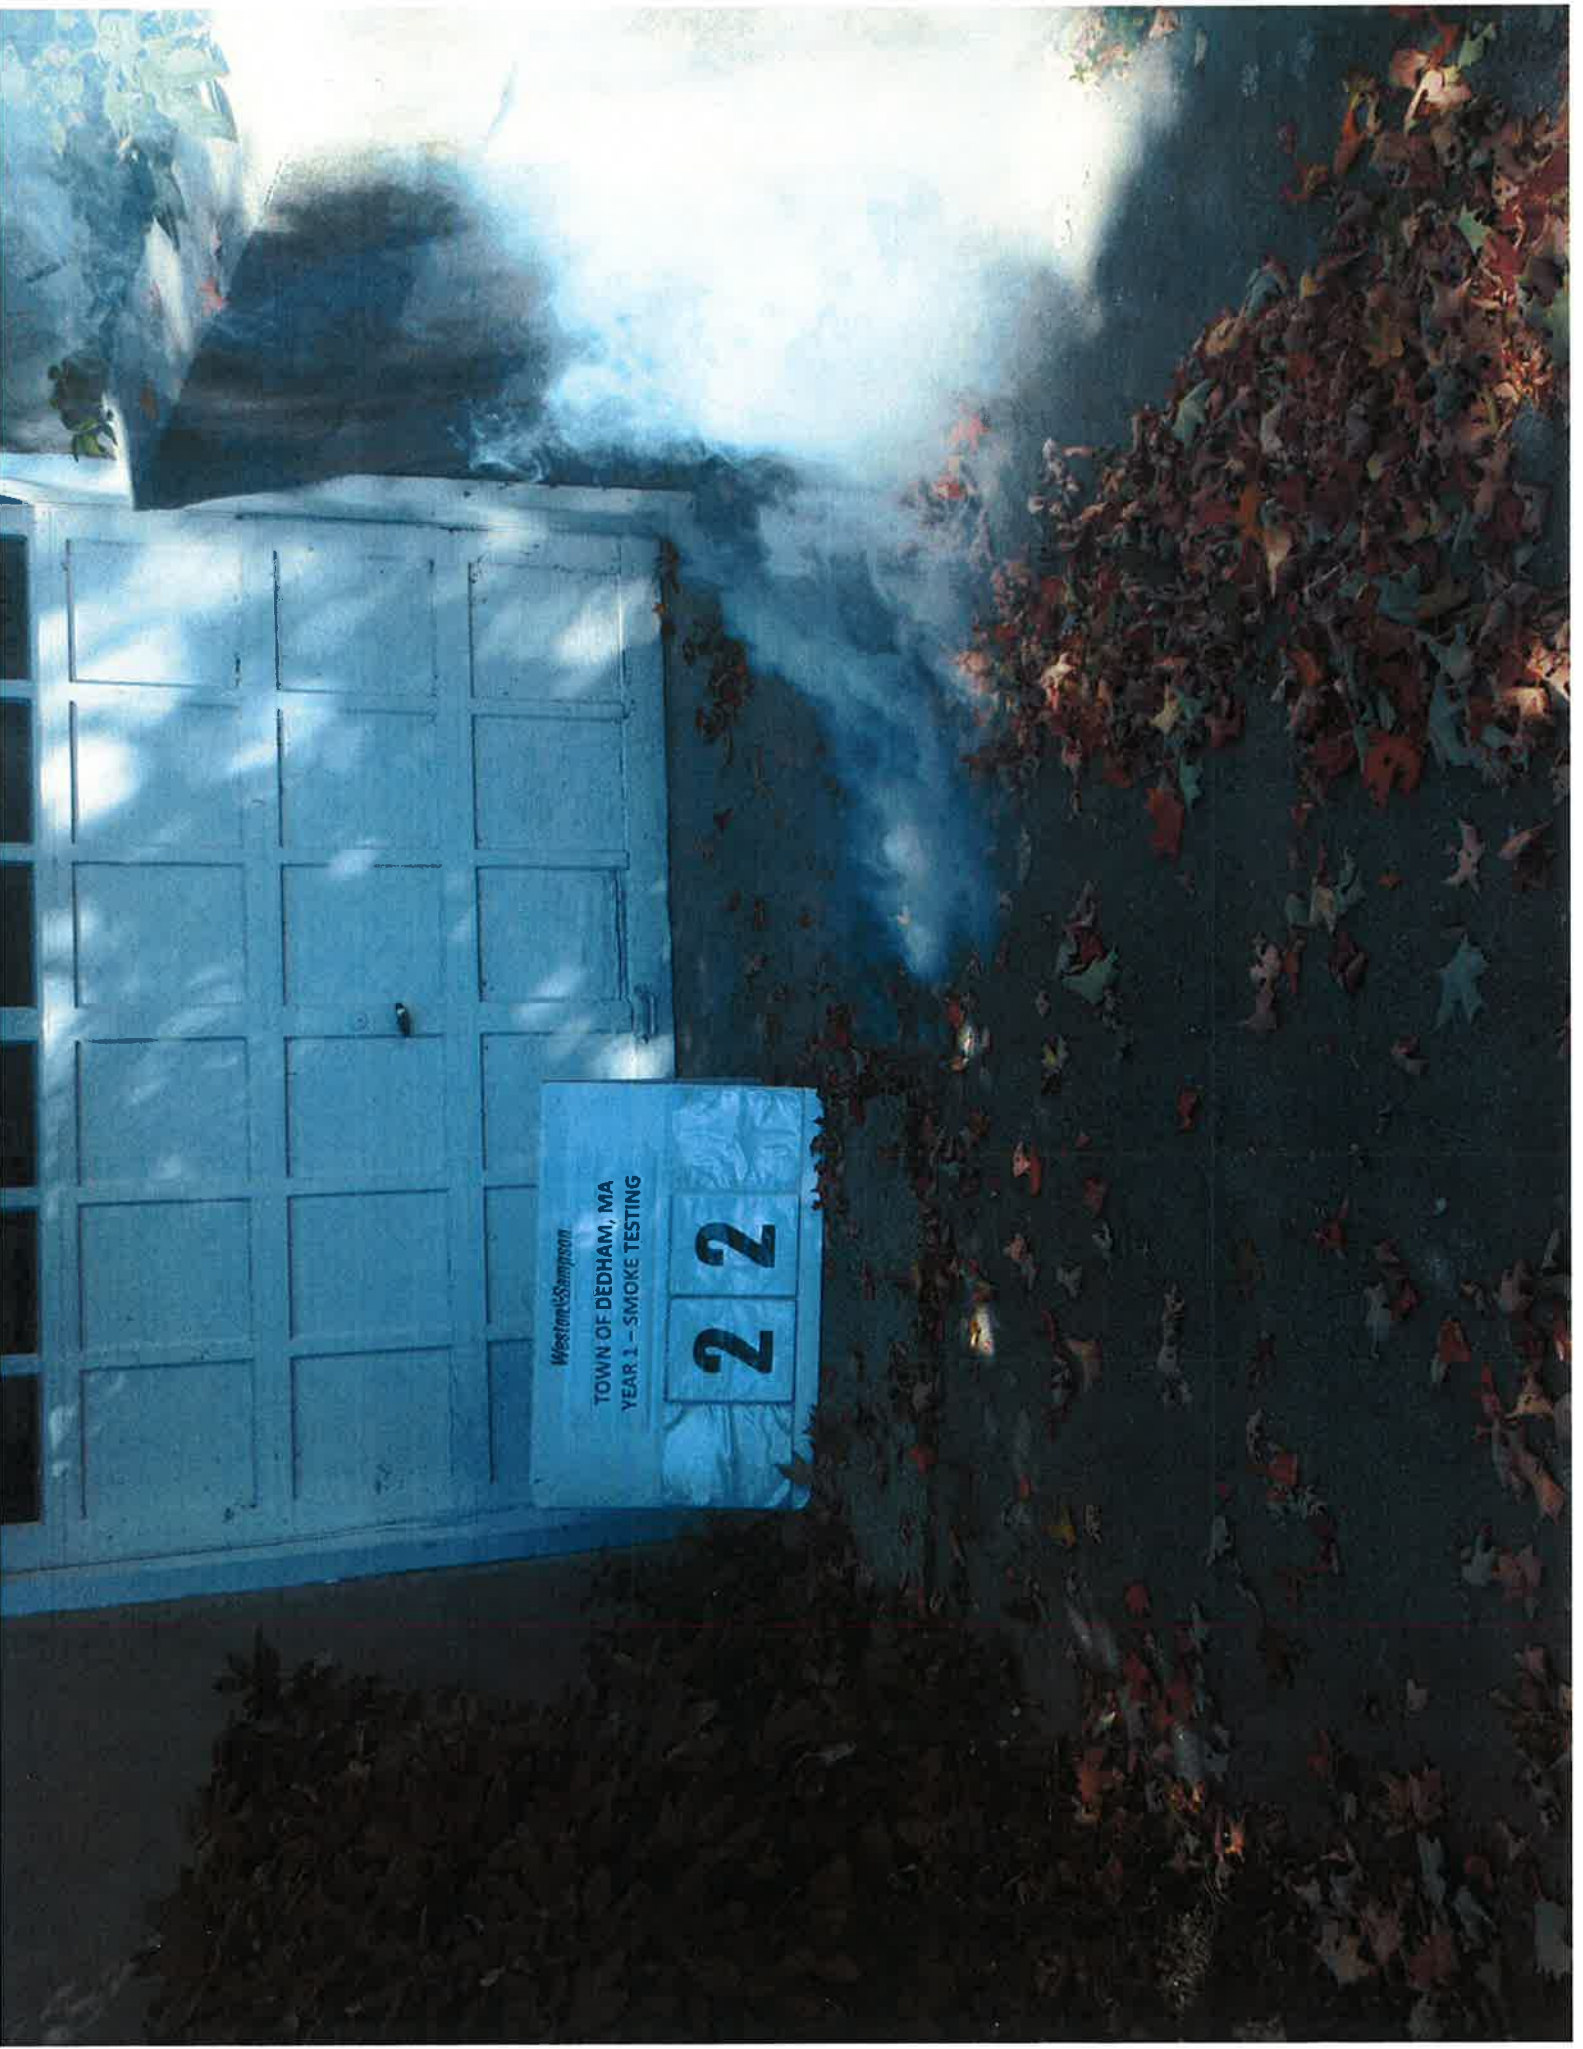
DEFECT	DESCRIPTION	Drainage Area	Surface Type	Severity			Picture No.(s)
				Major	Mod	Minor	
22	Driveway Drain.	243	Asphalt	X			22
