## **Town of Dedham, MA**

### **2013 Year One Inflow Investigation**

March 2014

**Town of Dedham, Massachusetts**  
**Weston & Sampson Project No. 2130225.A**

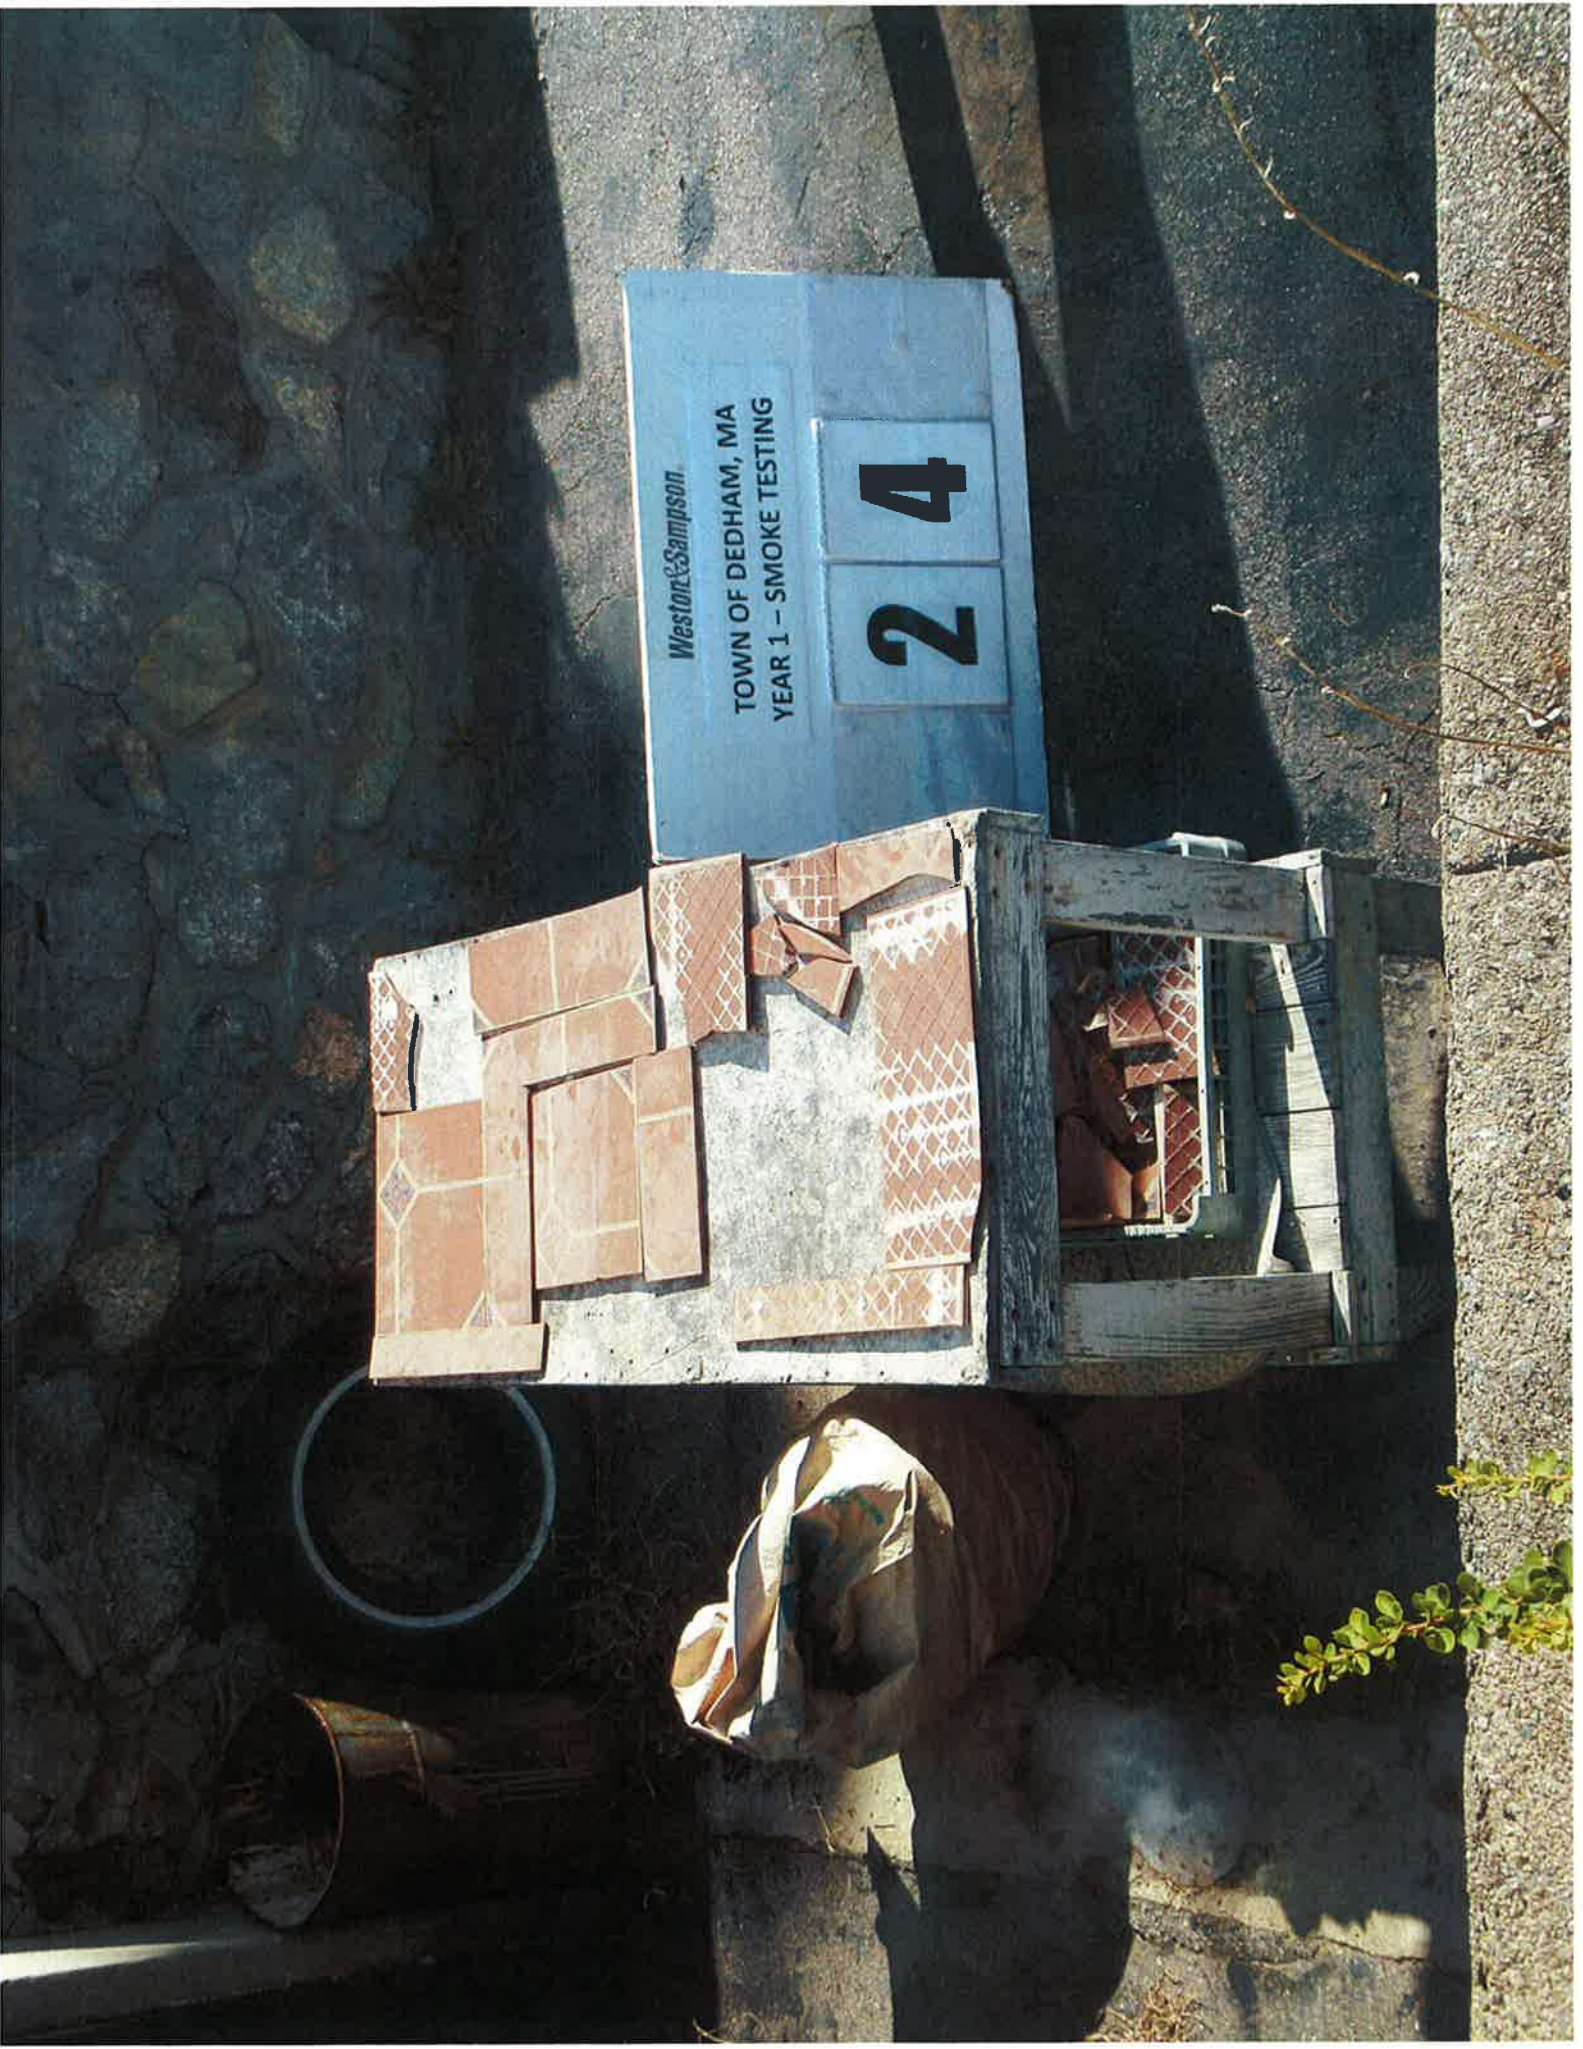
DEFECT	DESCRIPTION	Drainage Area	Surface Type	Severity			Picture No.(s)
				Major	Mod	Minor	
24	Driveway Drain.	252	Asphalt	X			24

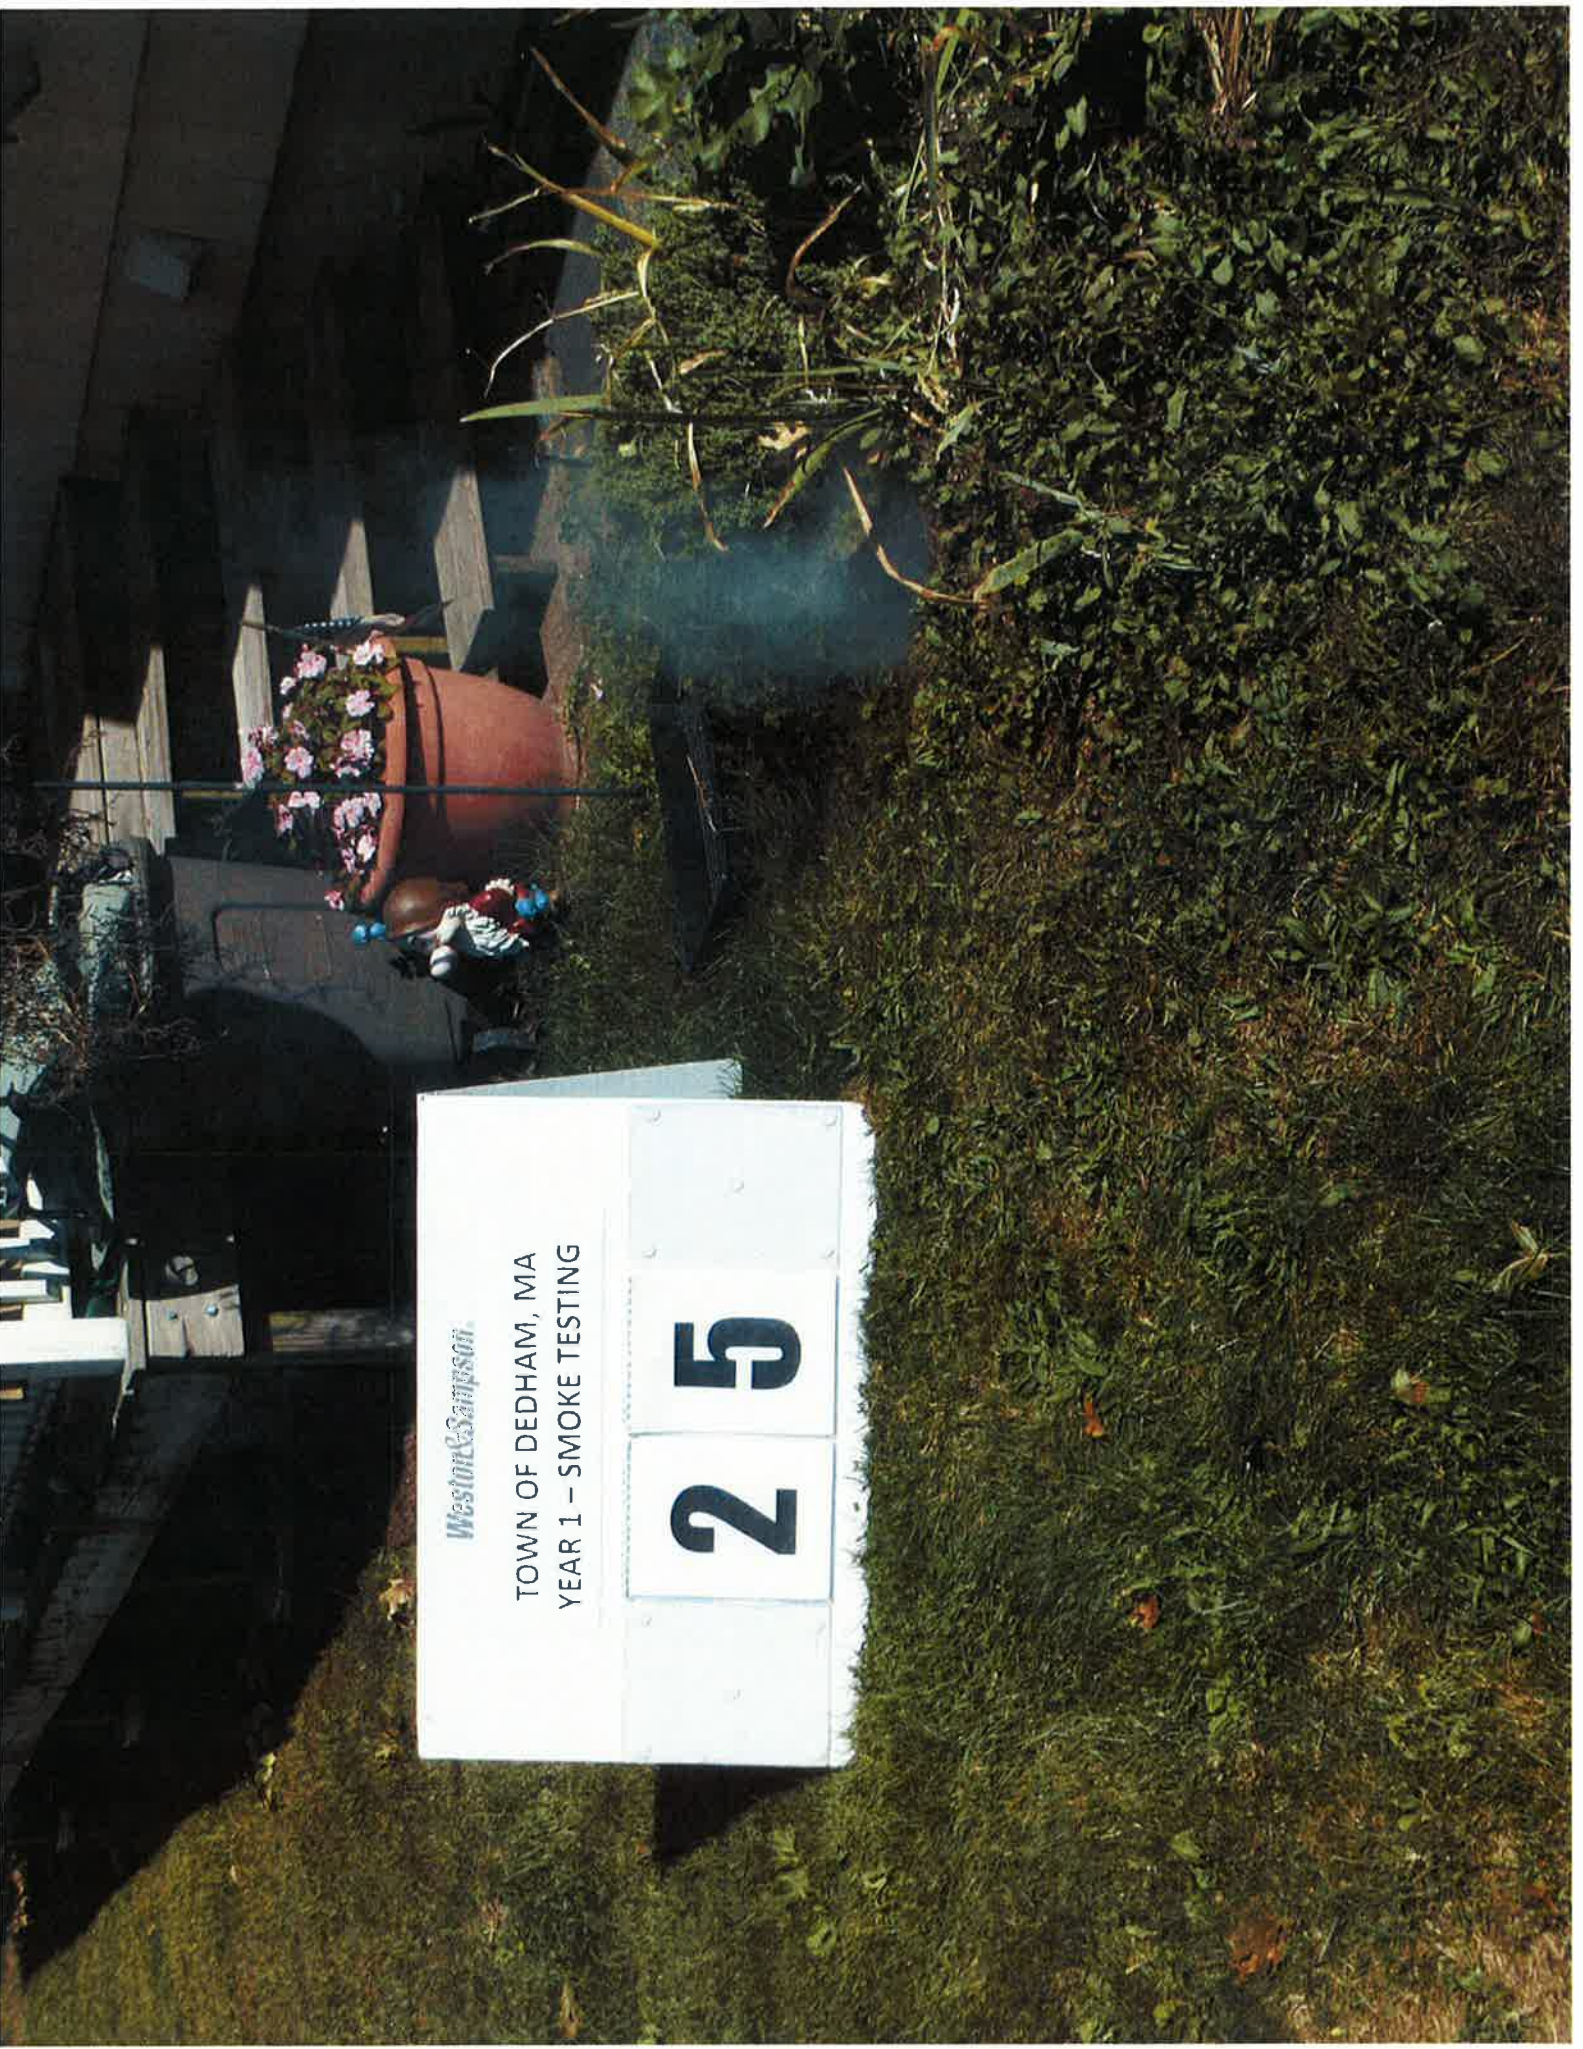
DEFECT	DESCRIPTION	Drainage Area	Surface Type	Severity			Picture No.(s)
				Major	Mod	Minor	
25	Missing Exterior Cleanout Cap.	25	Grass			X	25

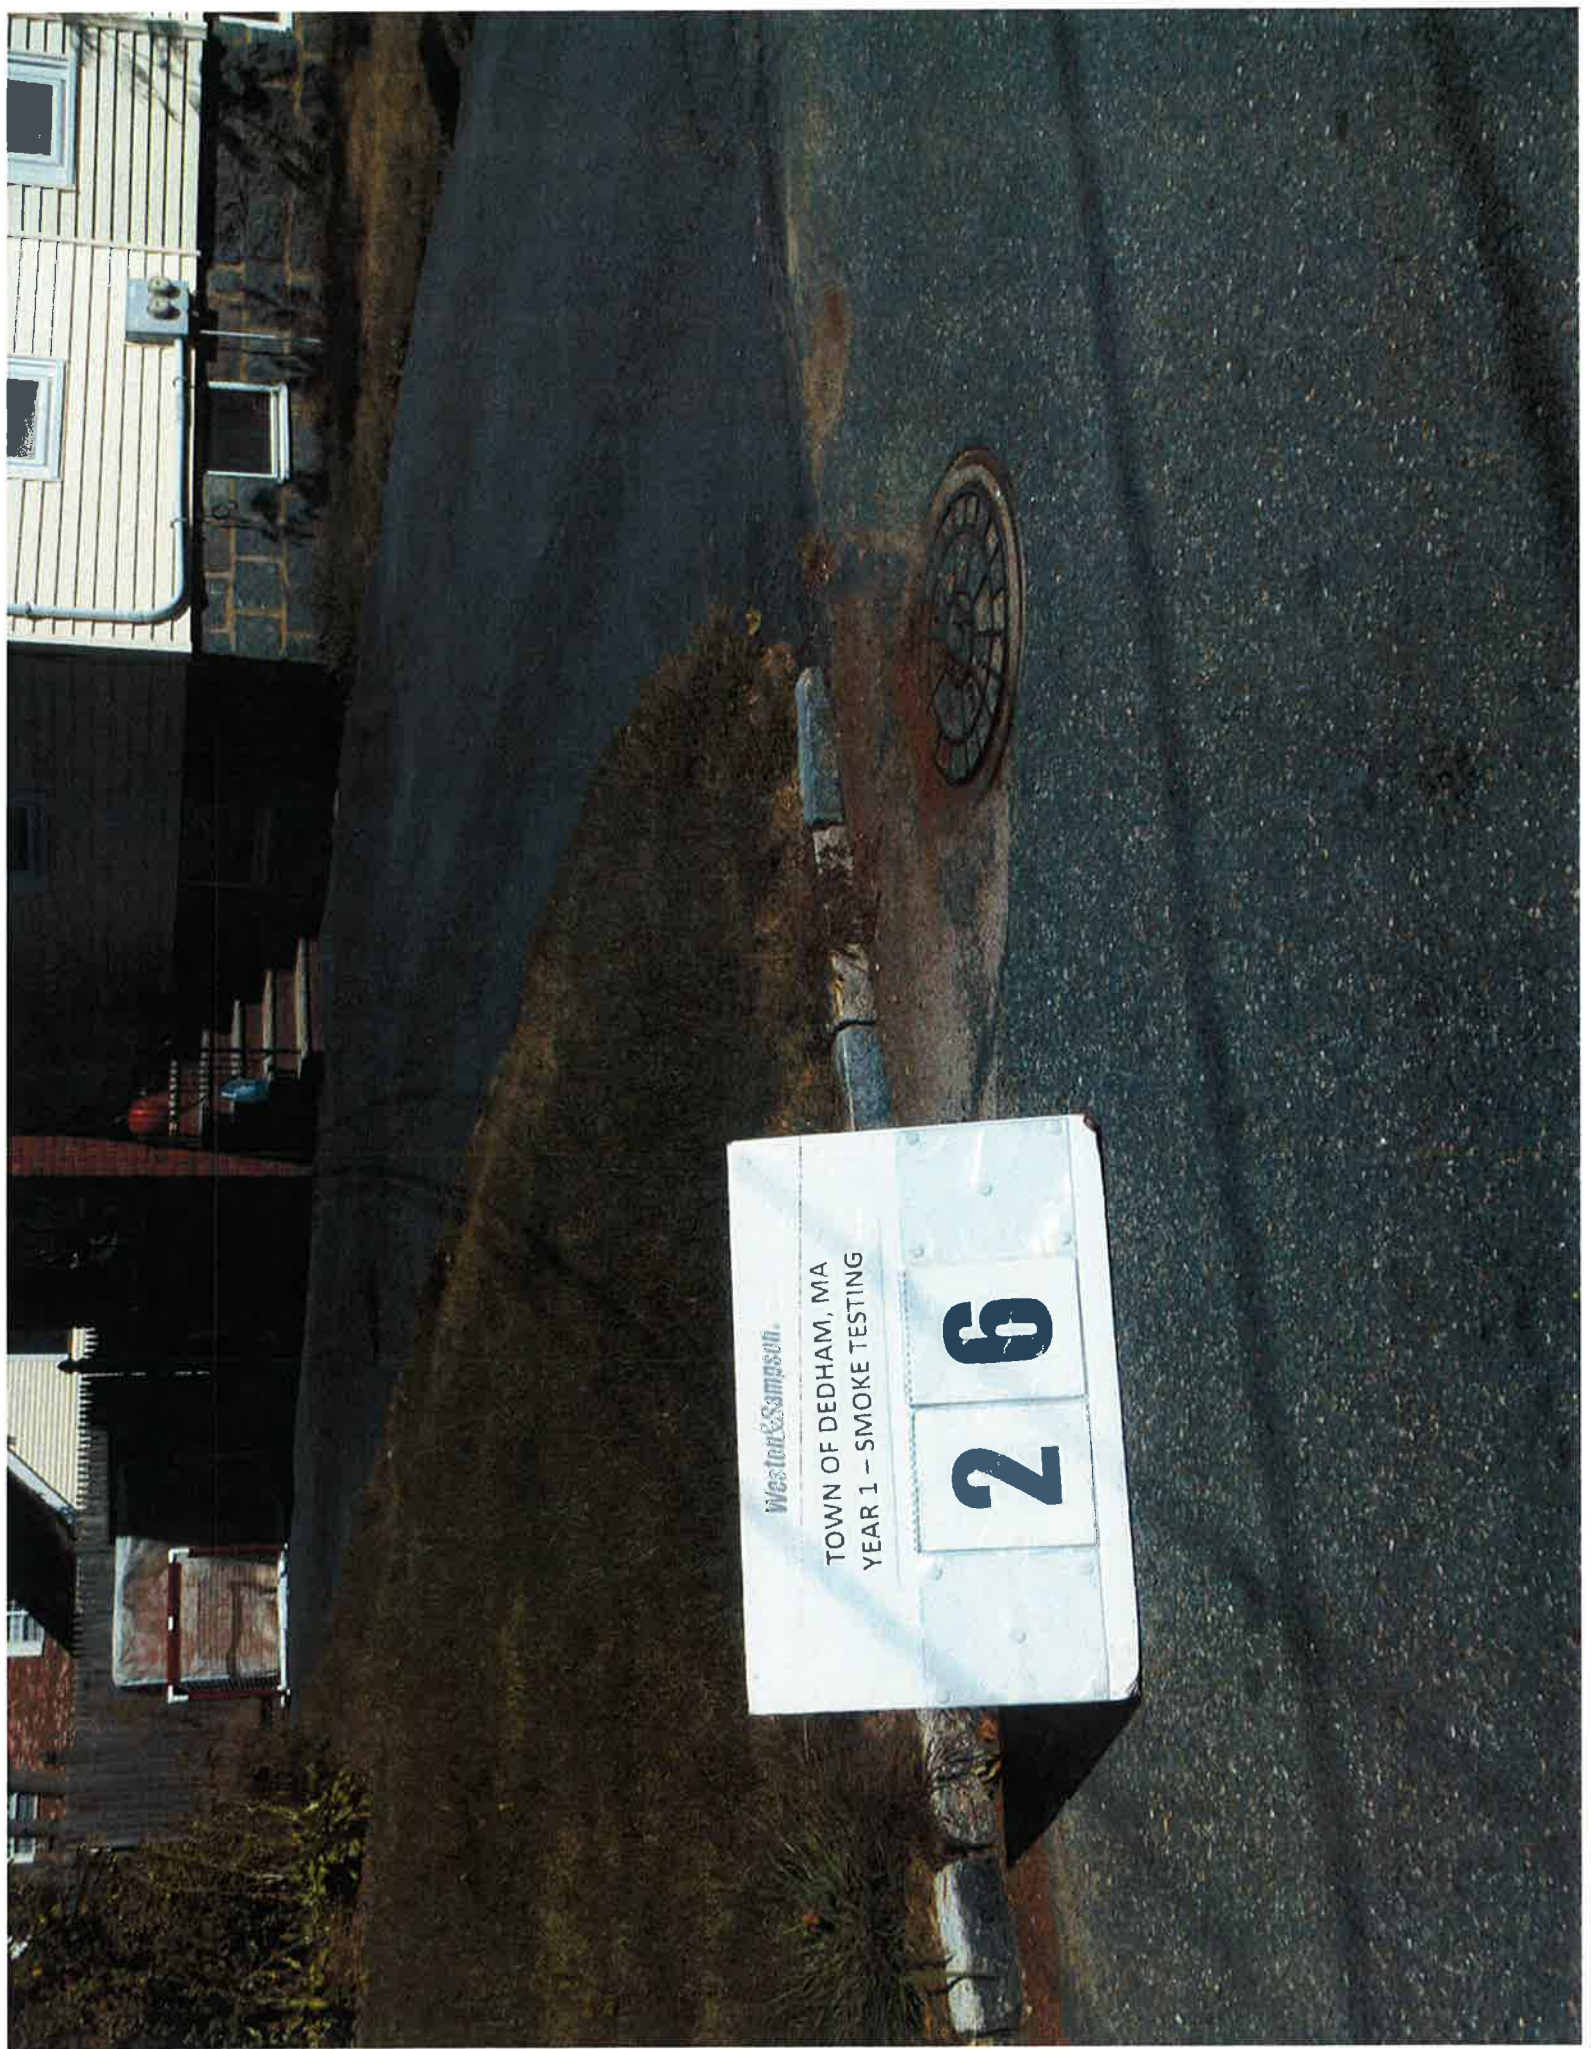
DEFECT	DESCRIPTION	Drainage Area	Surface Type	Severity			Picture No.(s)
				Major	Mod	Minor	
26	MWRA MH in Subarea KK with vent hole.	600	Asphalt	X			26
