**COLBURN STREET DAM  
FOLLOW-UP  
INSPECTION / EVALUATION REPORT**

**Dam Name: Colburn Street Dam**

**State Dam ID#: 6-11-73-2**

**Date of Inspection: July 15, 2013**

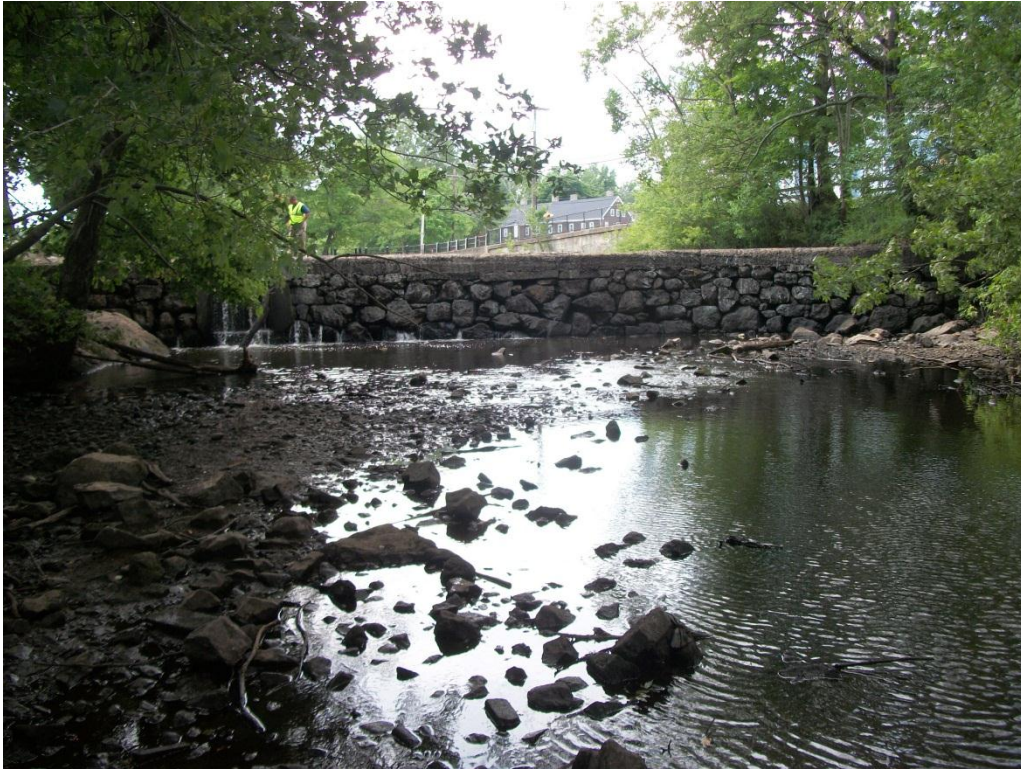
Photo 1: View of dam from downstream.

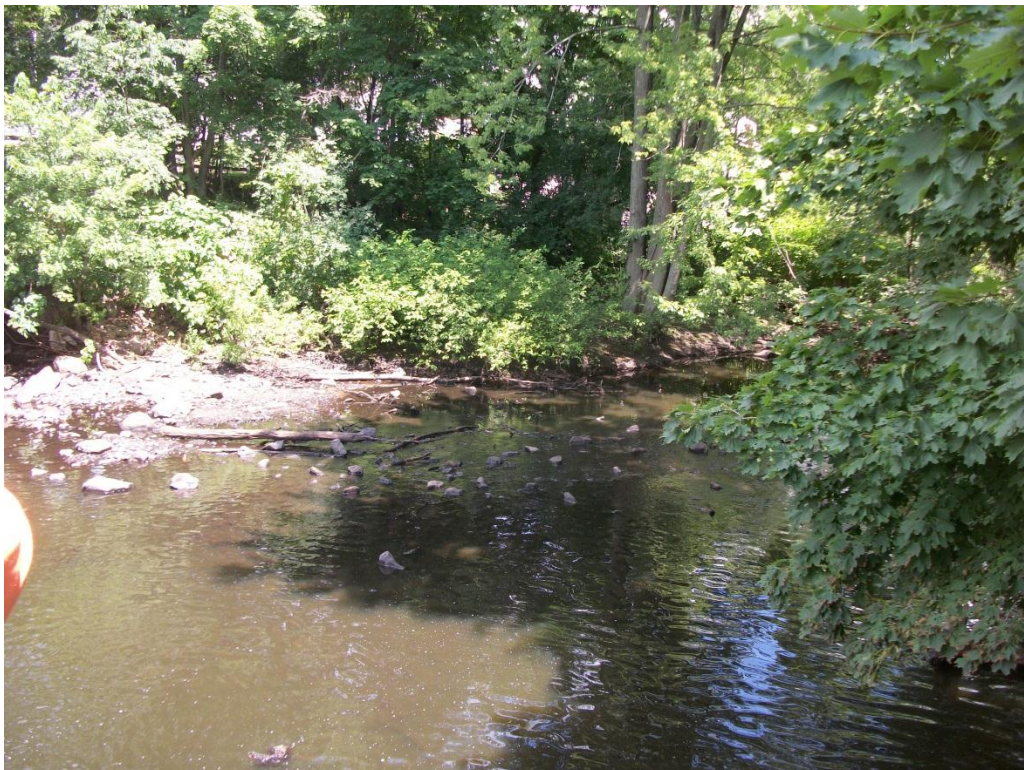
Photo 2: Downstream discharge channel from top of dam.

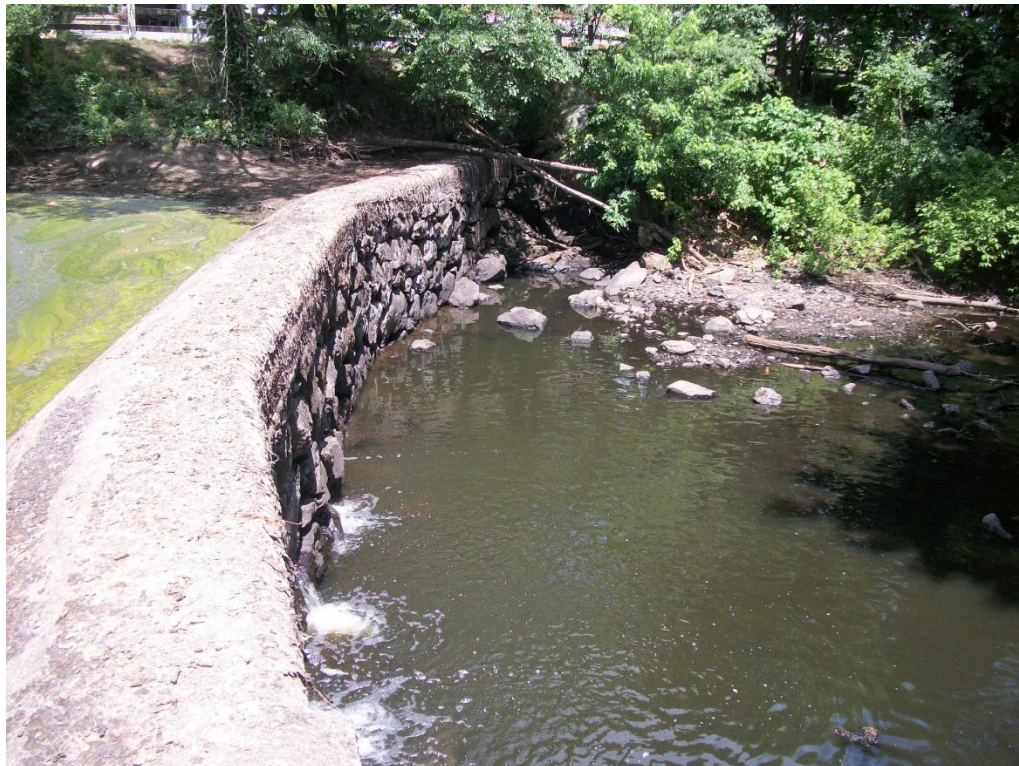
- **If yes, list the deficiencies and describe.**
  - Seepage was observed through the unmortared masonry downstream face of the dam, approximately six feet from the top of the dam.

Photo 4: Woody vegetation at right abutment. Note seepage through face of dam.

In addition, GZA recommends that consideration be given to addressing the observed leakage through the dam, missing stones on the downstream face, scour at the toe, and the condition of the stop logs.

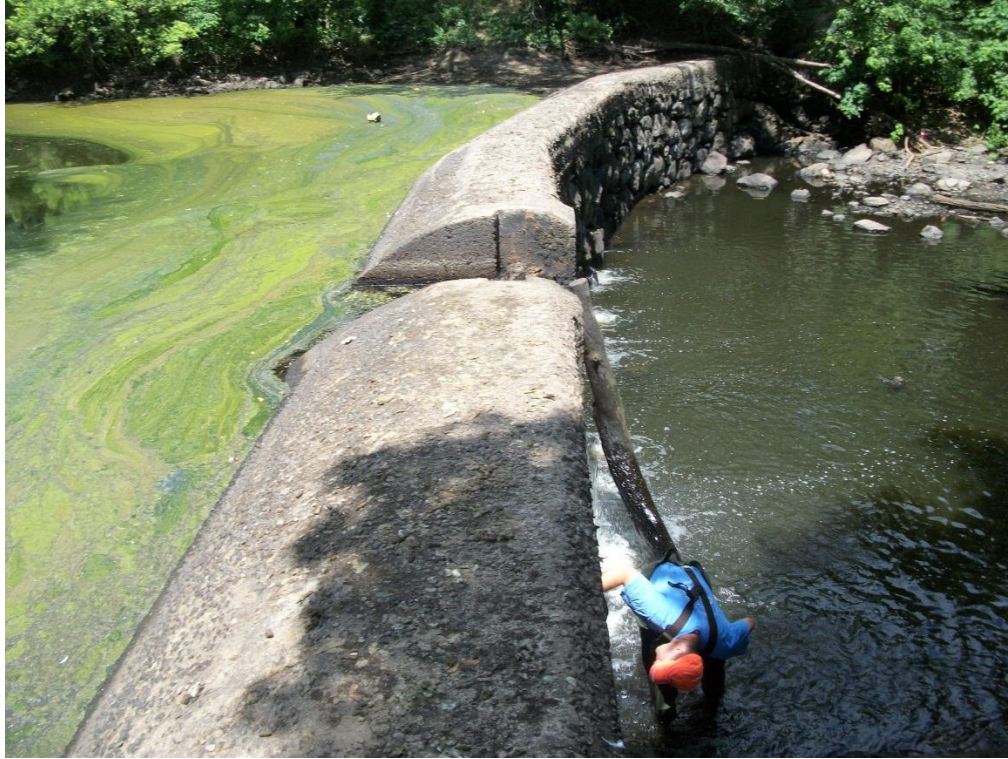
Photo 5: View of crest and sluiceway from right abutment.

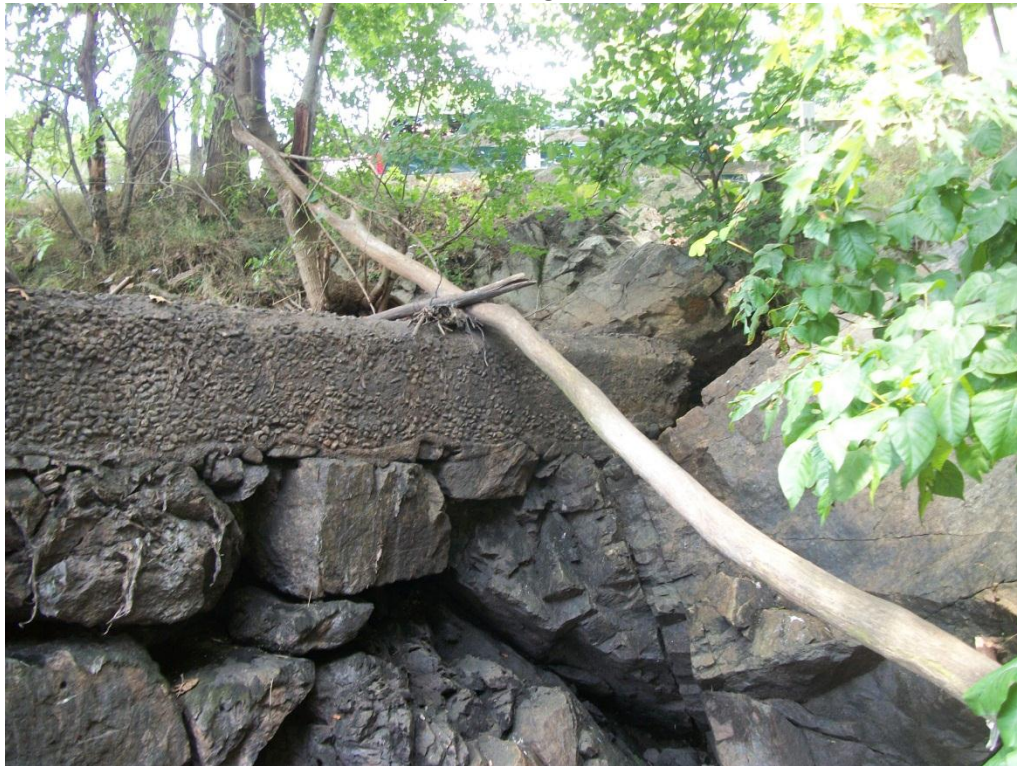
Photo 6: View of left abutment. Note good contact between concrete and bedrock.

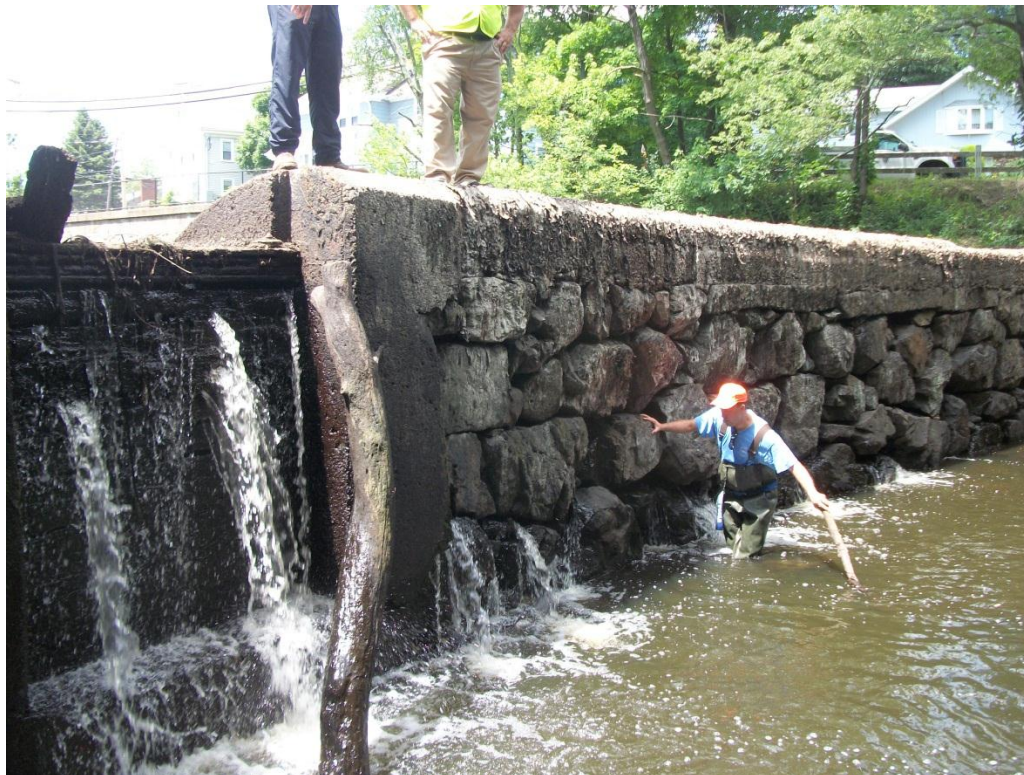
- Scour of up to approximately up to 5 feet was observed via probing immediately downstream of the sluiceway, as well as two to four feet downstream of the face of the dam, for the length of the dam.

Photo 8: Seepage through face of dam and leakage through stop logs. Note scour measured downstream by approximately six foot long stick.

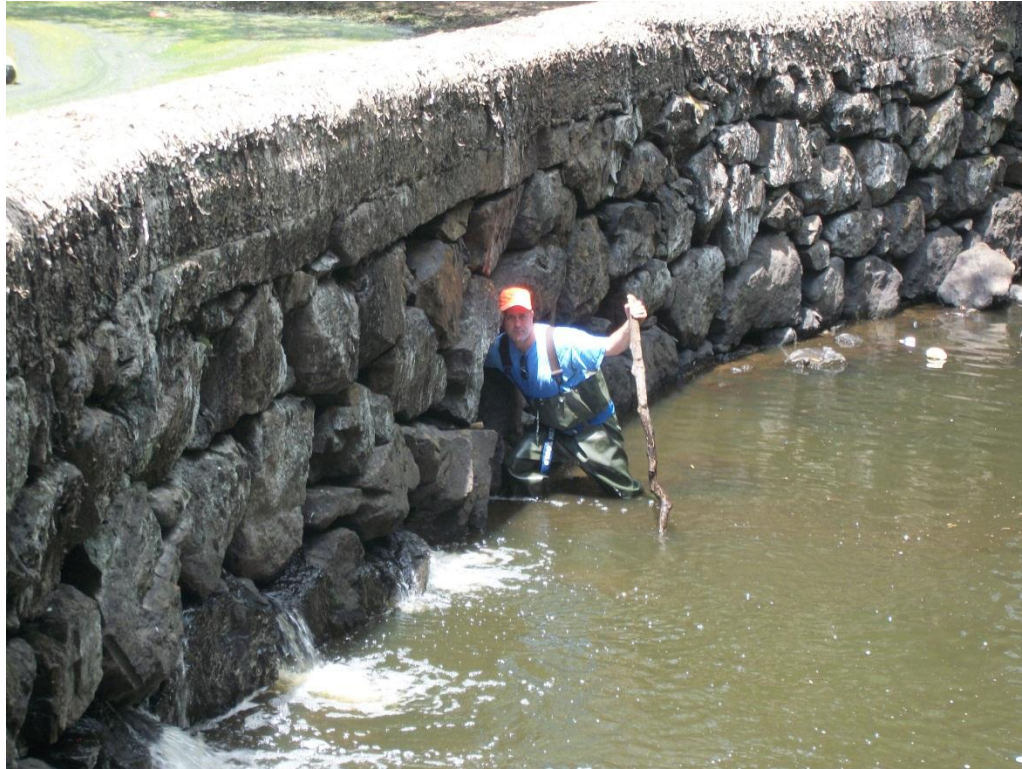
- Leakage through the installed timber stop logs was also observed.
  - Voids were found in the downstream face of the dam which suggested that large stones may have been displaced from the structure. There was not a general connection between the location of the voids and the location of seepage.

Photo 9: Large voids between stones on face of dam (no indication of soil movement).

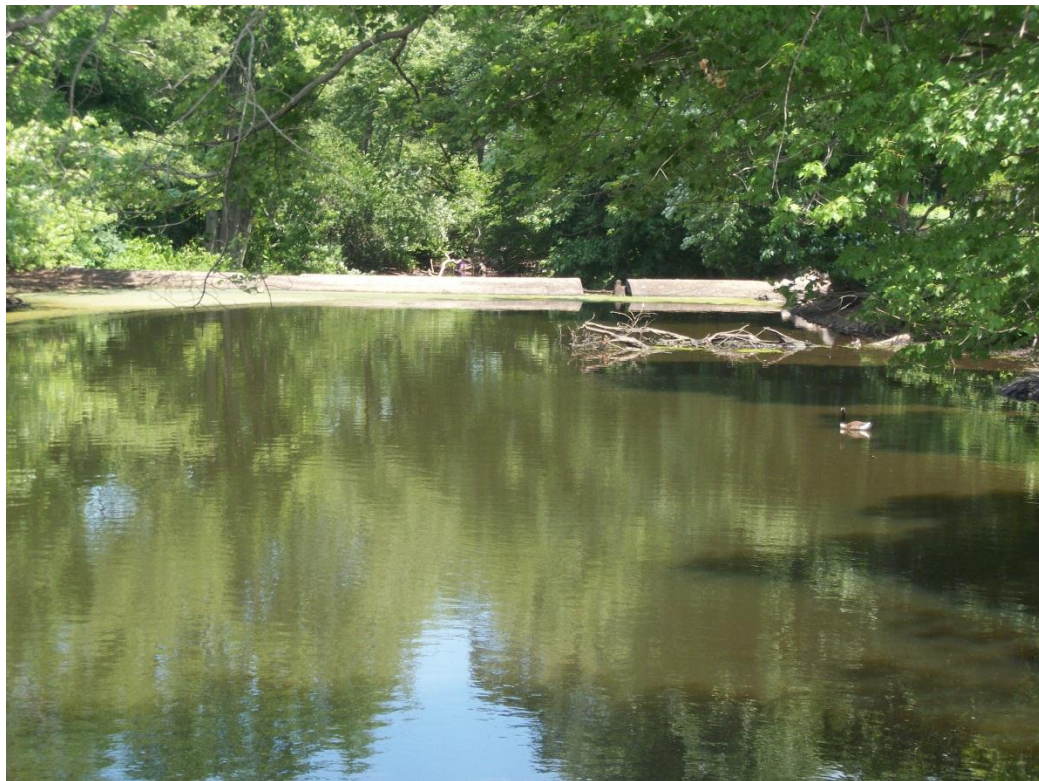
Photo 10: Upstream view of dam.
