# Colburn Street Dam

Town of Dedham, Massachusetts

Phase II Investigation Report

March 31, 2016

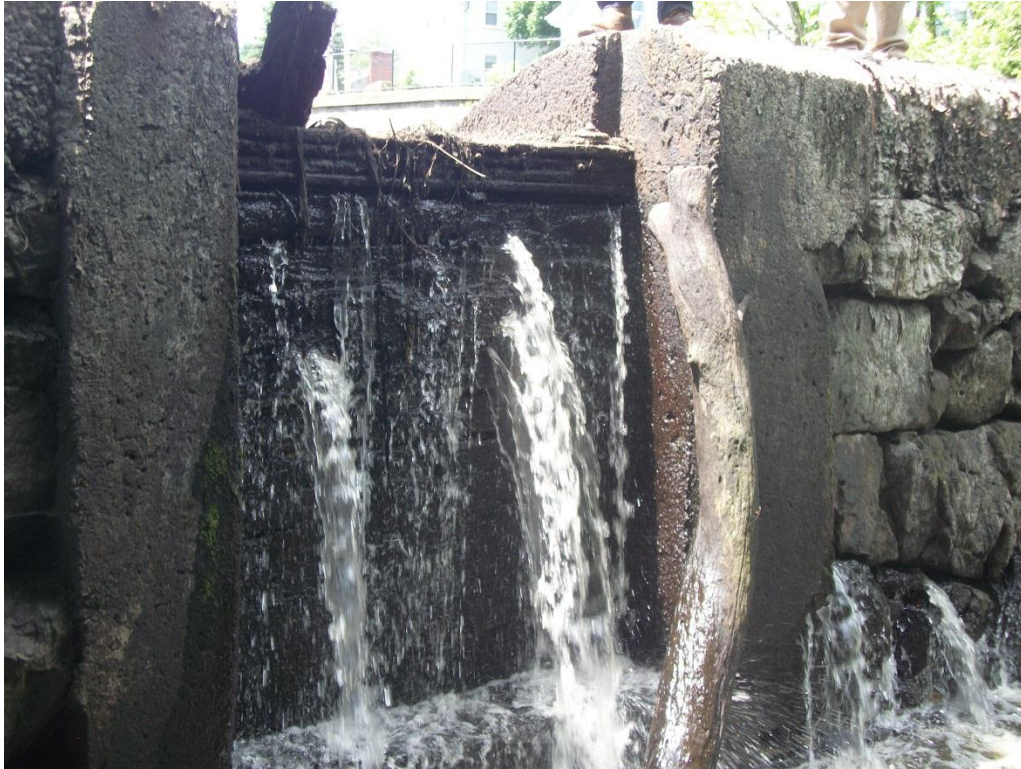
- Leakage through the installed timber stop logs was also observed.
  - Voids were found in the downstream face of the dam which suggested that large stones may have been displaced from the structure. There was not a general connection between the location of the voids and the location of seepage.

Photo 3: Leakage through the stop logs at the sluiceway.

Replacing the stop logs will provide an operable stop log system while eliminating the current leakage that occurs there.

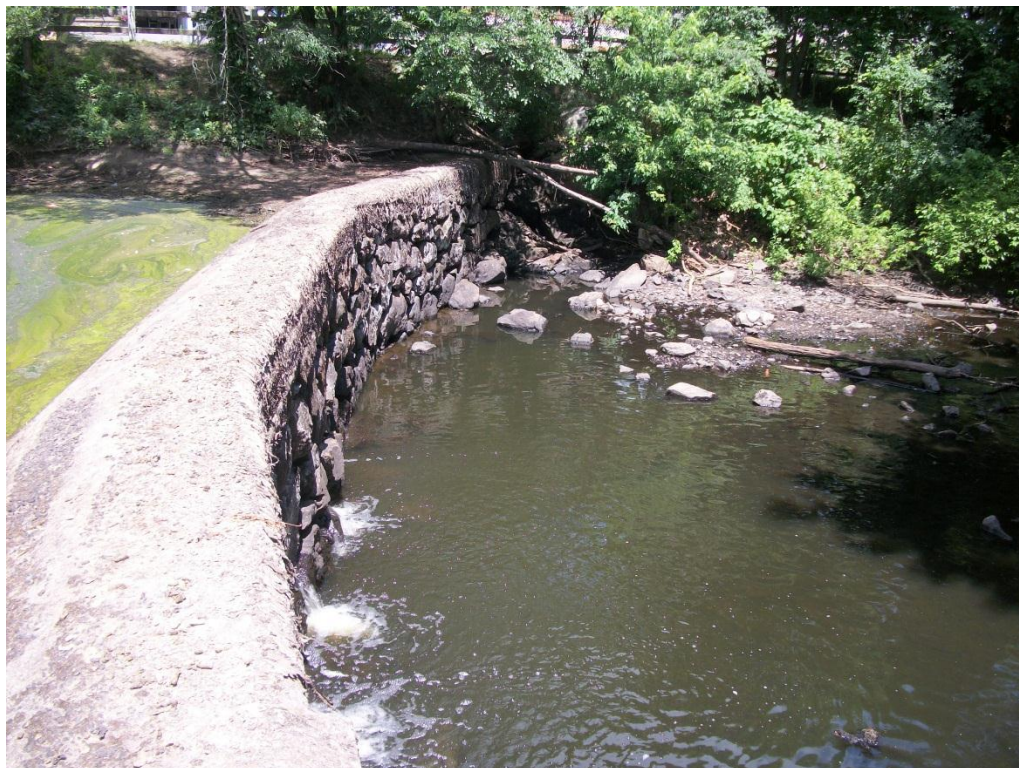
- **If yes, list the deficiencies and describe.**
  - Seepage was observed through the unmortared masonry downstream face of the dam, approximately six feet from the top of the dam.

Photo 4: Woody vegetation at right abutment. Note seepage through face of dam.

Alternatives 2, 3 and 4 will also address removal of woody vegetation and replacement with grass on the abutments and providing a fence to protect the dam from the adjacent Condon Park.

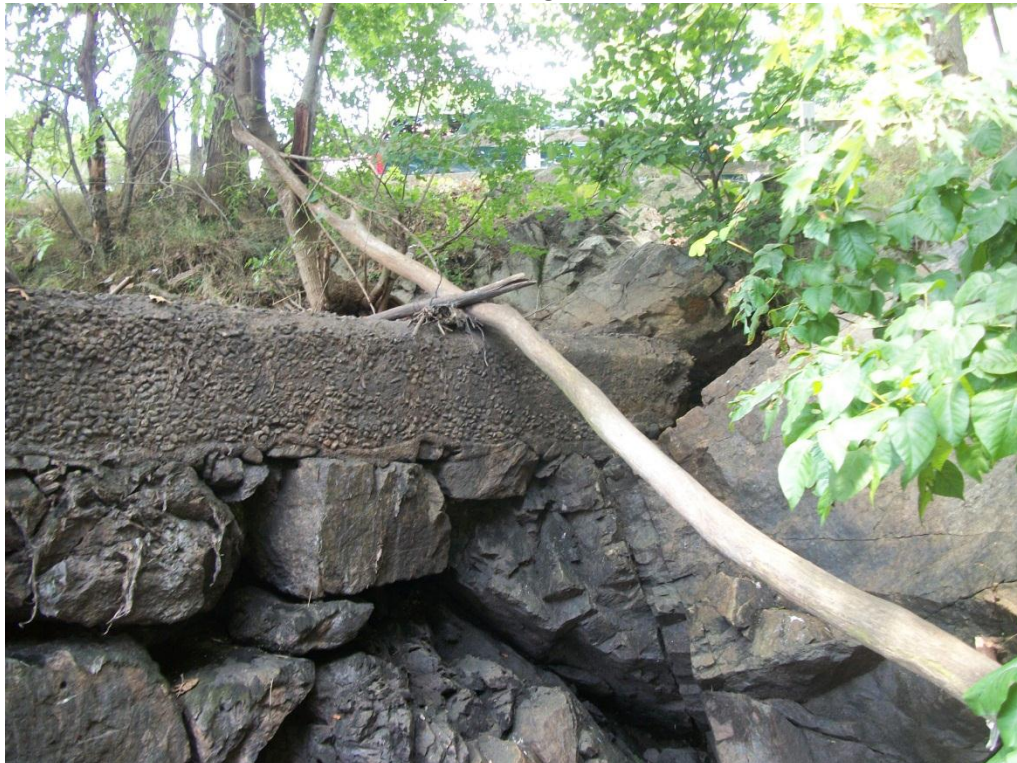
Photo 6: View of left abutment. Note good contact between concrete and bedrock.

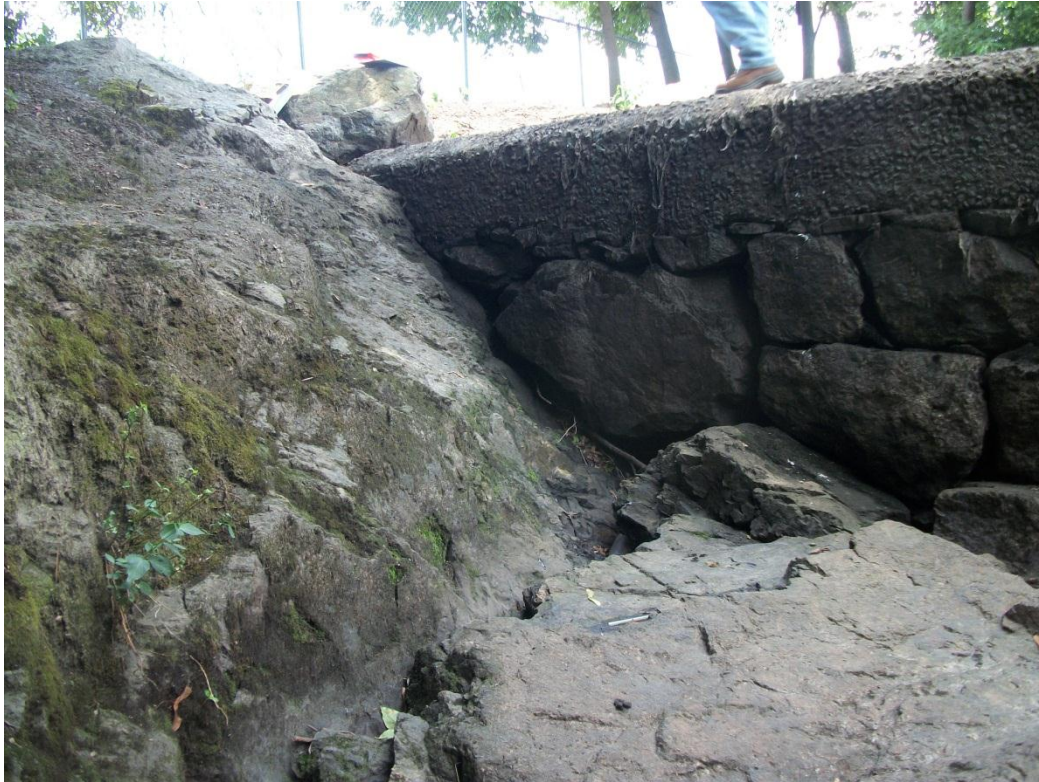
Photo 7: View of right abutment. Note good contact between concrete and bedrock.

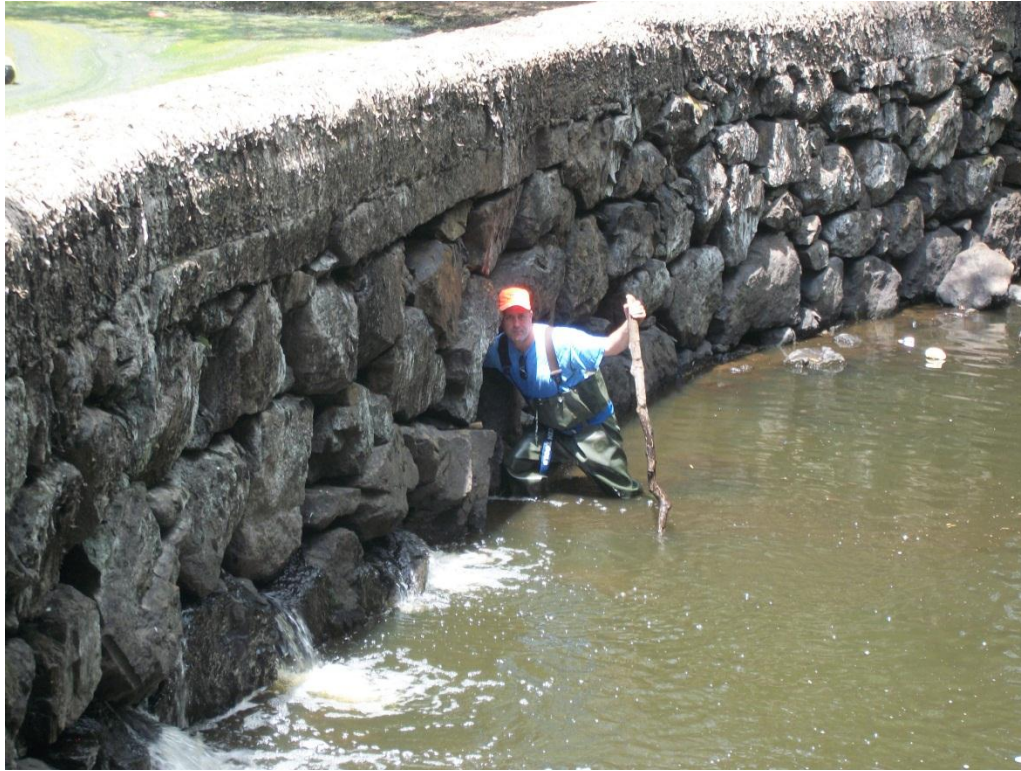
Photo 9: Large voids between stones on face of dam (no indication of soil movement).

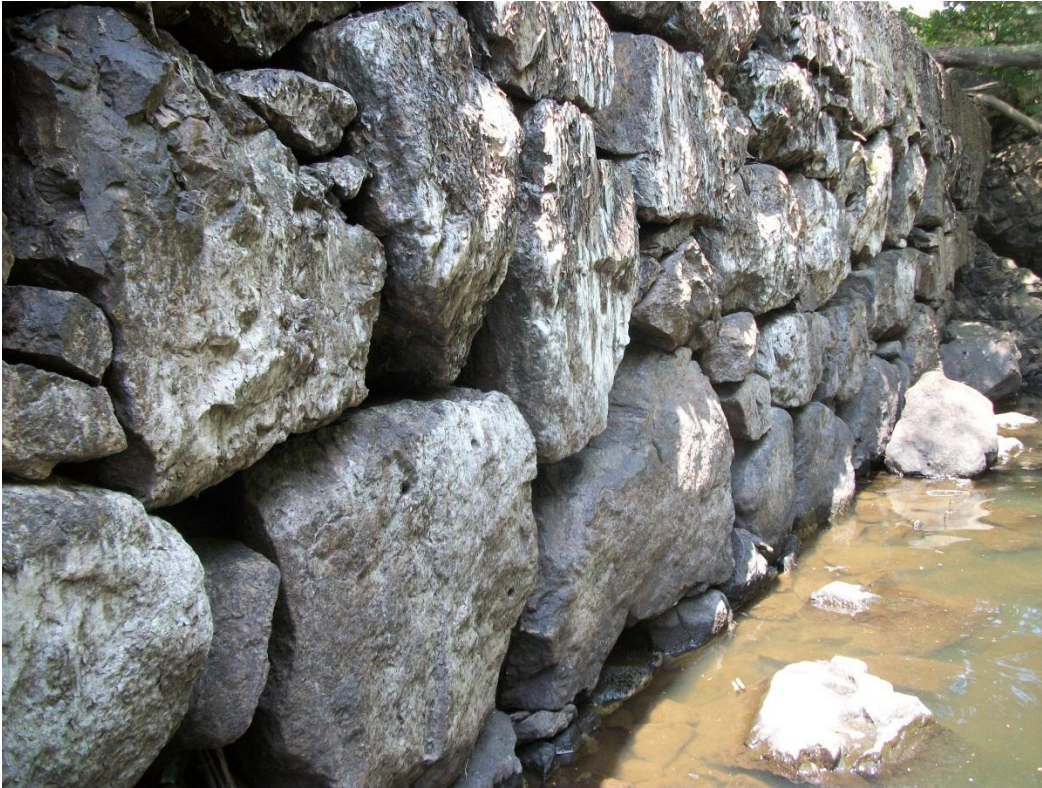
Photo 11: Large voids between stones making up downstream face of dam.

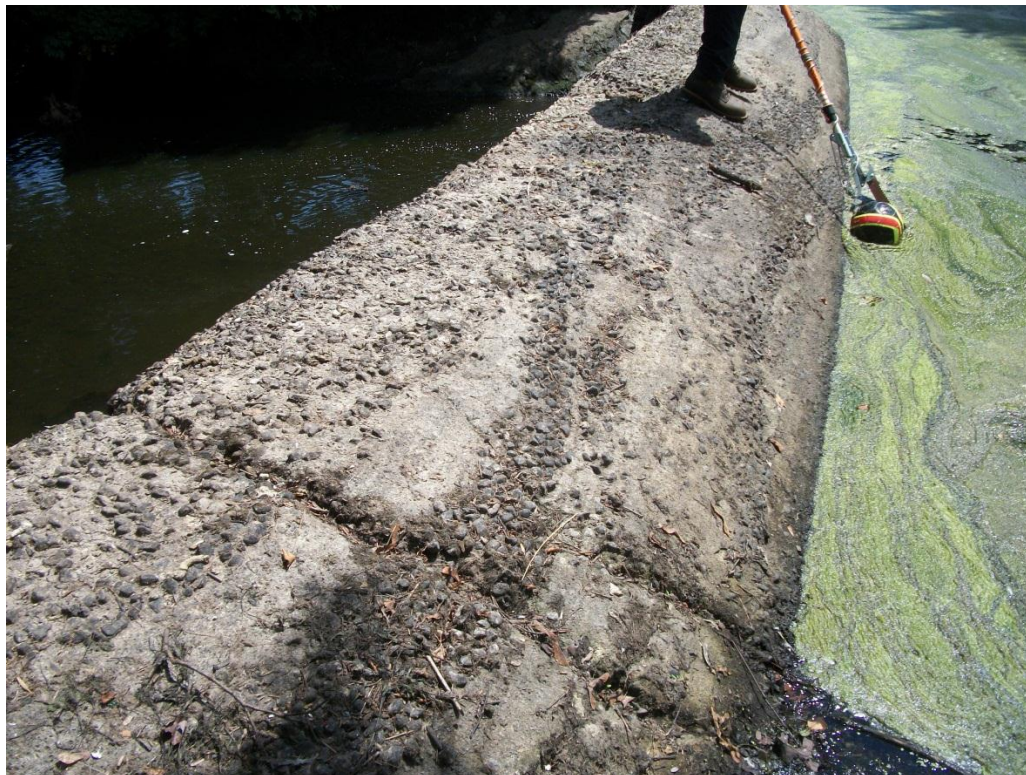
The follow-up inspection was completed by GZA on July 15, 2013. Flow conditions at the Colburn Street Dam allowed better observation than during the May 2006 Phase I Inspection, when high flows hindered the ability to see the overflow portions of the dam. On the basis of more extensive observations, the condition of the dam is now considered to be **FAIR**, in GZA's opinion. This is a downgrade in the previously reported condition of the dam. The noted deficiencies at Colburn Street Dam include scour downstream of the sluiceway area as well as scour approximately three to four feet downstream of the face of the dam, along the entire length of the dam. Seepage was noticed through the unmortared masonry face of the dam approximately six feet from the top of the dam near the sluiceway area. Large voids were observed between the stones comprising the downstream face of the dam. Leakage through the installed stop logs at the sluiceway was also observed. The concrete cap is also scoured along the upstream face the length of the dam.

Photo 12: Scoured concrete along top of dam.
