Dedham, MA

Violet Avenue – Riverdale Area Drainage Evaluation Hydraulic Flow Model Report

October 2014

Town of Dedham, Massachusetts Weston & Sampson Project No. 2140053

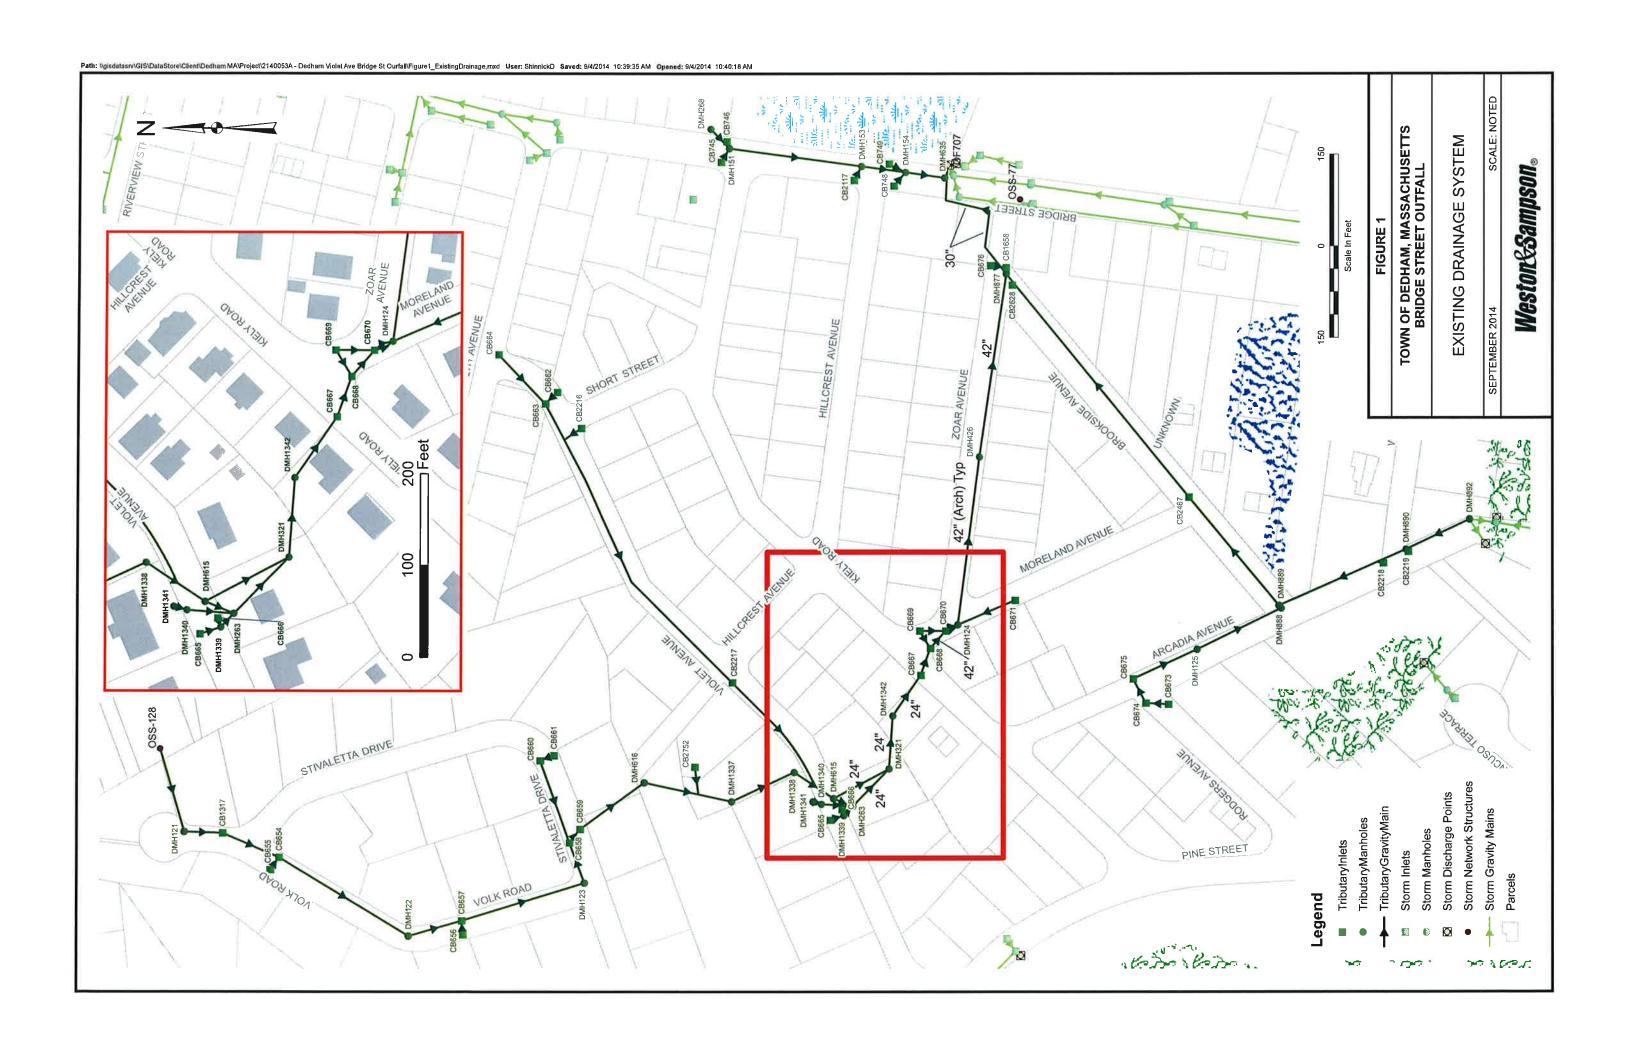
FIGURE 1 - EXISTING DRAINAGE SYSTEM

The Riverdale Area Drainage system discharges to the Charles River. The dynamics of the flooding that occurs in the Riverdale area are not uncommon. This area, which is tributary to the Charles River, collects flow from a significant land area, which is predominantly residential impervious. The flow is conveyed to the Charles River via approximately 5,500 feet of tributary drain system that discharge to the Bridge Street outfall. See Figure 1 Existing System, Attached

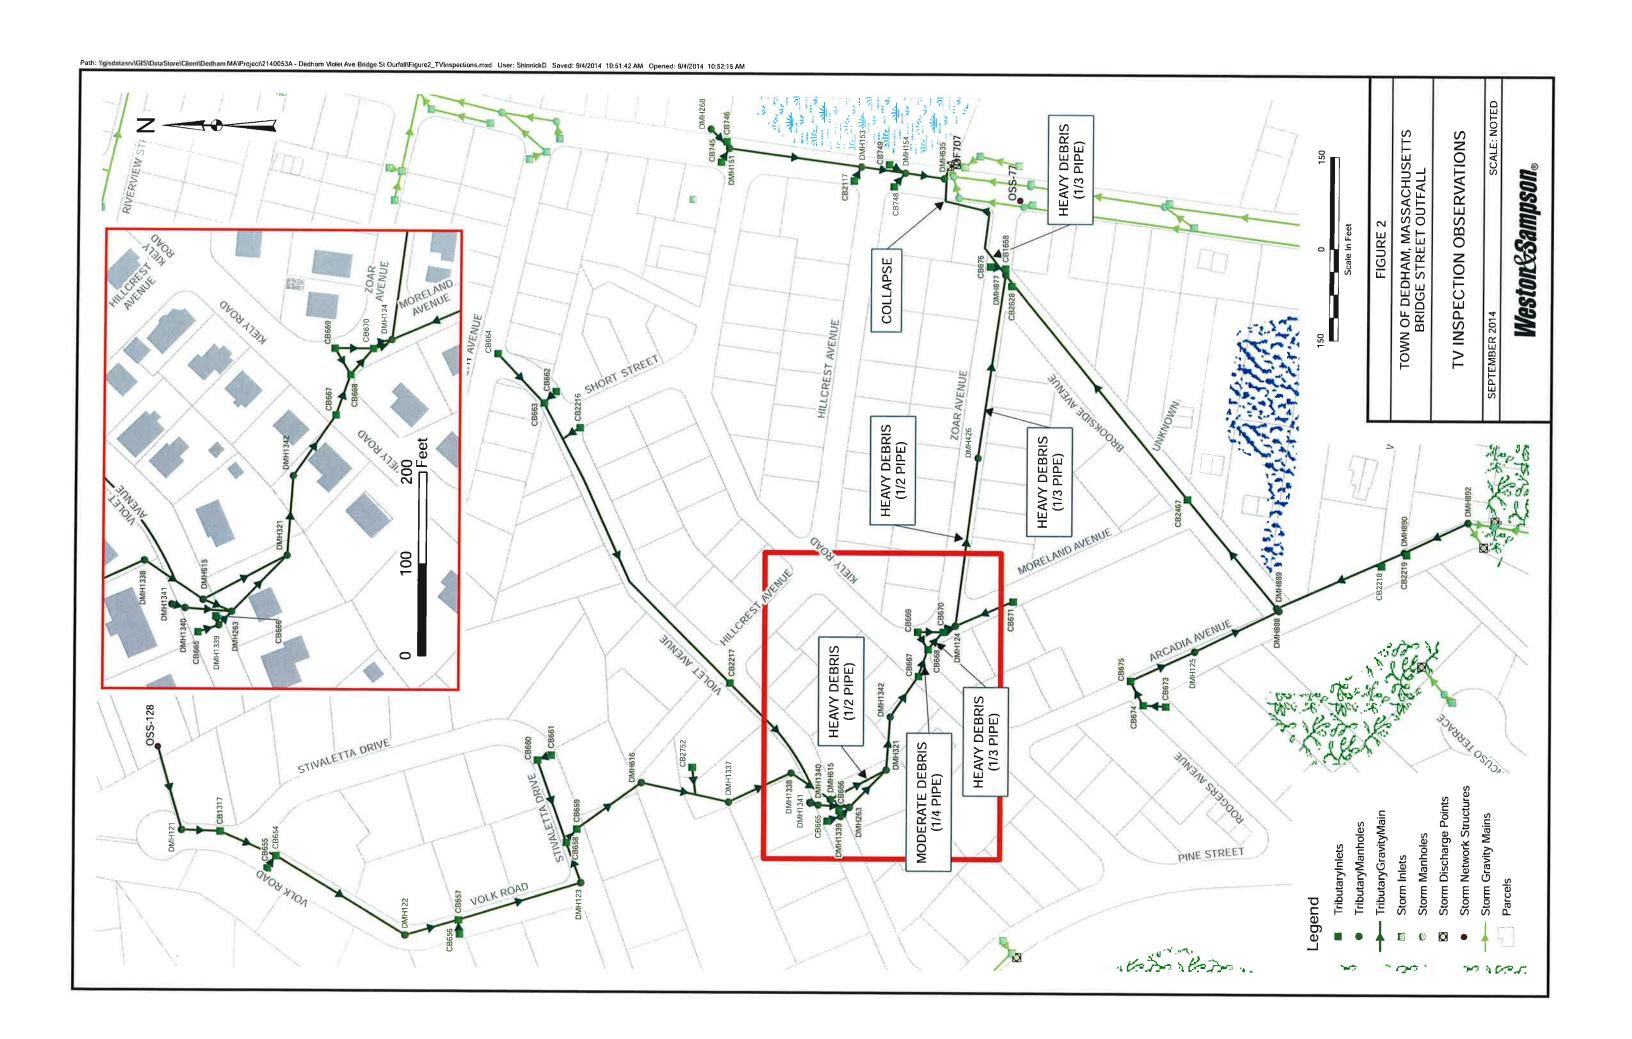
FIGURE 2 - TV INSPECTION OBSERVATIONS

In March 2014 New England Pipe Cleaning Company (NEPCCO) performed television inspection services of the Zoar Avenue mainline drain from DMH321, on the property of 76 Violet Ave, to the Bridge Street outfall of the Charles River. The objective of the television program is to identify system deficiencies or blockages that limit carrying capacity. The observations from the March 2014 television inspection, shown in Figure 2 – TV Inspection Results, Attached, are:

- 1. Heavy sag in section from DMH 1338 to DMH 615
- 2. Heavy debris (1/2 pipe) in section from DMH 615 to DMH 321
- 3. Moderate debris (1/4 pipe) in section from CB 667 to CB 668
- 4. Heavy debris (1/3 pipe) in section from CB 668 to DMH 124
- 5. Heavy debris (1/2 pipe) in section from DMH 124 to DMH 426
- 6. Heavy debris (1/3 pipe) in section from DMH 426 to DMH 877
- 7. Heavy debris (1/3 pipe) in section from DMH 877 to Outfall. Pipe full of debris and standing water before first bend.
- 8. Partially collapsed pipe 53 feet upstream of outfall on Bridge Street.

The above observations were incorporated into the calibration model as contributing factors to hydraulic capacity evaluation. The Town of Dedham has performed improvement projects to increase capacity and remove deficiencies observed during the television inspection program, including:

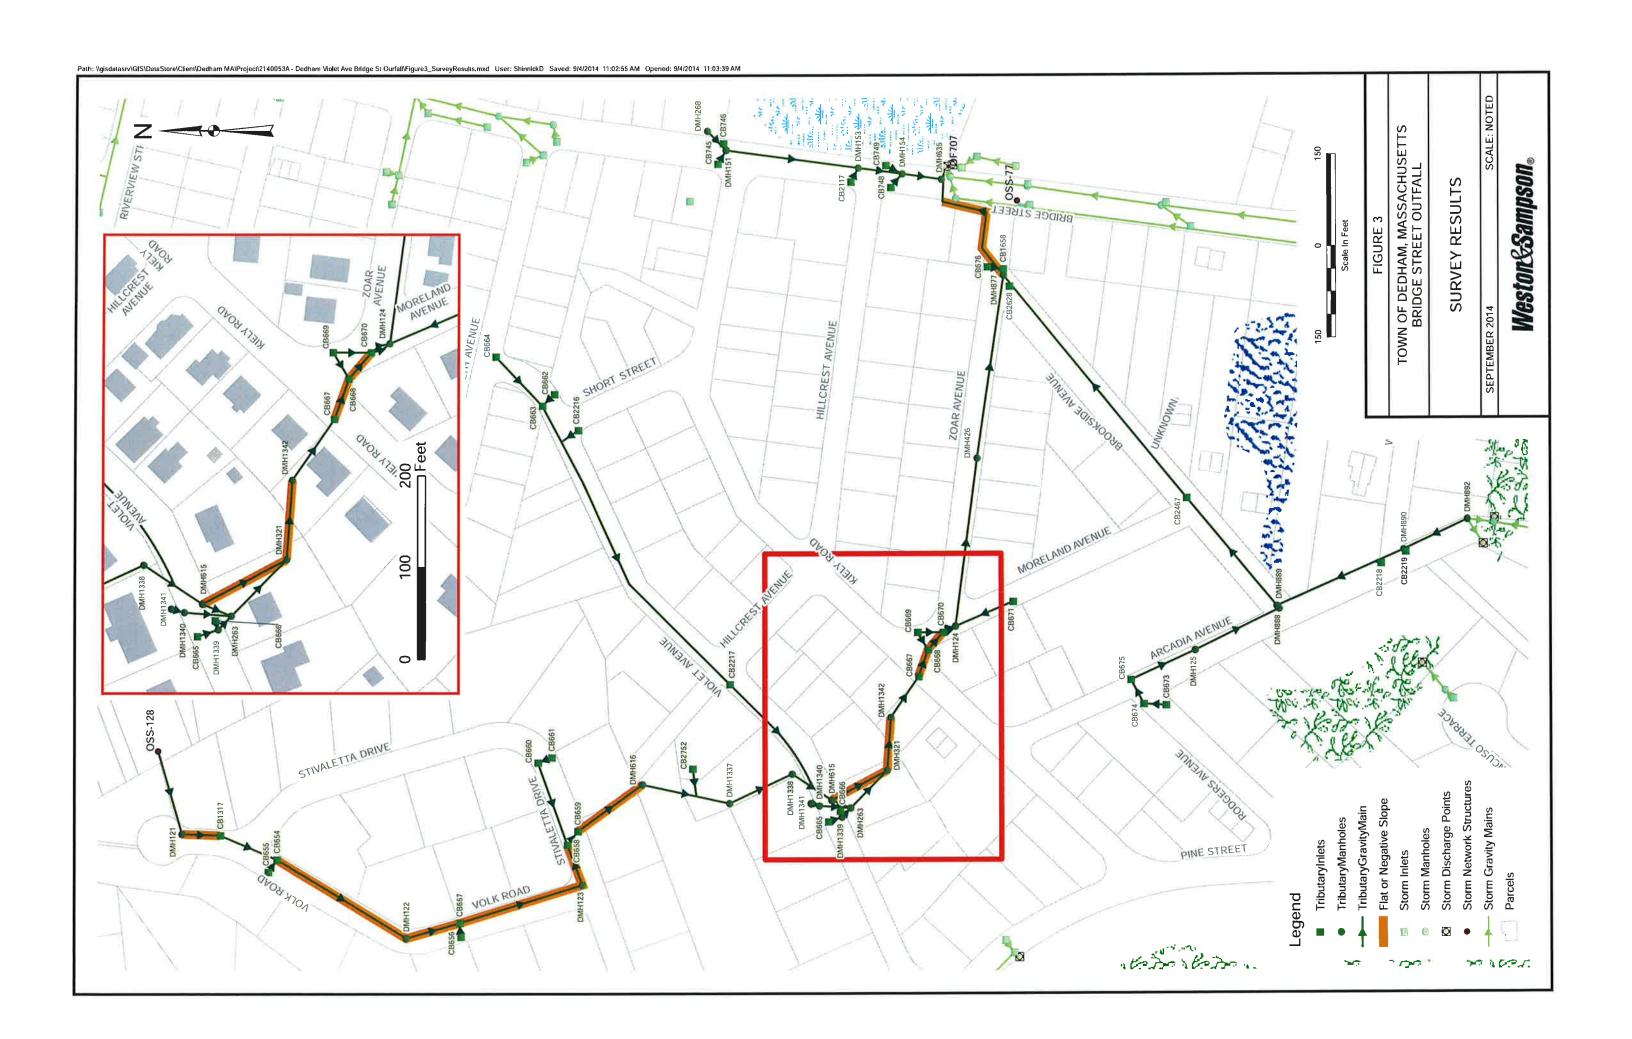
FIGURE 3 - SURVEY RESULTS

The land survey results, Figure 3 – Survey Results, Attached show the following deficiencies in the mainline drain pipe that contribute to limiting the system capacity:

- 1. Conduit C-DMH121 Volk RD : Flat Slope
- 2. Conduit C-CBNEW Volk RD: Back Pitched Negative Slope
- 3. Conduit C-DMH122 Volk RD : Back Pitched Negative Slope
- 4. Conduit C-CB657 Volk RD: Back Pitched Negative Slope
- 5. Conduit C-DMH123 Stivaletta RD: Back Pitched Negative Slope
- Conduit C-CB659 Cross-Country Stivaletta to Violet AVE : Back Pitched Negative Slope
- 7. Conduit C-DMH615 Violet AVE: Back Pitched Negative Slope
- Conduit C-DMH321 Cross-Country Violet Ave to Kiely RD : Back Pitched Negative Slope
- 9. Conduit C-CB667 Kiely RD: Back Pitched Negative Slope
- 10. Conduit C-CB668 Kiely RD: Back Pitched Negative Slope
- 11. Conduit C-DMH1589 Bridge ST: Back Pitched Negative Slope

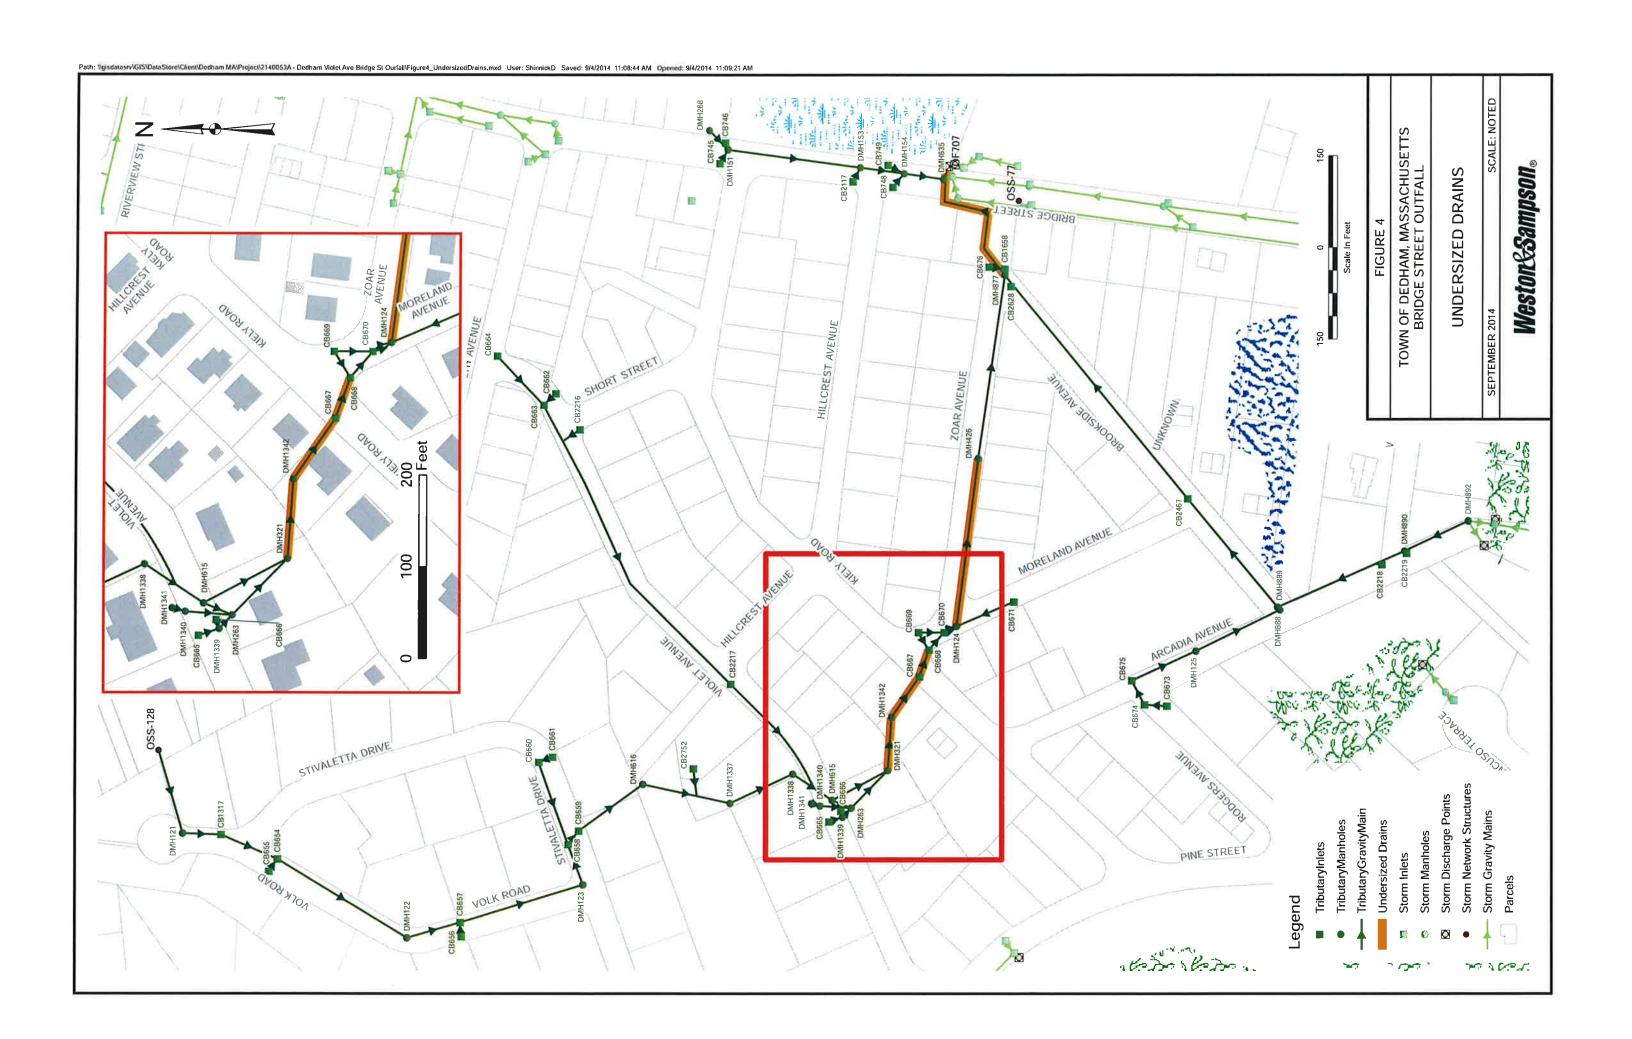
FIGURE 4 - UNDERSIZED DRAINS

The storm drain conveyance system is undersized downstream of DMH321 on the property of 76 Violet Ave and has limiting capacity in the following pipe sections on Figure 4 – Undersized Storm Drains:

- 1. Conduit C-DMH321 Cross-Country Violet Ave to Kiely Rd.
- 2. Conduit C-DMH1342 Cross-Country Violet Ave to Kiely Rd.
- 3. Conduit C-CB667 Kiely Rd.
- 4. Conduit C-DMH124 Zoar Ave.
- 5. Conduit C-DMH877Zoar Ave to Bridge St.

The removal of downstream obstructions does not eliminate the flooding at DMH321 in the area of 76 Violet Avenue. The undersized storm drains downstream of DMH321 in the area of 76 Violet Ave will require replacement to eliminate flooding for a 1 Year frequency storm or greater.

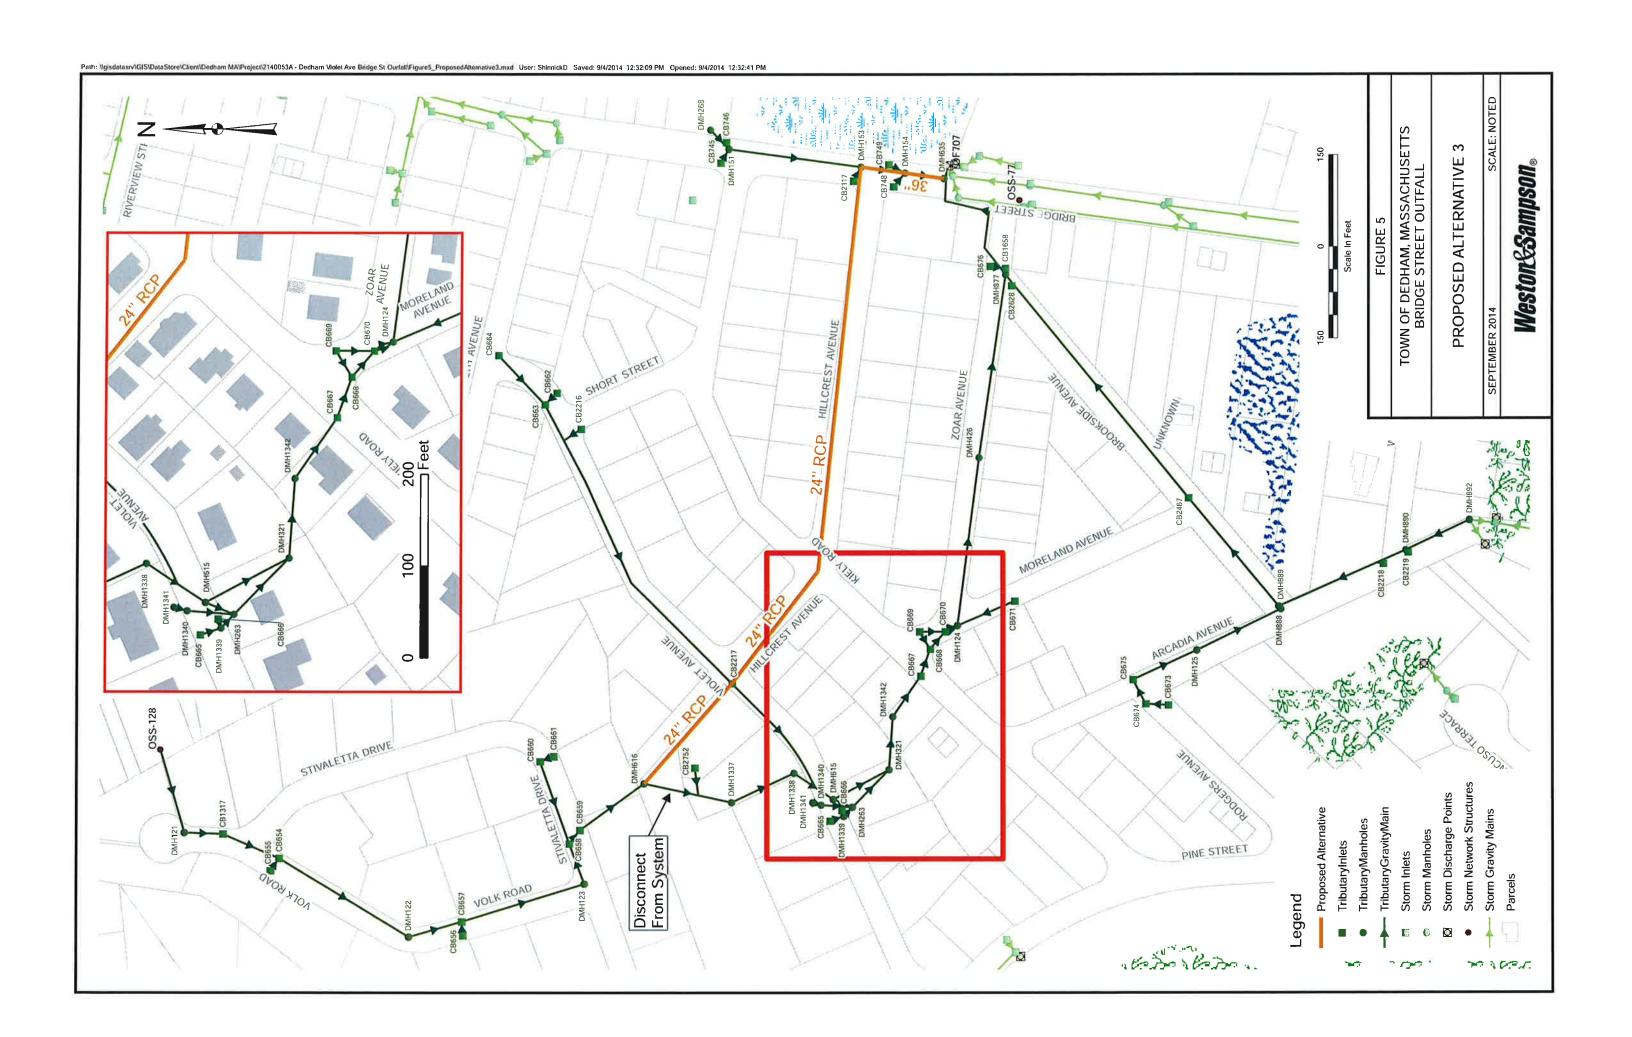
FIGURE 5 - PROPOSED ALTERNATIVE 3

- 4. Scenario 9 10 Year 24 Hour Event Reroute upstream flow around Violet Ave low-lying area via a new drain on Hillcrest to Bridge St to increase capacity. Including System Improvements By Town of Dedham Engineering In May 2014. Replaced Collapsed Pipe and Proposed Full system cleaning. Figure 5 Proposed Alternative 3, Attached

Alternative 3 incorporates the installation of a new 24 inch drain on Hillcrest Ave to the existing Bridge St outfall to reduce the flow to the Violet Ave drainage system. The negative impacts of Alternative 3 are:

- The creation of a new utility corridor and increased maintenance demands.
- The potential for moving the flooding problem to other areas of the neighborhood that did not previously flood for storm frequencies greater than the 10 year design storm event.

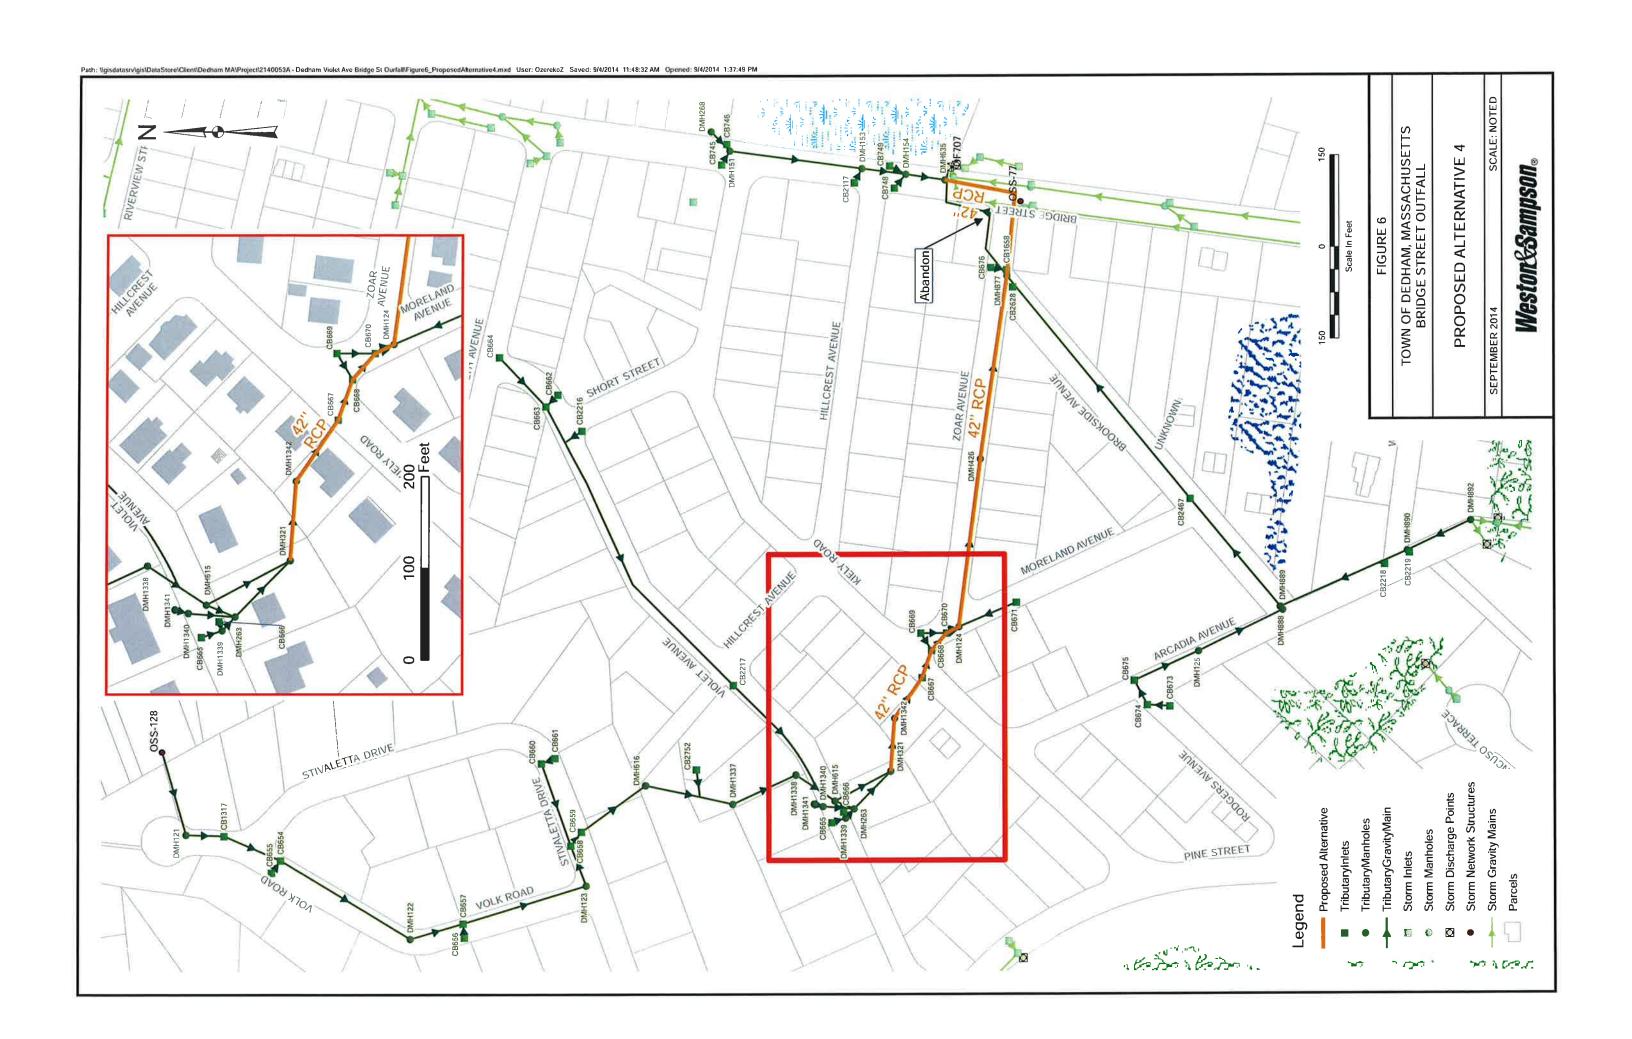
FIGURE 6 - PROPOSED ALTERNATIVE 4

- 5. Scenario 10 10 Year 24 Hour Event Increase system capacity from DMH321 to Bridge St outfall. Figure 6 Proposed Alternative 4, Attached
- 6. Scenario 11 10 Year 24 Hour Event Replace residential properties with neighborhood detention pond on Violet Ave. Including System Improvements By

Alternative 4 incorporates the replacement of the existing Violet Ave to Zoar Ave 24 inch circular and 42 inch arch drain pipes with a new 48 inch RCP drain with more carrying capacity and positive flow conditions for existing and future flows. Alternative 4 is the recommended improvement for its relative low cost differential, continued but reduced maintenance demands, and it directly alleviates the Violet Ave drainage flooding. The positive of Alternative 4 is the utilization of an existing utility corridor that makes for efficient construction. The negatives of Alternative 4 are:

- The lack of slope to the outfall that limits capacity of any size pipe.
- Grading issues to be resolved on private properties.
- Minimal depth of cover available for the new pipe.

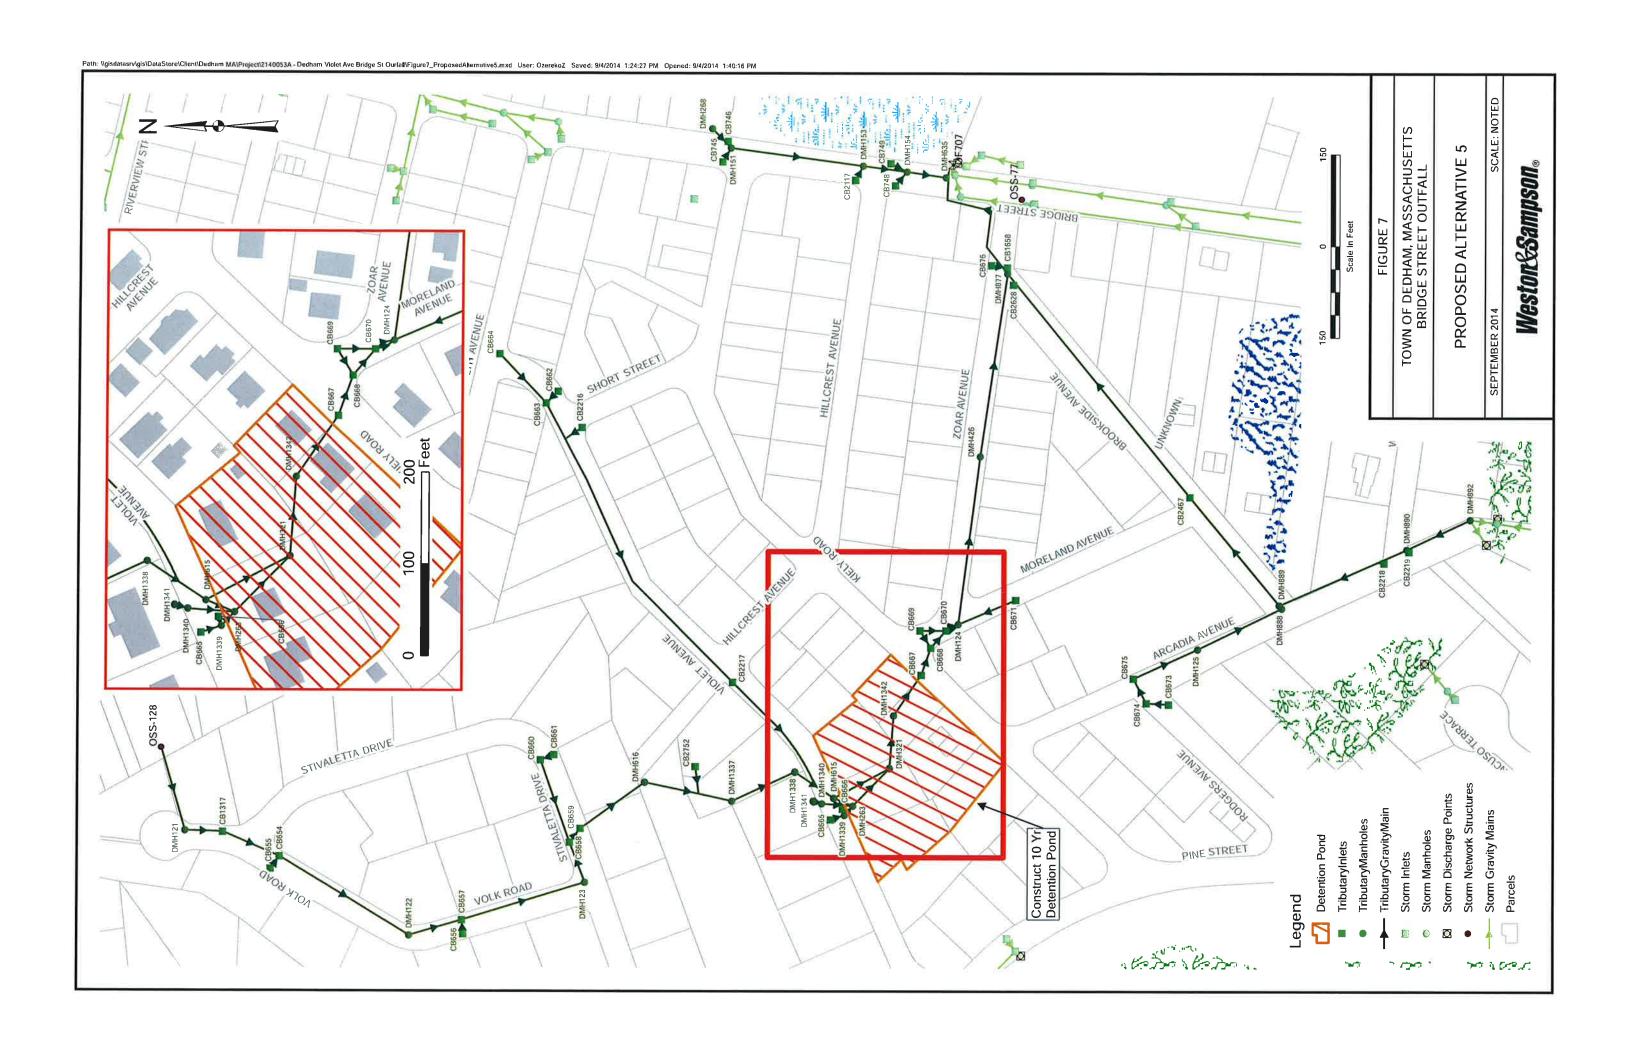
FIGURE 7 - PROPOSED ALTERNATIVE 5

Town of Dedham Engineering In May 2014. Replaced Collapsed Pipe and Proposed Full system cleaning. Figure 7 – Proposed Alternative 5, Attached

Alternative 5 incorporates the installation of a new detention pond through the acquisition of six properties on Violet Ave and Kiely Rd. The detention pond is sized to handle the flow volume from the 10 year storm event and discharging flow downstream to the existing Zoar Ave drain. The negatives of Alternative 5 are:

- The relative project cost for only 10 year storm protection.
- The soil conditions in the area likely would require the detention pond (Dry) to be a retention pond (Wet) that holds water at all times.
- The impacts to the neighborhood ascetics.
- The impact to the neighborhood flooding pattern under a storm event greater than a 10 year frequency.
- Future yearly maintenance cost of \$25,000 per year.

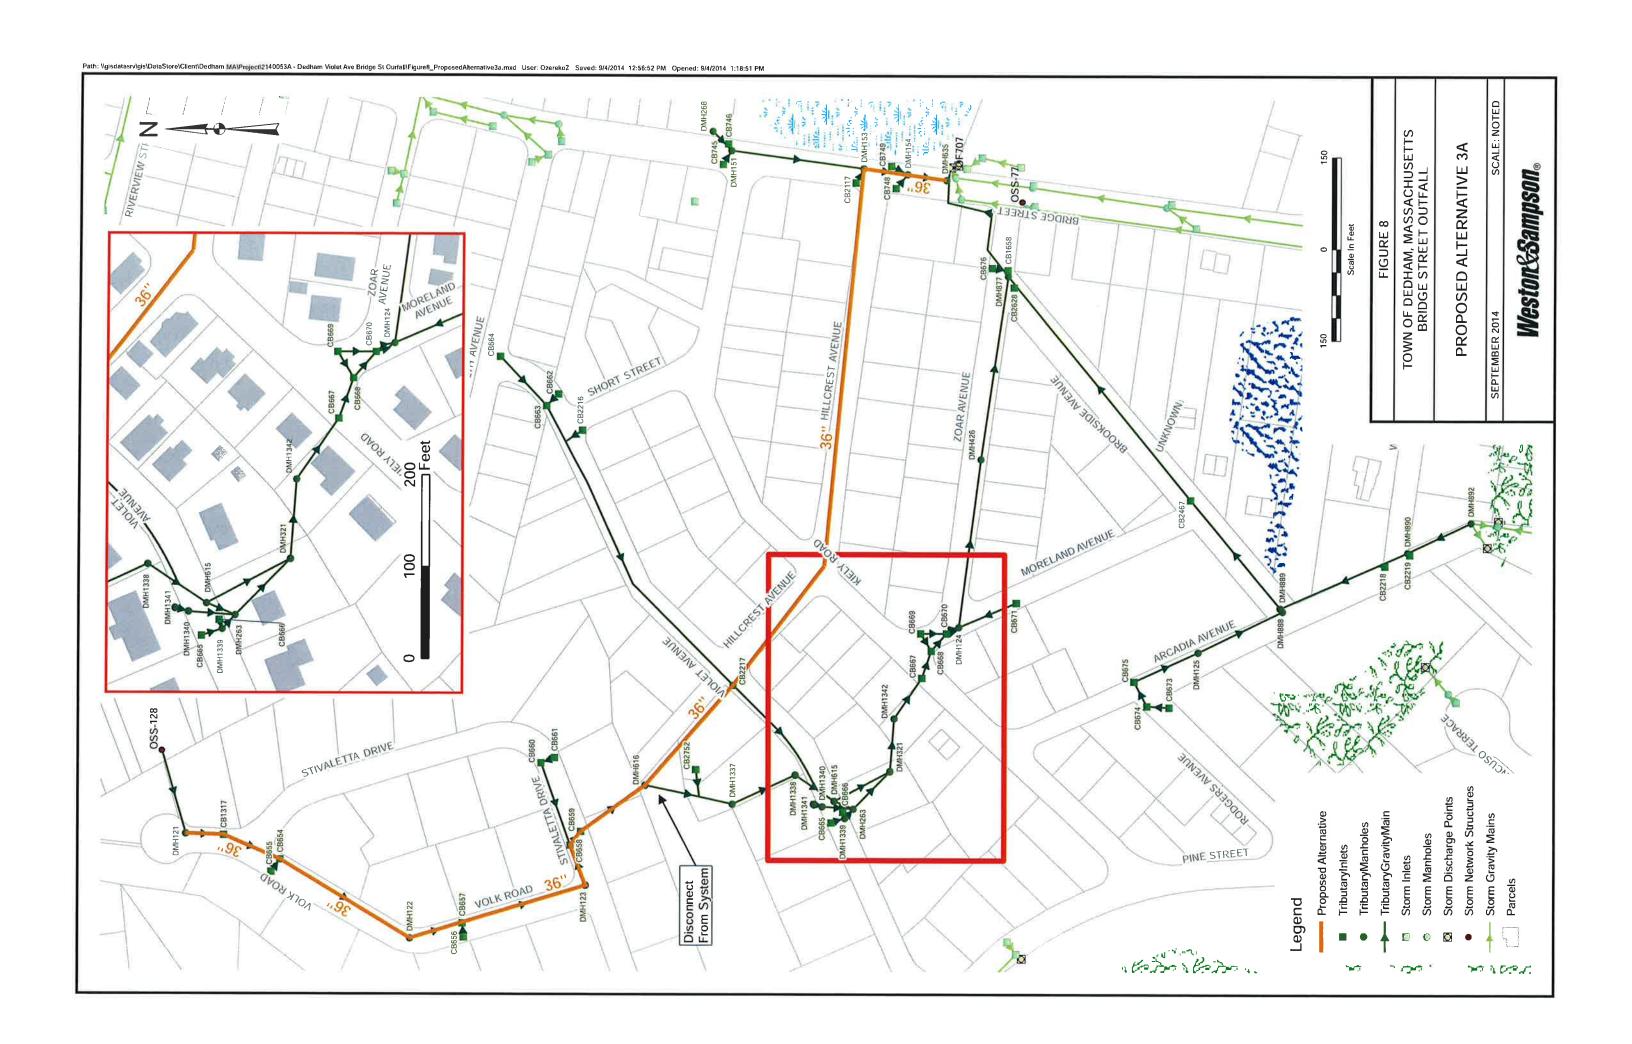
FIGURE 8 - PROPOSED ALTERNATIVE 3A

The 10 year 24 Hour storm event model also generated flooding in the upstream neighborhood of Volk Road. Alternatives 3A and 4A are presented for comparison consideration for potential upstream improvements and their impact of moving flow downstream. If such upstream improvements were constructed, the need for additional capacity downstream would also be required and accounted for in our analysis. Alternative 3A requires the upstream installation of approximately 1000 feet of 36 inch drain and the increase of downstream improvements to 36 inch from the 24 inch presented in Alternative 3.

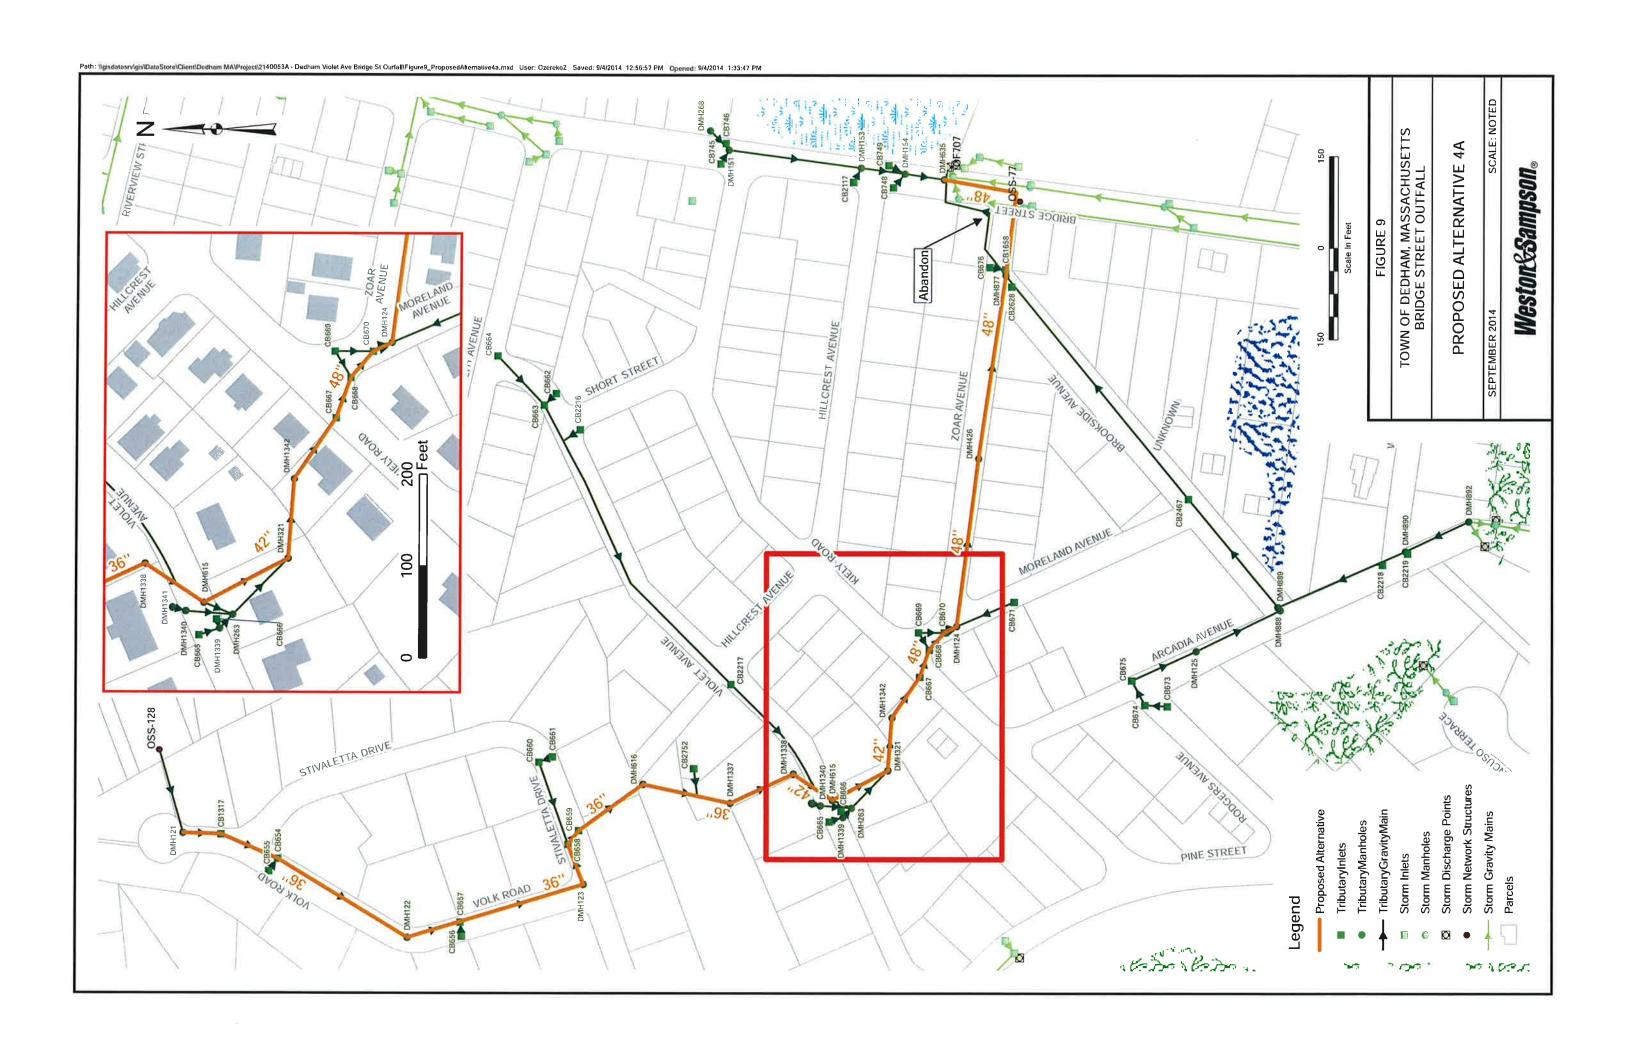
FIGURE 9 - PROPOSED ALTERNATIVE 4A

Alternative 4A requires the upstream installation of approximately 1000 feet of 36 inch drain and the increase of downstream improvements to 48 inch from the 42 inch presented in Alternative 4.
