# FEASIBILITY STUDY

## TOWN OF DEDHAM POLICE STATION Dedham, MA

# **Site & Building Assessment**

Town of Dedham Police Station

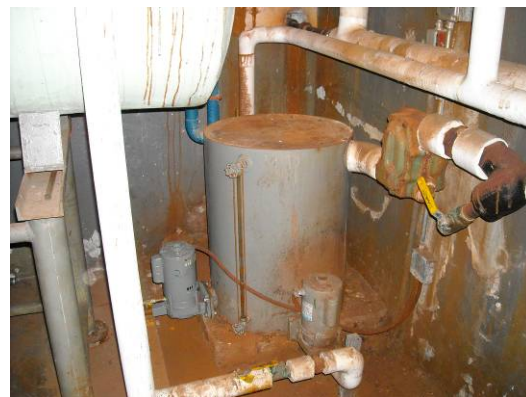
*Boiler Feed Pump*

The condensate receiver and boiler feed unit serving the boiler are in poor condition and in need of replacement.

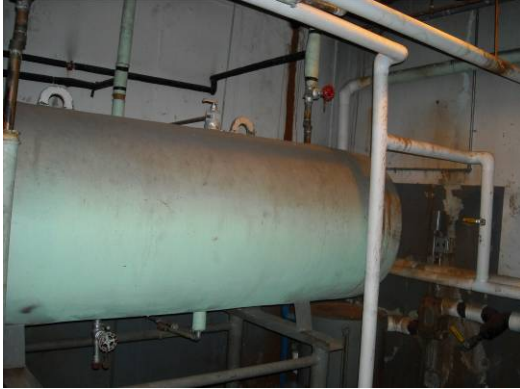
*Illustration 1: Abandoned DHW Heater*

The original boiler also used to serve the building's domestic hot water heating system by supplying steam to a steam-fired domestic hot water heater. This system is no longer in service and has been abandoned in place.

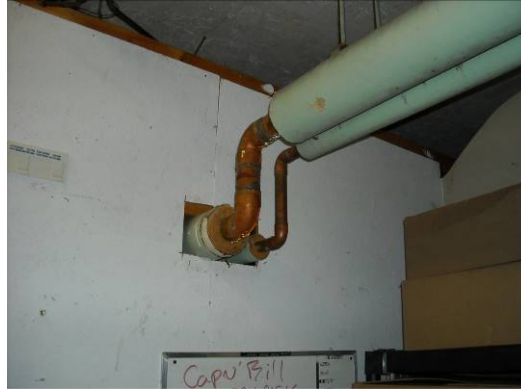
*Steam and Condensate Piping Elbows without Insulation*

The main steam and condensate piping appears to be old and in poor condition. Many segments of the piping are un-insulated. It also appears that the original piping insulation located at elbows have been removed (as the insulation for these fittings may have contained asbestos). Sections of the branch steam and condensate piping appear to have been recently replaced as part of a heating system repair project.

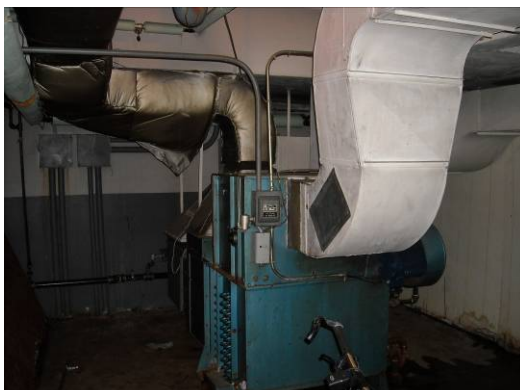
*Basement – AHU (Serves First Floor)*

There are two air handling units installed in the basement. One of these units is in active operation, while the other unit appears to be abandoned in place. The unit which is operating serves the first floor of the building. The unit appears to have been originally installed in 1962 as manufactured by Dunham Bush Co. The unit is a modular indoor air handling unit with steam heating, DX cooling and supply fan sections. The unit operates loudly and it appears that there are condensate drainage problems associated with the unit's cooling coil and drain piping. The unit's associated air cooled condensing unit is installed outdoors at grade adjacent to the building. Insulated, galvanized sheet metal ductwork is routed from the unit to the first floor. The majority of the ductwork appears to be original vintage and in poor condition.

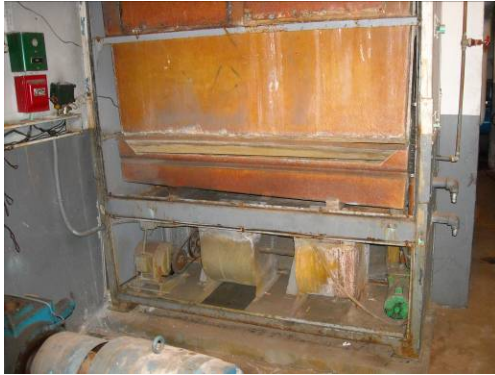
*Gun Range AHU (Abandoned in Place)*

The basement unit that has been abandoned in place previously serve the basement firing range. This unit is located in Storage Room #003. The associated gun range exhaust fan located in Basement Storage Room#005 is also not currently in operation.

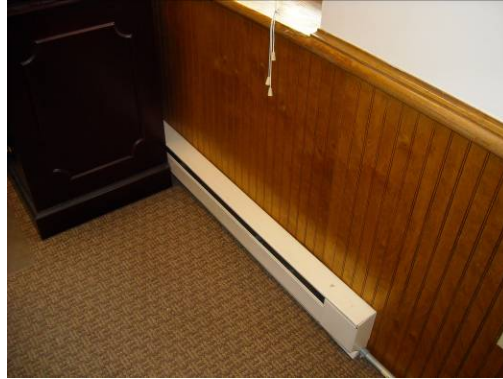
*Electric Baseboard Heating*

The majority of the rooms in the building also have heating provided by either steam convectors or steam fin tube radiation. The Chief's office has supplemental electric baseboard heating installed. The majority of the steam terminal heating equipment appears to be original vintage and in poor condition.

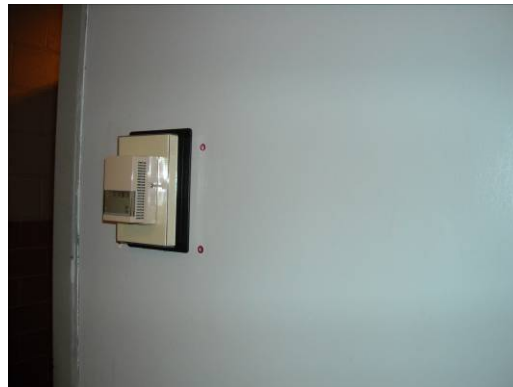
*Newer Thermostat Controls*

The majority of the building's automatic temperature control systems are pneumatic type. The control system's compressor is located in the basement boiler room and appears to be in fair condition. During recent HVAC system upgrades it appears that some HVAC system controls have been replaced with stand alone analog electric type controls.

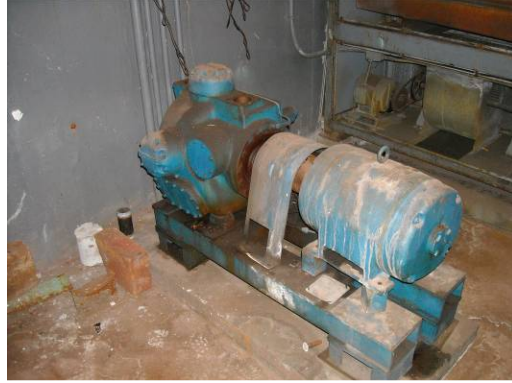
*Compressor (Abandoned in Place)*

As part of past HVAC system repair and replacement projects it appears that some original HVAC systems and equipment have been abandoned in place. One example of this is a set of Compressors that are located in the basement Boiler Room which previously served the First and Second Floor Air Handling unit systems before the Outdoor air cooled condensing units shown above were installed.

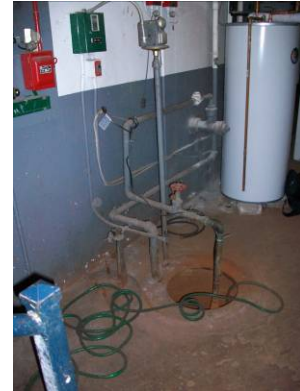
The floor drains in the Boiler Room appear to discharge into a small simplex ejector. The ejector discharges into the sanitary drainage system.

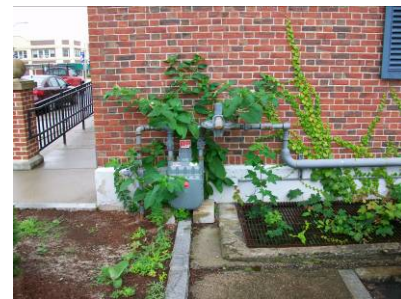
There is an existing gas service with a meter located at the rear of the building. Gas is used for building heating only.

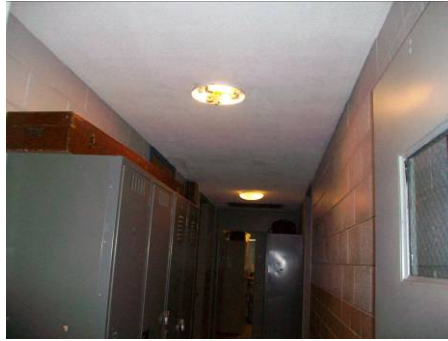
Corridor lighting consists of a combination of 4 lamp surface wraparounds with acrylic lenses and surface circlines with (3) PL13's compact fluorescent lamps. Corridor and stair lighting is locally switched.

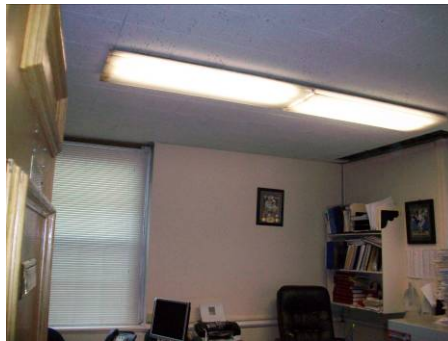
Offices have 2x2 & 2x4 recessed troffers controlled with a single switch. Surface wraparounds used where GWB ceilings exist. No occupancy sensors exist to turn lights off when space is unoccupied.

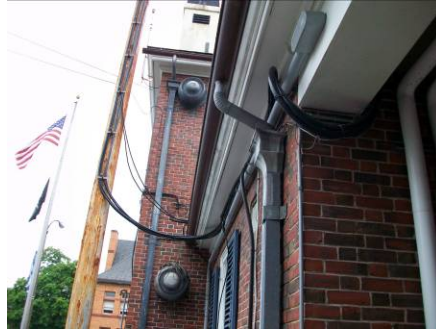
There is a monopoint antenna pole +/- 100' high with cables entering building thru attic space.
