## **Town of Dedham, MA**

### **2013 Year One Inflow Investigation**

March 2014

**Town of Dedham, Massachusetts**  
**Weston & Sampson Project No. 2130225.A**

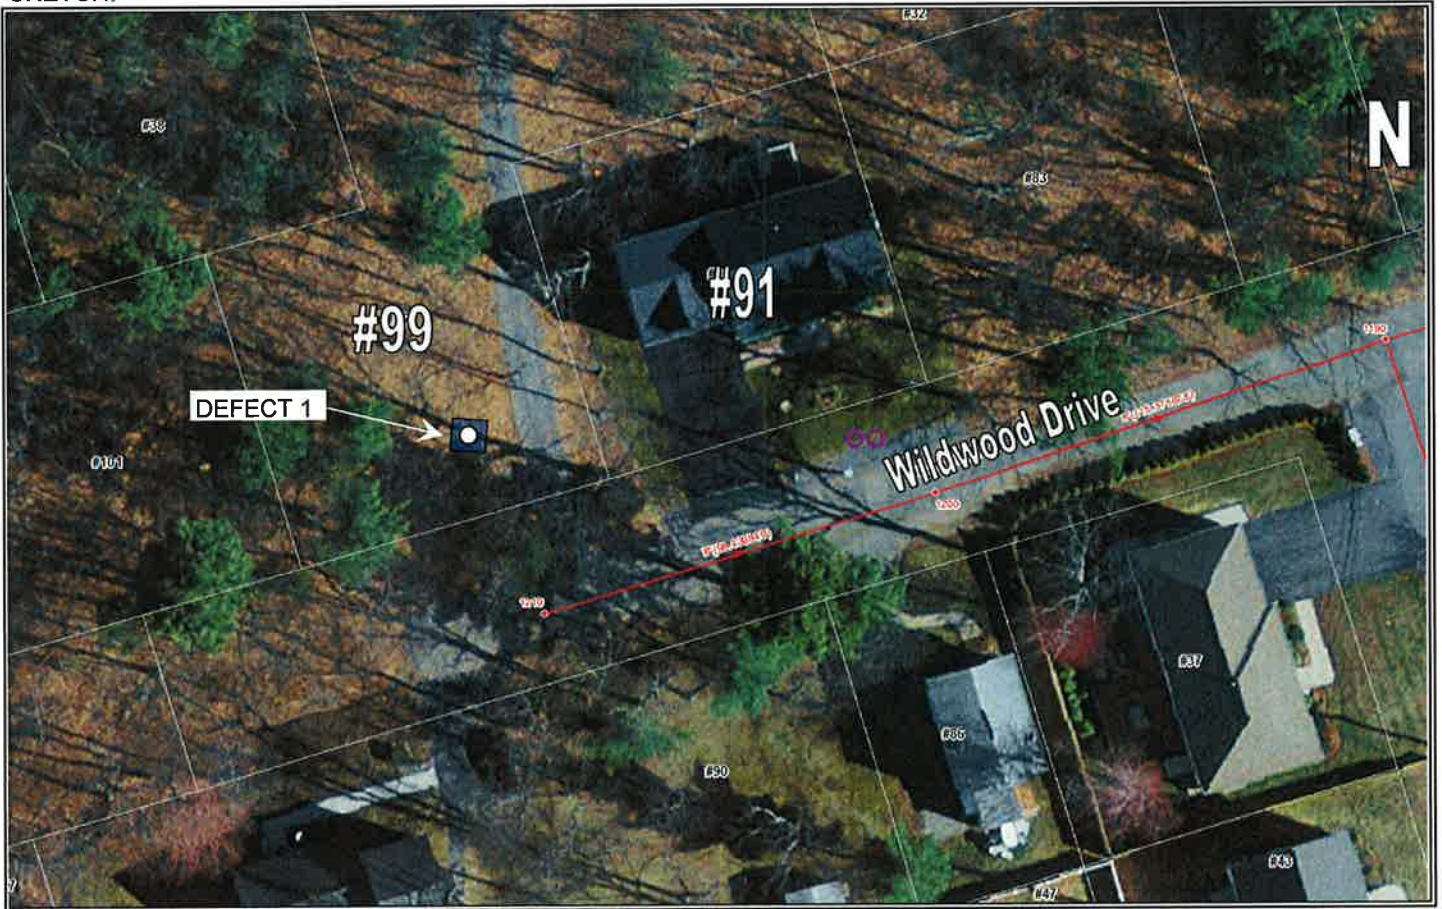
DEFECT: 1 thru 1

DEFECT	DESCRIPTION	Drainage Area	Surface Type	Severity			Picture No.(s)
				Major	Mod	Minor	
1	Defective Cleanout Cap	5' x 5'	Grass			X	1

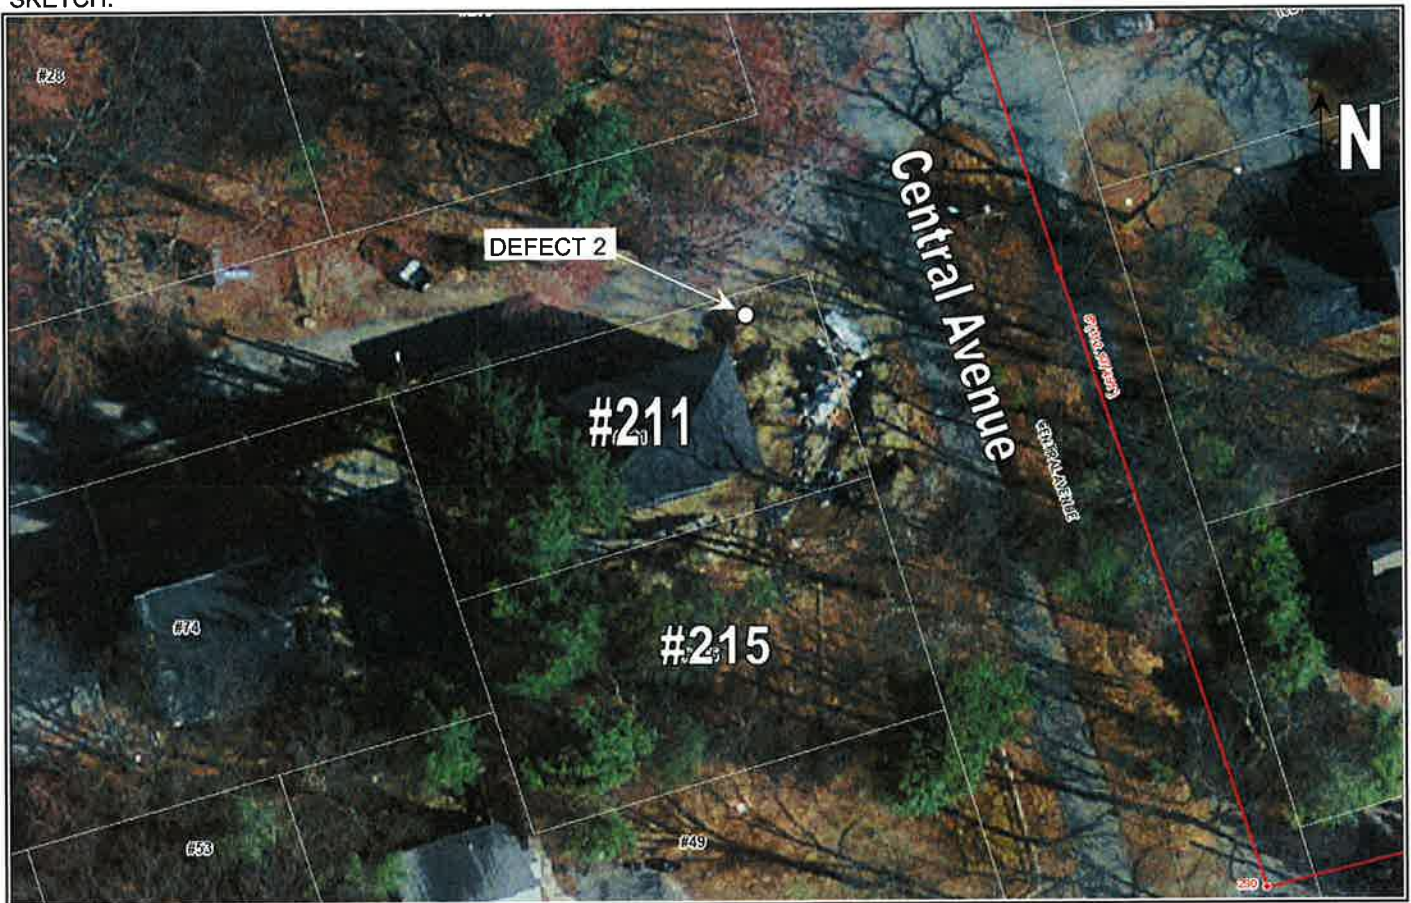
DEFECT: 2 thru 2

DEFECT	DESCRIPTION	Drainage Area	Surface Type	Severity			Picture No.(s)
				Major	Mod	Minor	
2	Defective Cleanout Cap	0	Above Grade			X	2

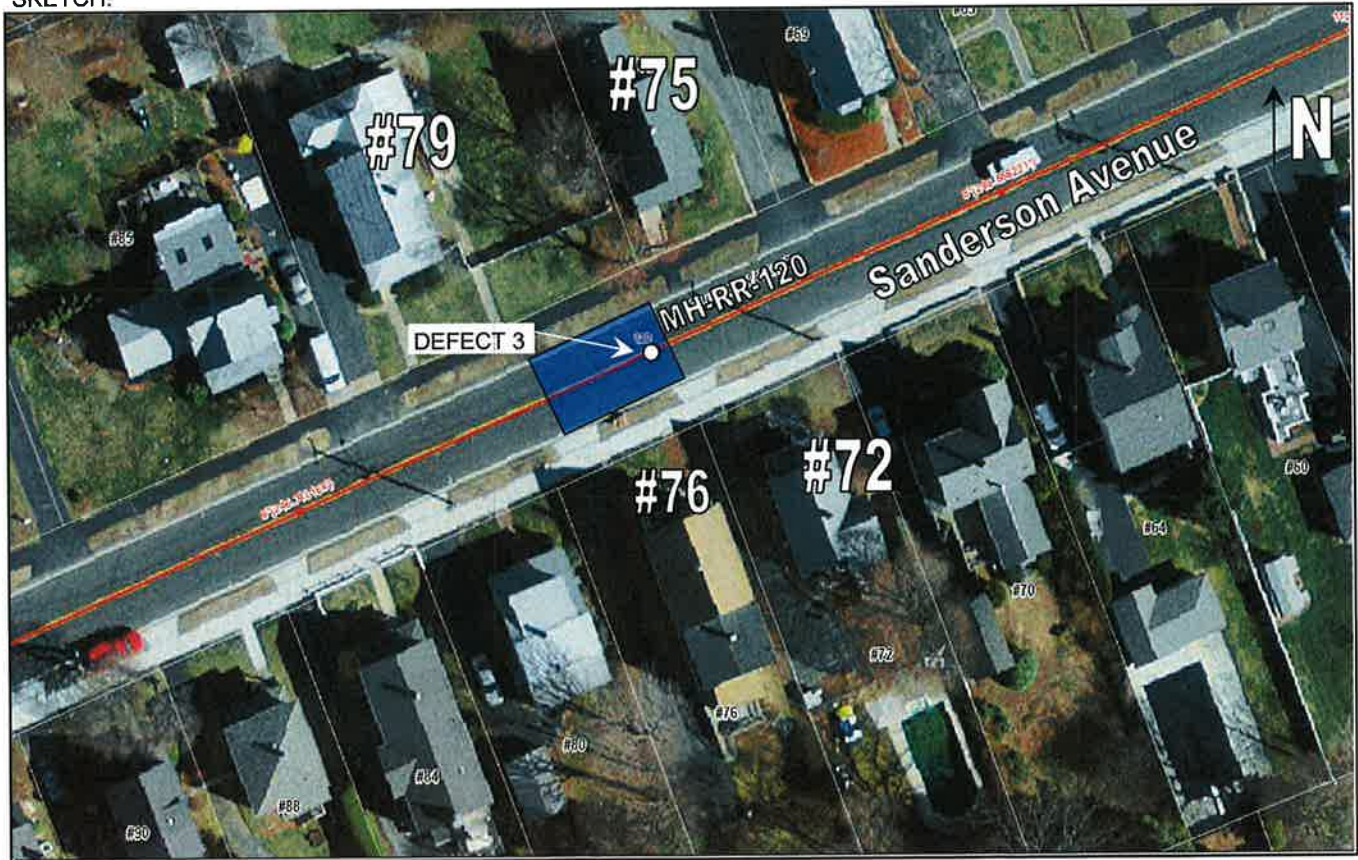
DEFECT: 3 thru 3

DEFECT	DESCRIPTION	Drainage Area	Surface Type	Severity			Picture No.(s)
				Major	Mod	Minor	
3	MH RR-120 - Holes in Cover	10' x 5'	Asphalt			X	3

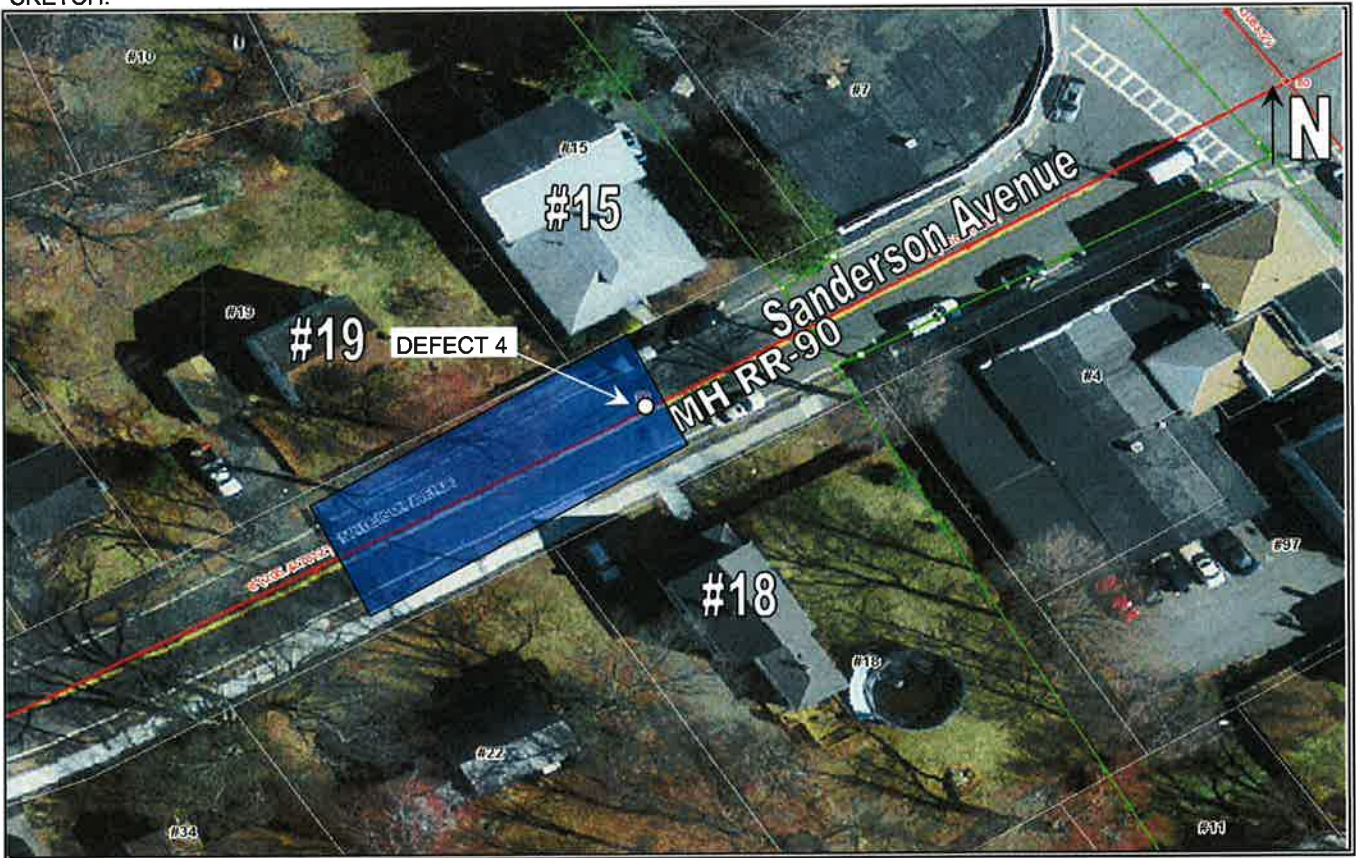
DEFECT: 4 thru 4

DEFECT	DESCRIPTION	Drainage Area	Surface Type	Severity			Picture No.(s)
				Major	Mod	Minor	
4	MH RR-90 - Holes in Cover	30' x 5'	Asphalt			X	4

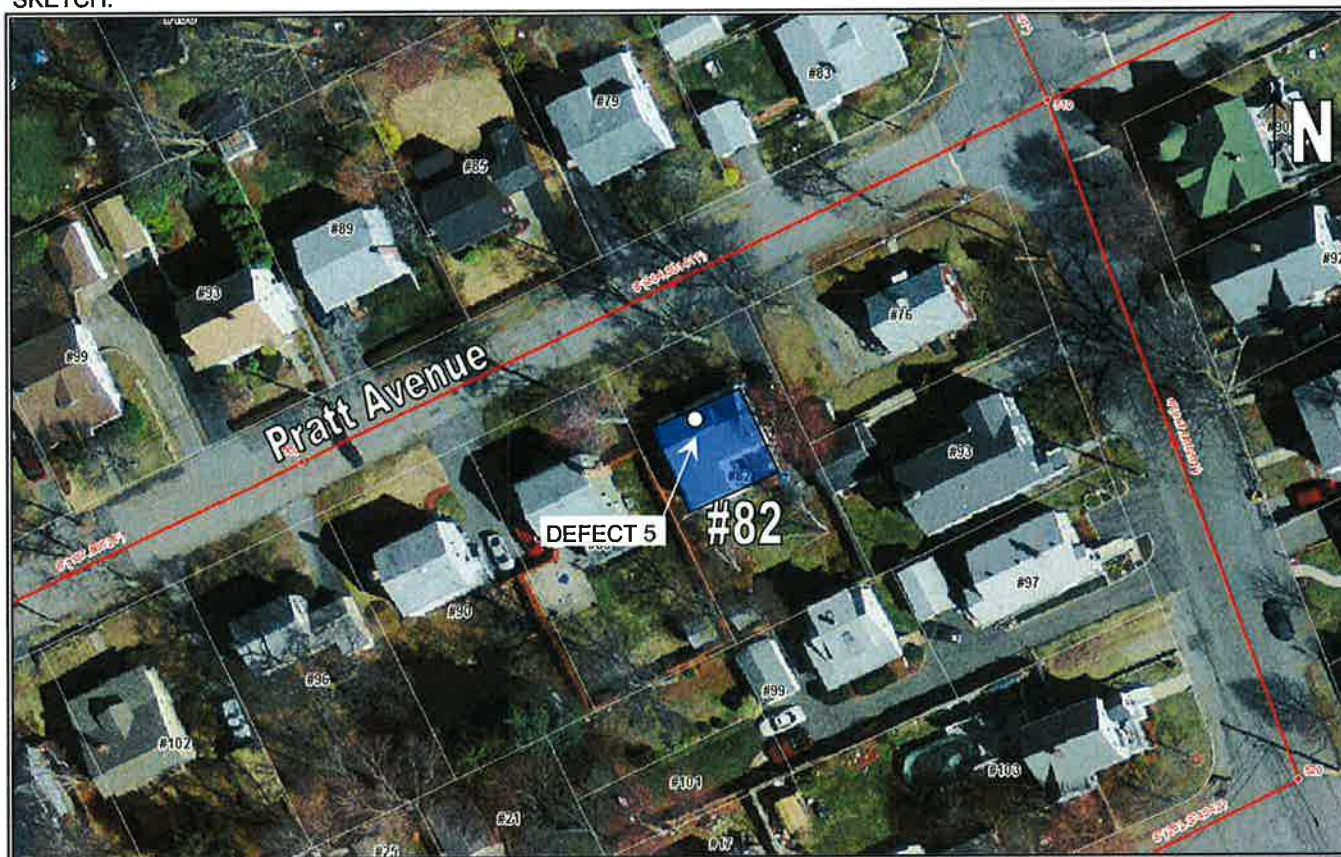
DEFECT: 5 thru 5

DEFECT	DESCRIPTION	Drainage Area	Surface Type	Severity			Picture No.(s)
				Major	Mod	Minor	
5	Sump hole in basement floor with suspected open cleanout below grade covered with crushed stone.	1020	Concrete		X		5

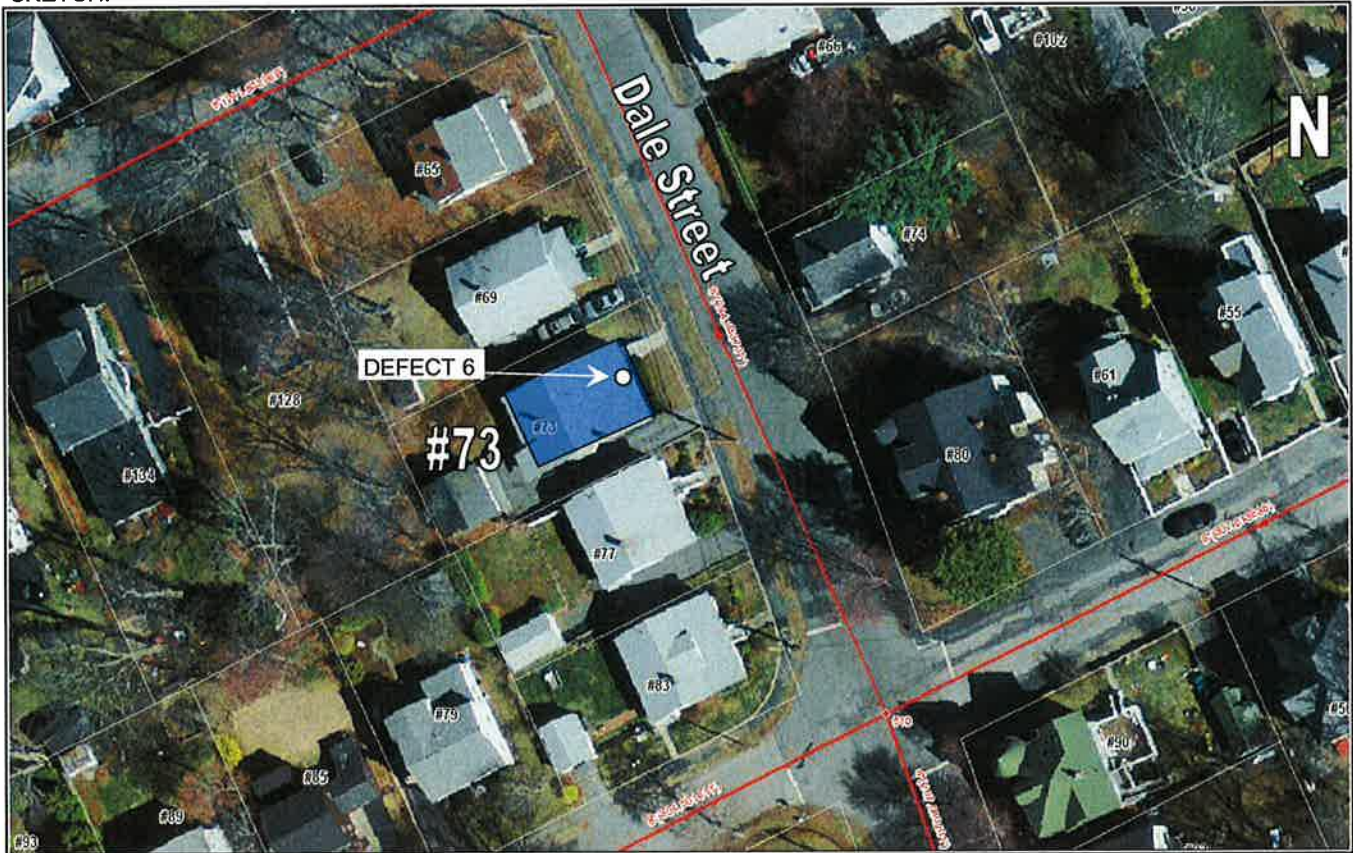
DEFECT: 6 thru 6

DEFECT	DESCRIPTION	Drainage Area	Surface Type	Severity			Picture No.(s)
				Major	Mod	Minor	
6	Open cleanout cap below grade.	1,330	Concrete		X		6

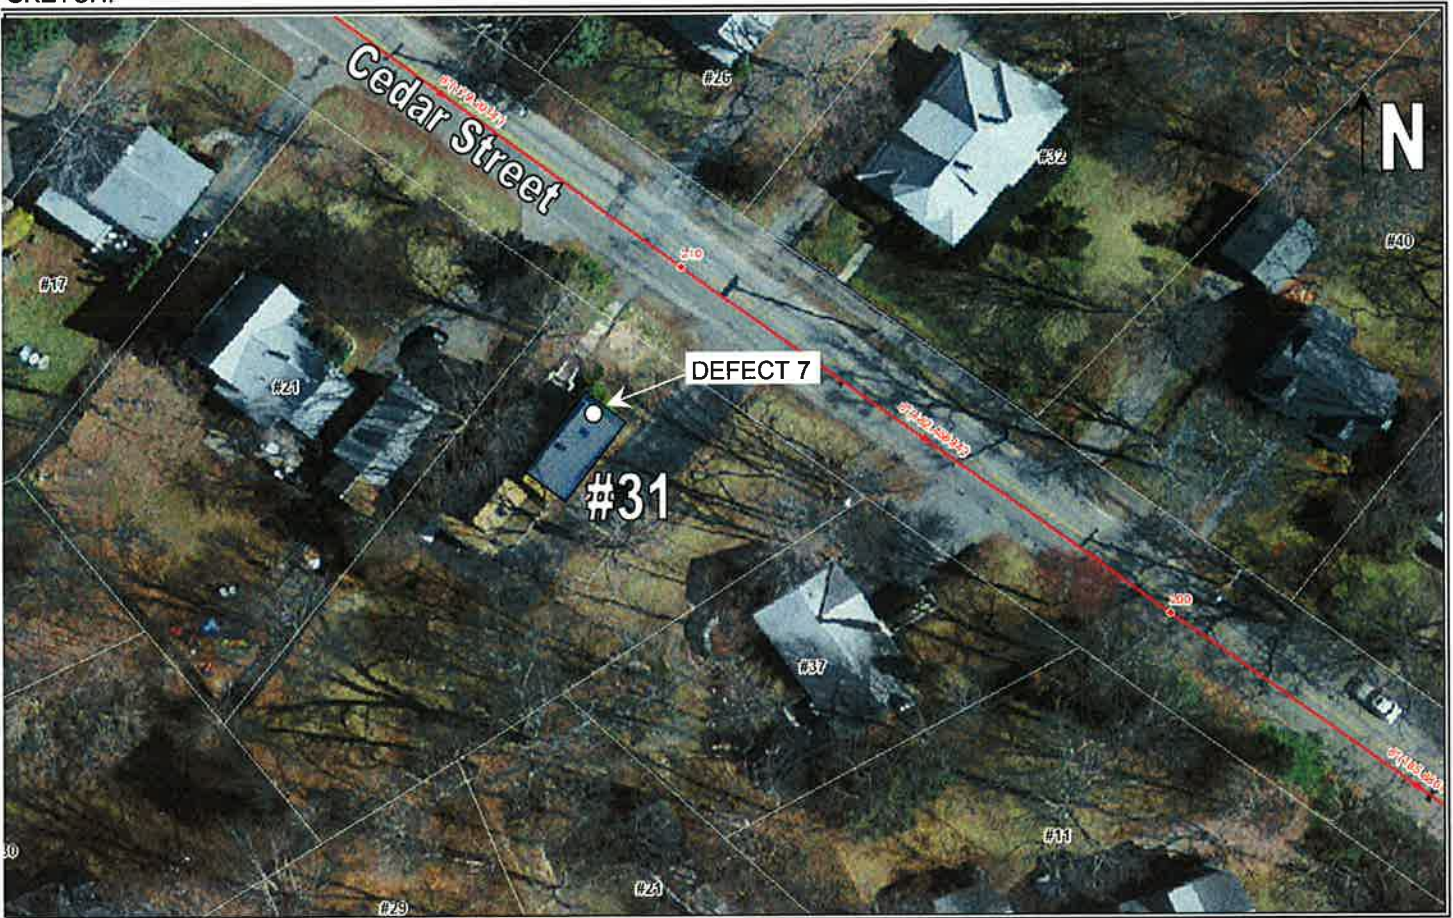
DEFECT: 7 thru 7

DEFECT	DESCRIPTION	Drainage Area	Surface Type	Severity			Picture No.(s)
				Major	Mod	Minor	
7	Open cleanout cap below grade found by Ron Lawrence. No photo taken.	340	Concrete		X		-

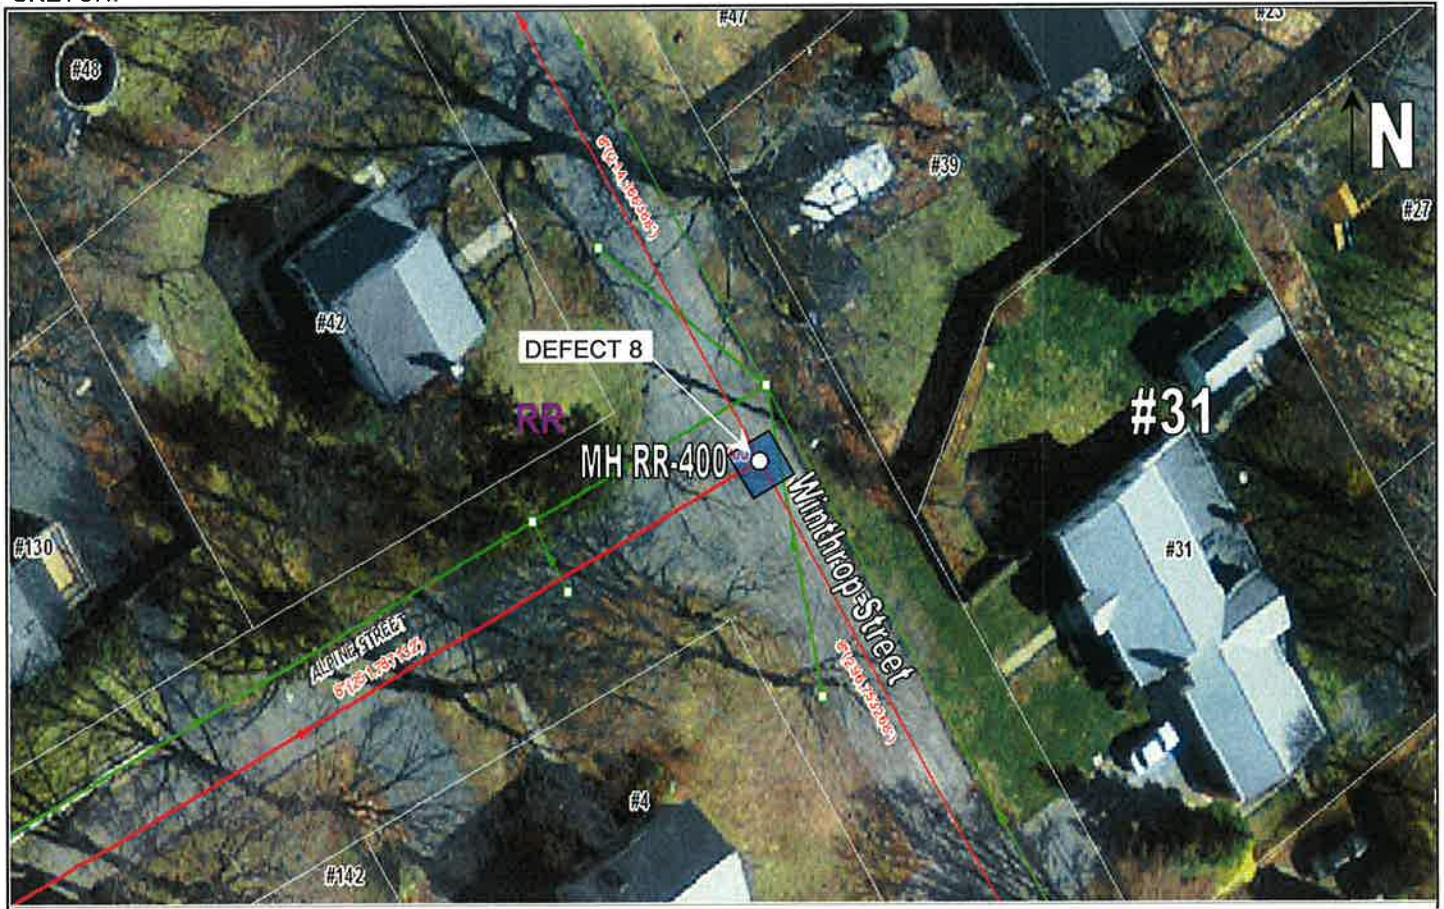
DEFECT: 8 thru 8

DEFECT	DESCRIPTION	Drainage Area	Surface Type	Severity			Picture No.(s)
				Major	Mod	Minor	
8	Manhole RR-400 with one vent hole.	25	Asphalt			X	8, 8A

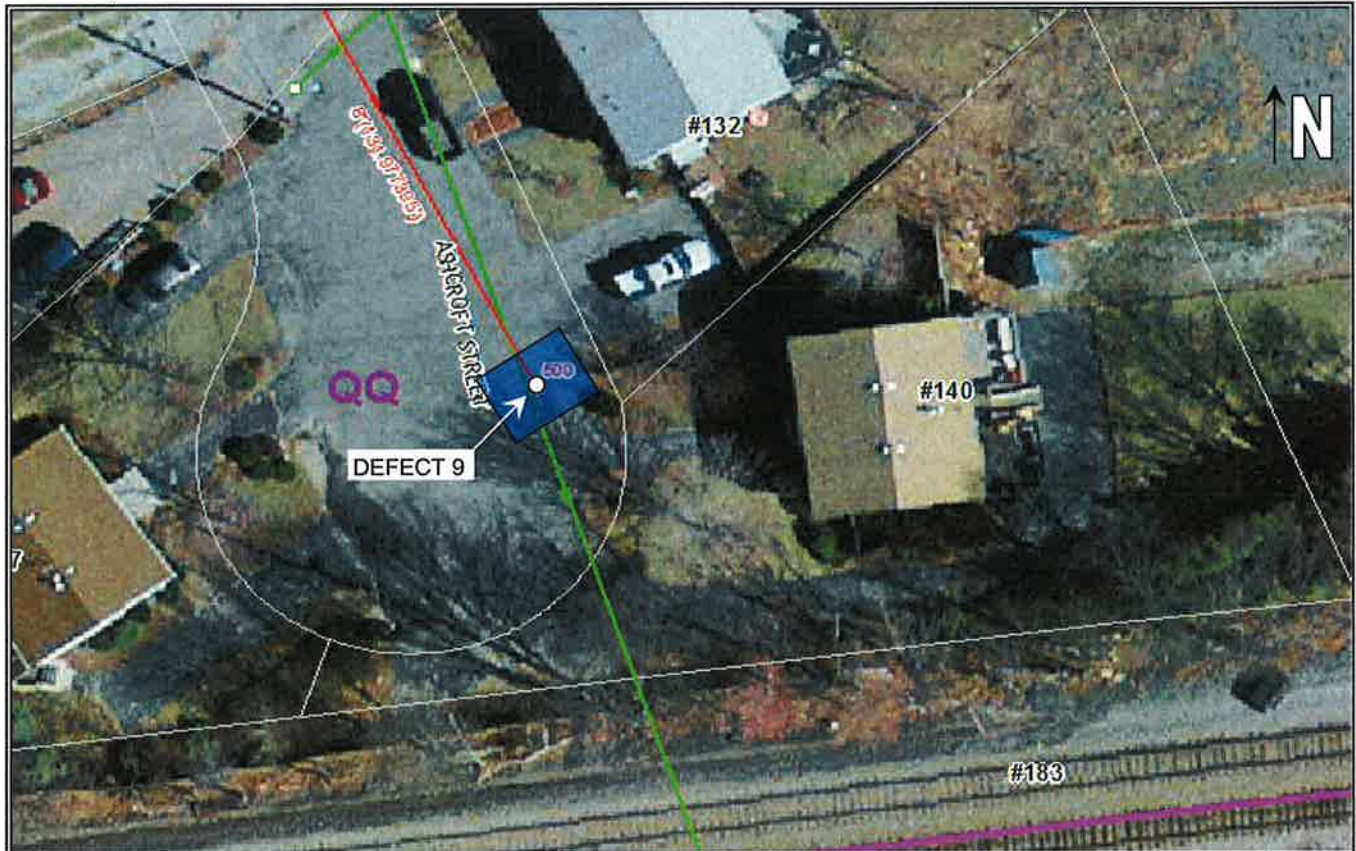
DEFECT: 9 thru 9

DEFECT	DESCRIPTION	Drainage Area	Surface Type	Severity			Picture No.(s)
				Major	Mod	Minor	
9	Manhole QQ-500 with vent holes.	50	Asphalt			X	9

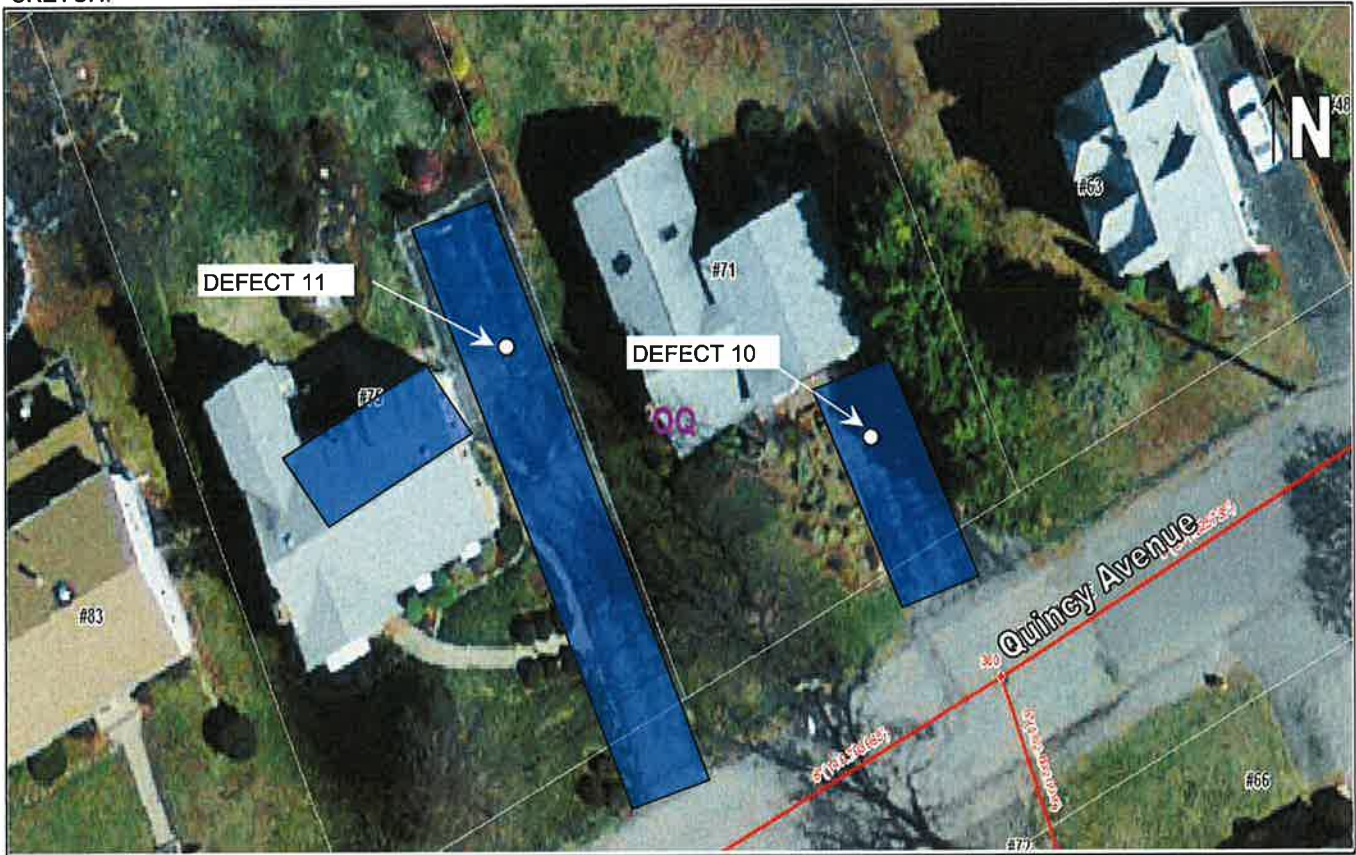
DEFECT: 10 thru 11

DEFECT	DESCRIPTION	Drainage Area	Surface Type	Severity			Picture No.(s)
				Major	Mod	Minor	
10	Driveway Drain.	748	Asphalt	X			10
11	Driveway Drain.	2381	Asphalt	X			11

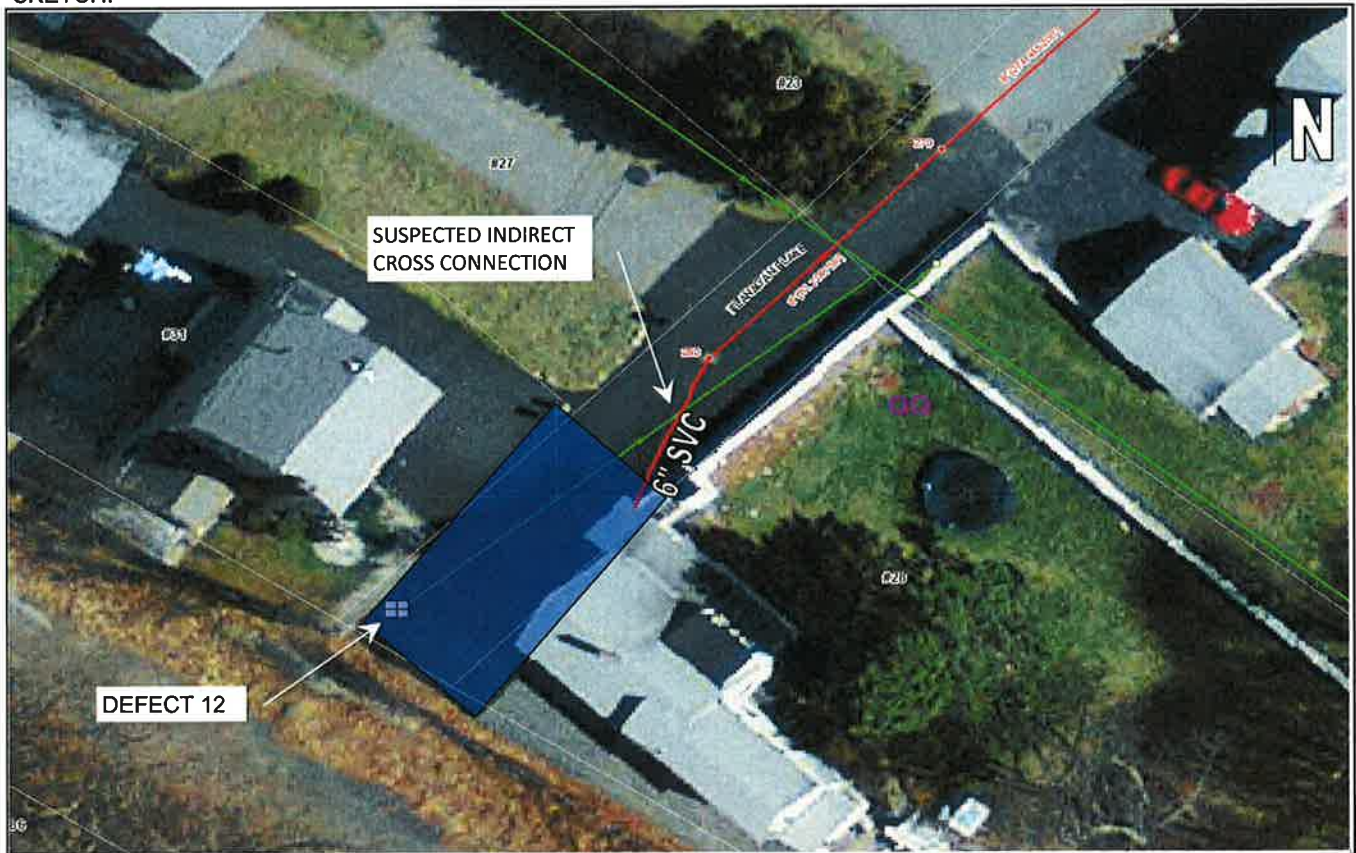
DEFECT: 12 thru 12

DEFECT	DESCRIPTION	Drainage Area	Surface Type	Severity			Picture No.(s)
				Major	Mod	Minor	
12	Indirect Public Catch Basin - 6" service connection between end manhole and 28 Flanagan Place.	925	Asphalt	X			12

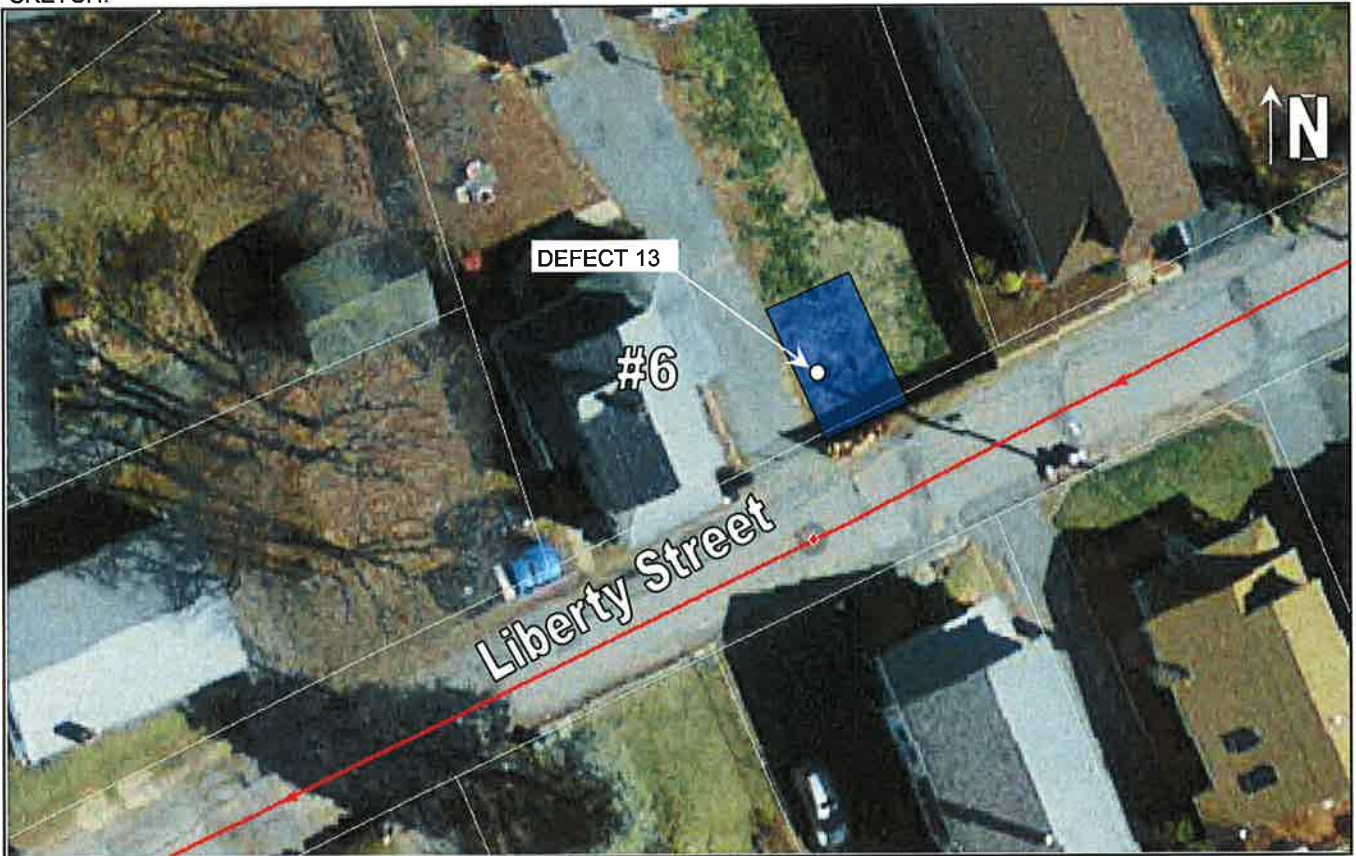
DEFECT: 13 thru 13

DEFECT	DESCRIPTION	Drainage Area	Surface Type	Severity			Picture No.(s)
				Major	Mod	Minor	
13	Broken Service Connection.	100	Grass		X		13

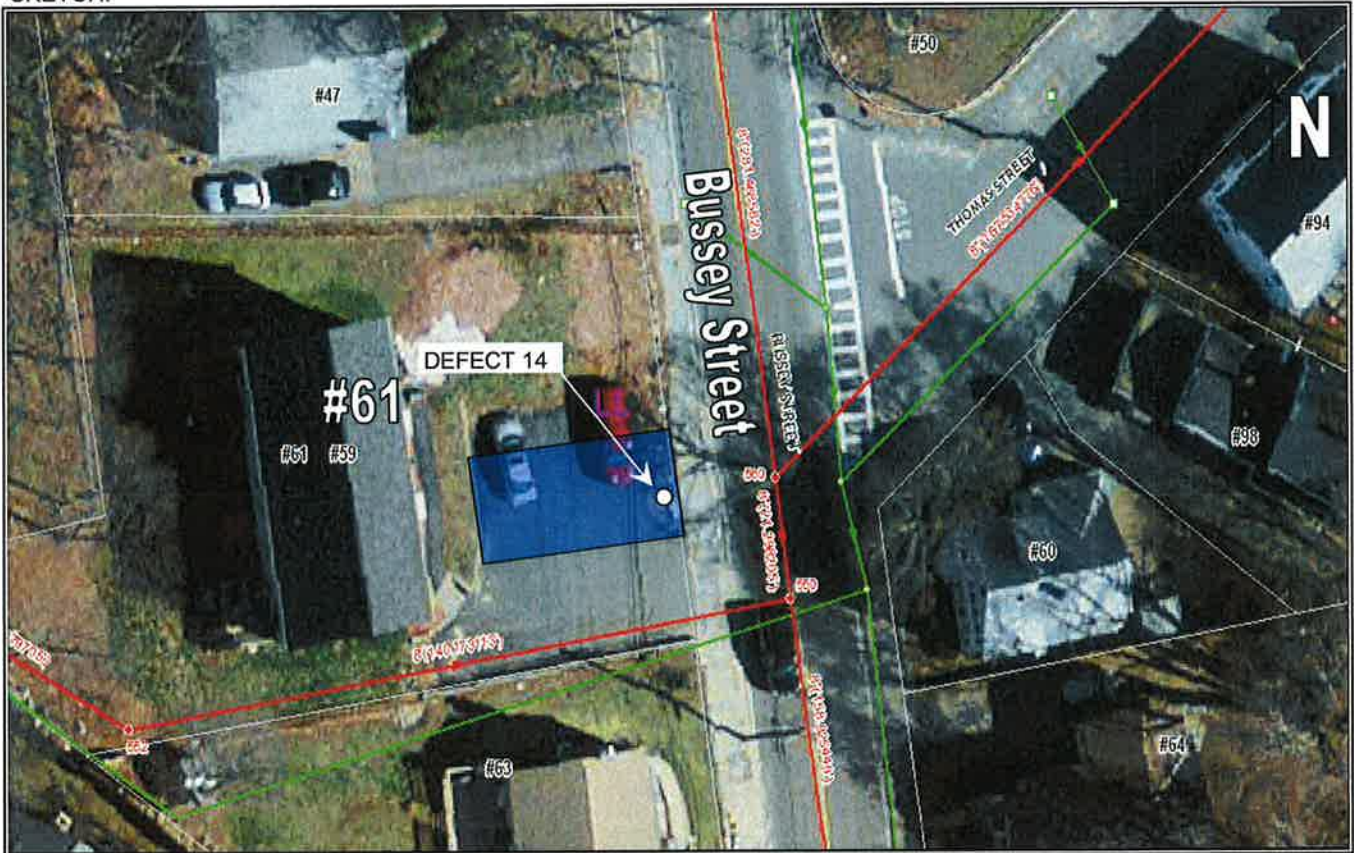
DEFECT: 14 thru 14

DEFECT	DESCRIPTION	Drainage Area	Surface Type	Severity			Picture No.(s)
				Major	Mod	Minor	
14	Broken Service Connection.	576	Asphalt		X		14

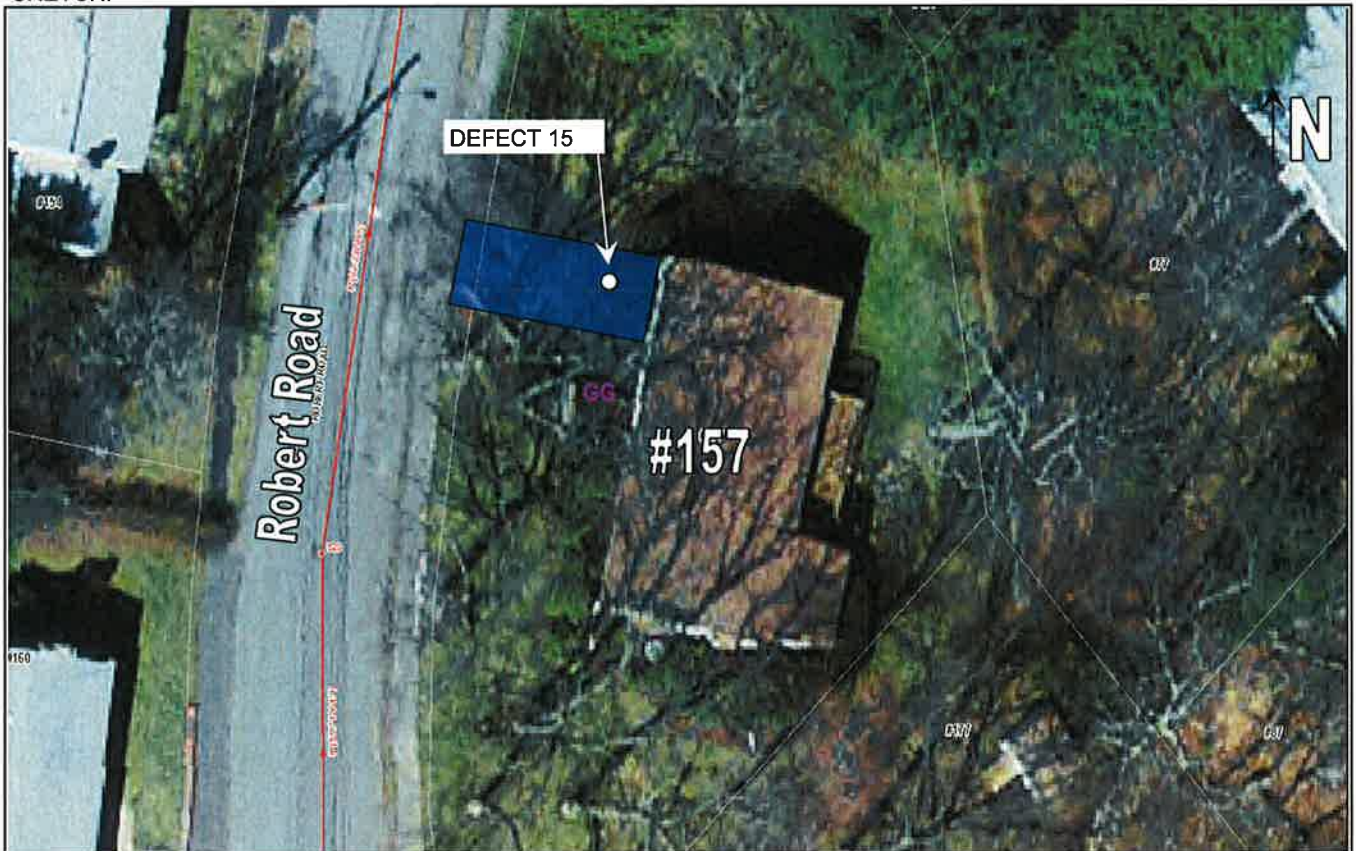
DEFECT: 15 thru 15

61 Bussey Street	LL	14	Broken service connection	Private	x			N/A	0	720	
157 Robert Road	GG	15	Driveway Drain	Private	x			Dye Observed in SMH GG-510	10,336	0	Redirect Driveway Drain at 157 Robert Road
100 Robert Road	GG	16	Outfall with Light Smoke	Public			x	Negative	0	0	
1 Newcourt Lane	GG	17	Catch Basin directly connected to sewer	Private	x			Dye Observed in SMH GG-1370 and SMH GG-1380	7,611	0	Redirect Catch Basin from SMH GG-1380
1 Newcourt Lane	GG	18	Catch Basin directly connected to sewer	Private			x	Dye Observed in SMH GG-1370 and SMH GG-1381	4,228	0	Redirect Catch Basin from SMH GG-1380
27 Highland Street	GG	19	Catch Basin Smoking from Brick Walls	Public	x			Negative	0	0	
832 High Street	GG	20	Manhole GG-170 with loose frame and holes in cover	Public	x			No Dye Test Performed, Visual Confirmation	0	1,440	Install Watertight Frame and Cover for SMH GG-170
832 High Street	GG	21	Manhole GG-160 with loose frame and holes in cover	Public	x			No Dye Test Performed, Visual Confirmation	0	1,440	Install Watertight Frame and Cover for SMH GG-160

DEFECT	DESCRIPTION	Drainage Area	Surface Type	Severity			Picture No.(s)
				Major	Mod	Minor	
15	Driveway Drain with Sump Pump.	880	Asphalt	X			15

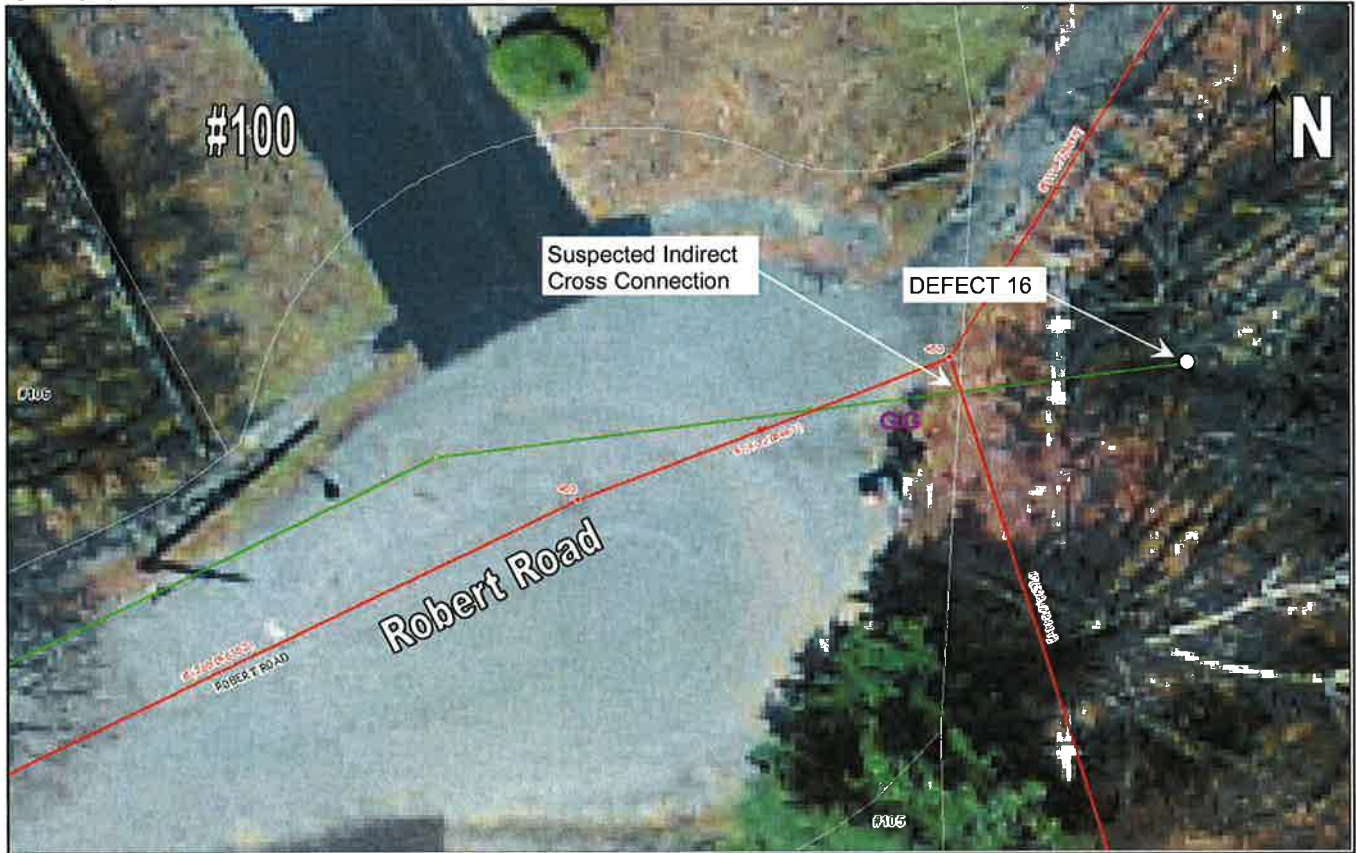
DEFECT: 16 thru 16

DEFECT	DESCRIPTION	Drainage Area	Surface Type	Severity			Picture No.(s)
				Major	Mod	Minor	
16	Drainage Outfall with light smoke.	0	Grass			X	16

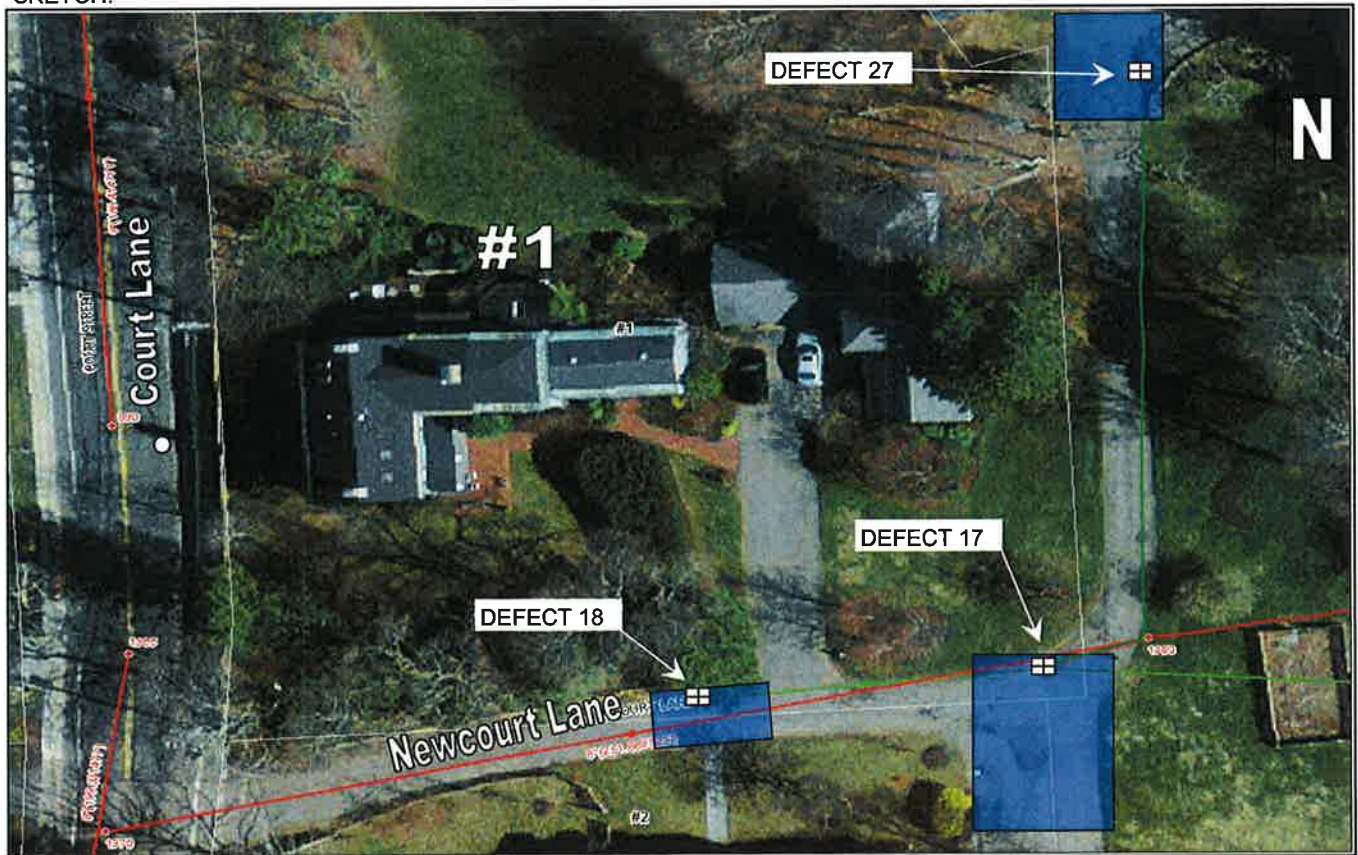
DEFECT: 17 thru 18,27

DEFECT	DESCRIPTION	Drainage Area	Surface Type	Severity			Picture No.(s)
				Major	Mod	Minor	
17	Catch Basin directly connected to sewer 5.5' deep by 4' wide to invert of overflow pipe.	648	Asphalt	X			17,17A
18	Catch Basin directly connected to sewer 5.5' deep by 4' wide to invert of overflow pipe.	360	Asphalt	X			18
27	Catch Basin directly connected to sewer 5.5' deep by 4' wide to invert of overflow pipe. (No Photo)	600	Asphalt	X
