## **Town of Dedham, MA**

### **2013 Year One Inflow Investigation**

March 2014

**Town of Dedham, Massachusetts**  
**Weston & Sampson Project No. 2130225.A**

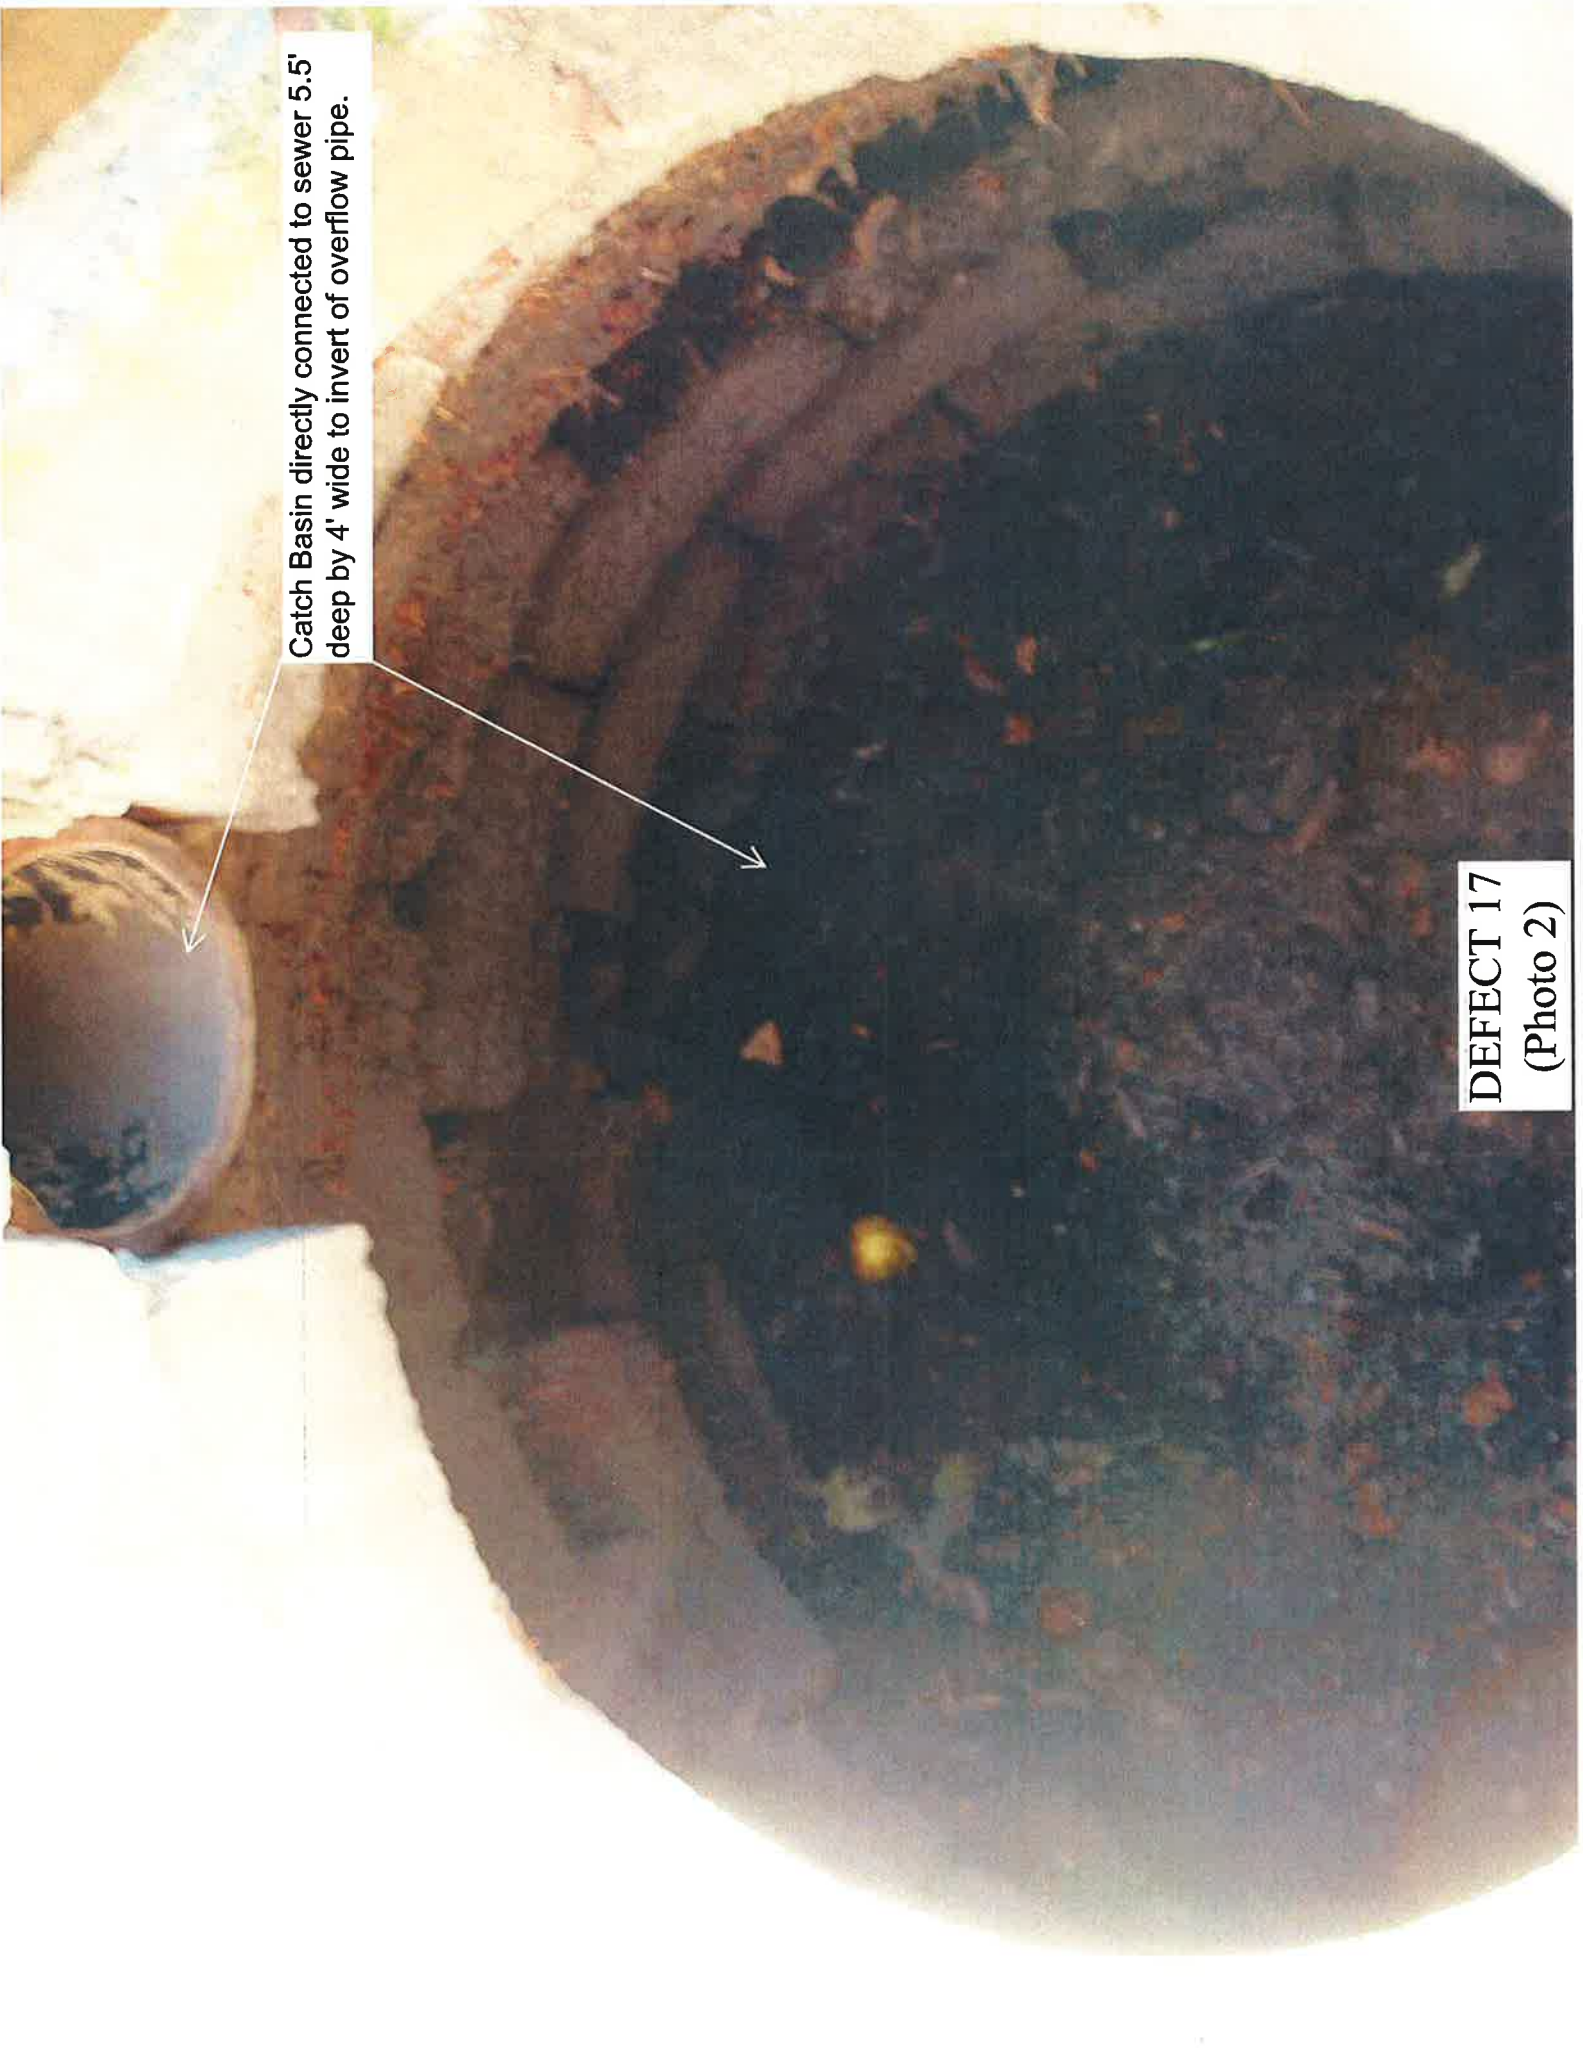
**DEFECT 17**  
**(Photo 2)**

DEFECT	DESCRIPTION	Drainage Area	Surface Type	Severity			Picture No.(s)
				Major	Mod	Minor	
17	Catch Basin directly connected to sewer 5.5' deep by 4' wide to invert of overflow pipe.	648	Asphalt	X			17,17A
18	Catch Basin directly connected to sewer 5.5' deep by 4' wide to invert of overflow pipe.	360	Asphalt	X			18
27	Catch Basin directly connected to sewer 5.5' deep by 4' wide to invert of overflow pipe. (No Photo)	600	Asphalt	X

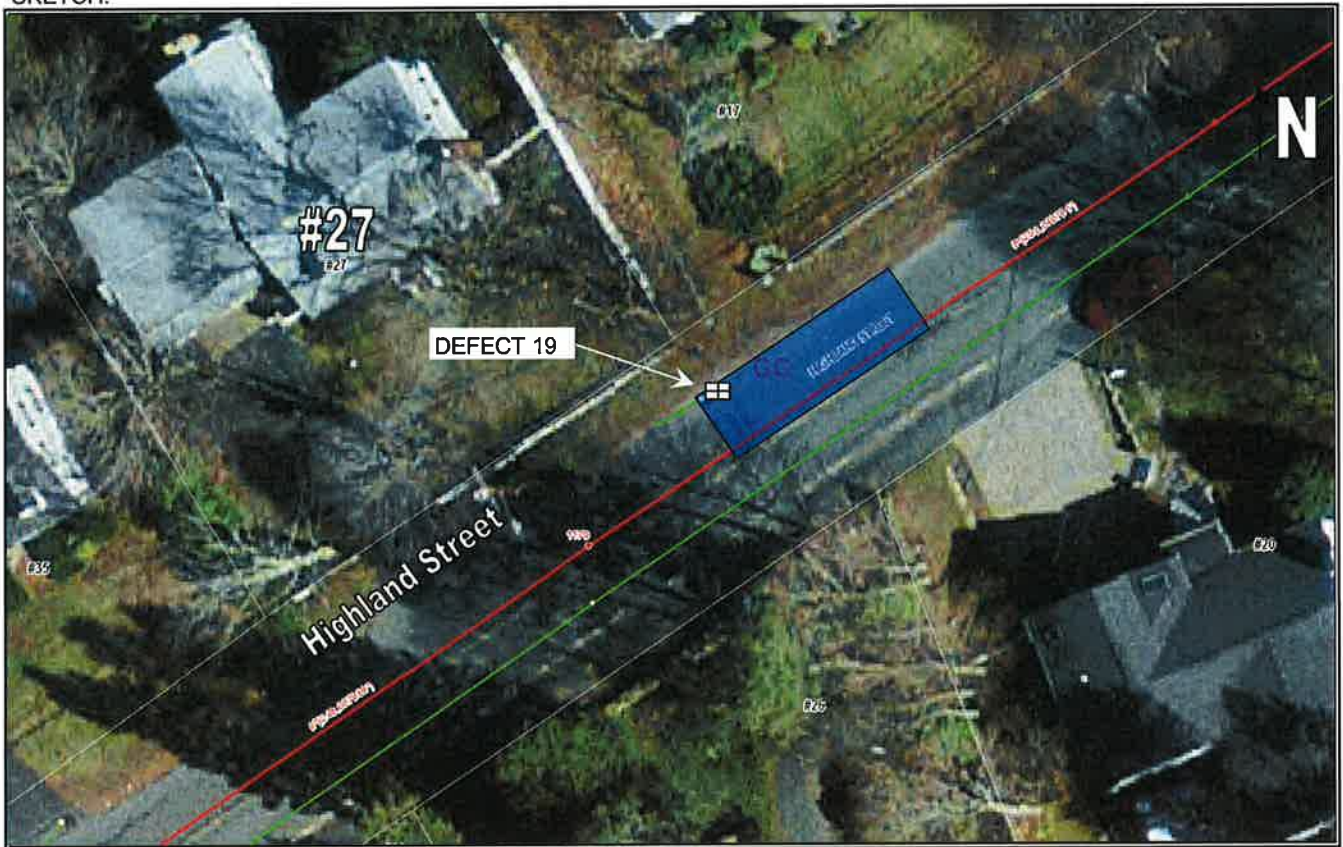
DEFECT: 19 thru 19

DEFECT	DESCRIPTION	Drainage Area	Surface Type	Severity			Picture No.(s)
				Major	Mod	Minor	
19	Catch Basin Indirectly connected to sewer. Smoke leaking in from brick walls.	480	Asphalt		X		19

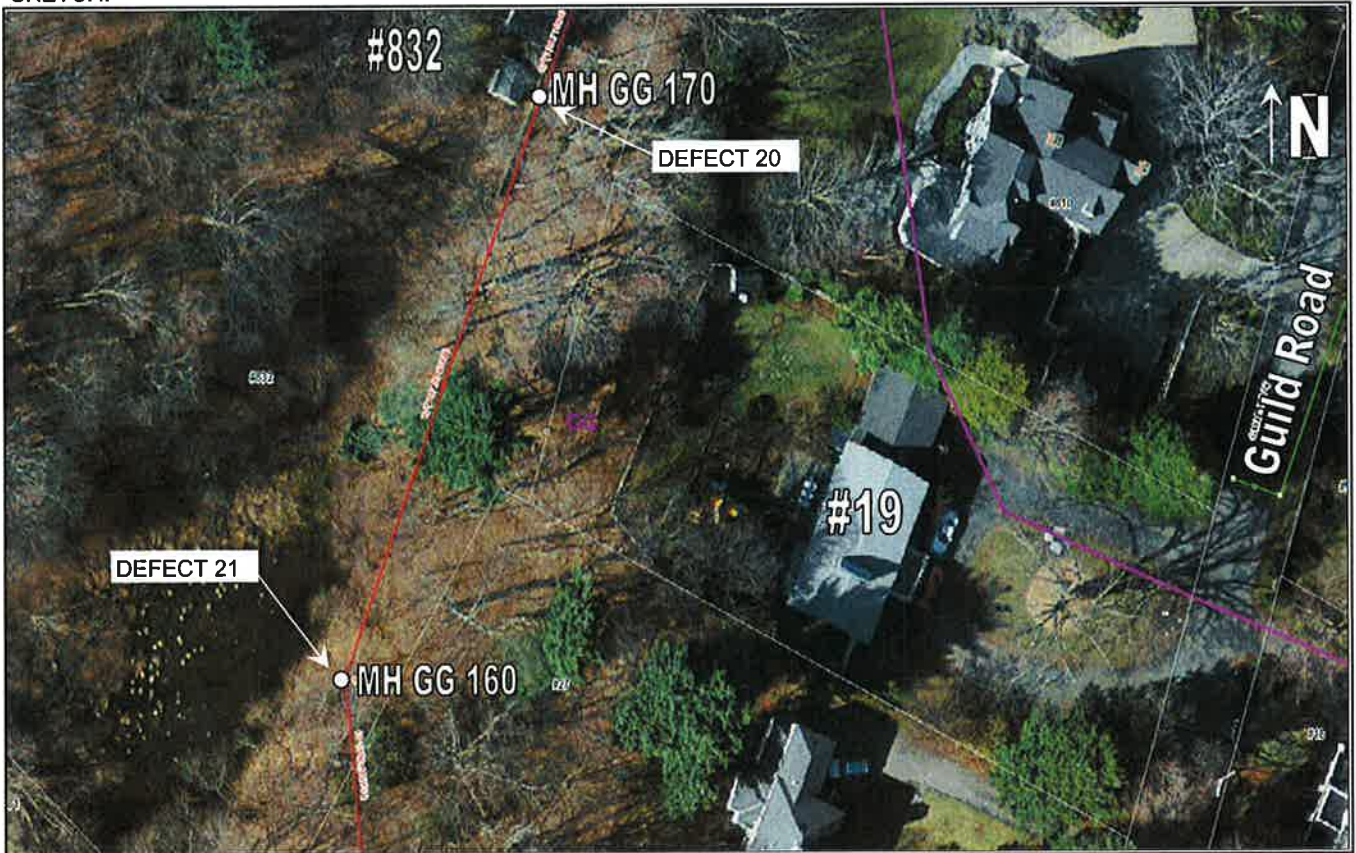
DEFECT: 20 thru 21

DEFECT	DESCRIPTION	Drainage Area	Surface Type	Severity			Picture No.(s)
				Major	Mod	Minor	
20	MH GG 170 with loose frame and vent holes in cover.		Grass		X		20
21	MH GG 160 with loose frame and vent holes in cover.		Grass		X		21

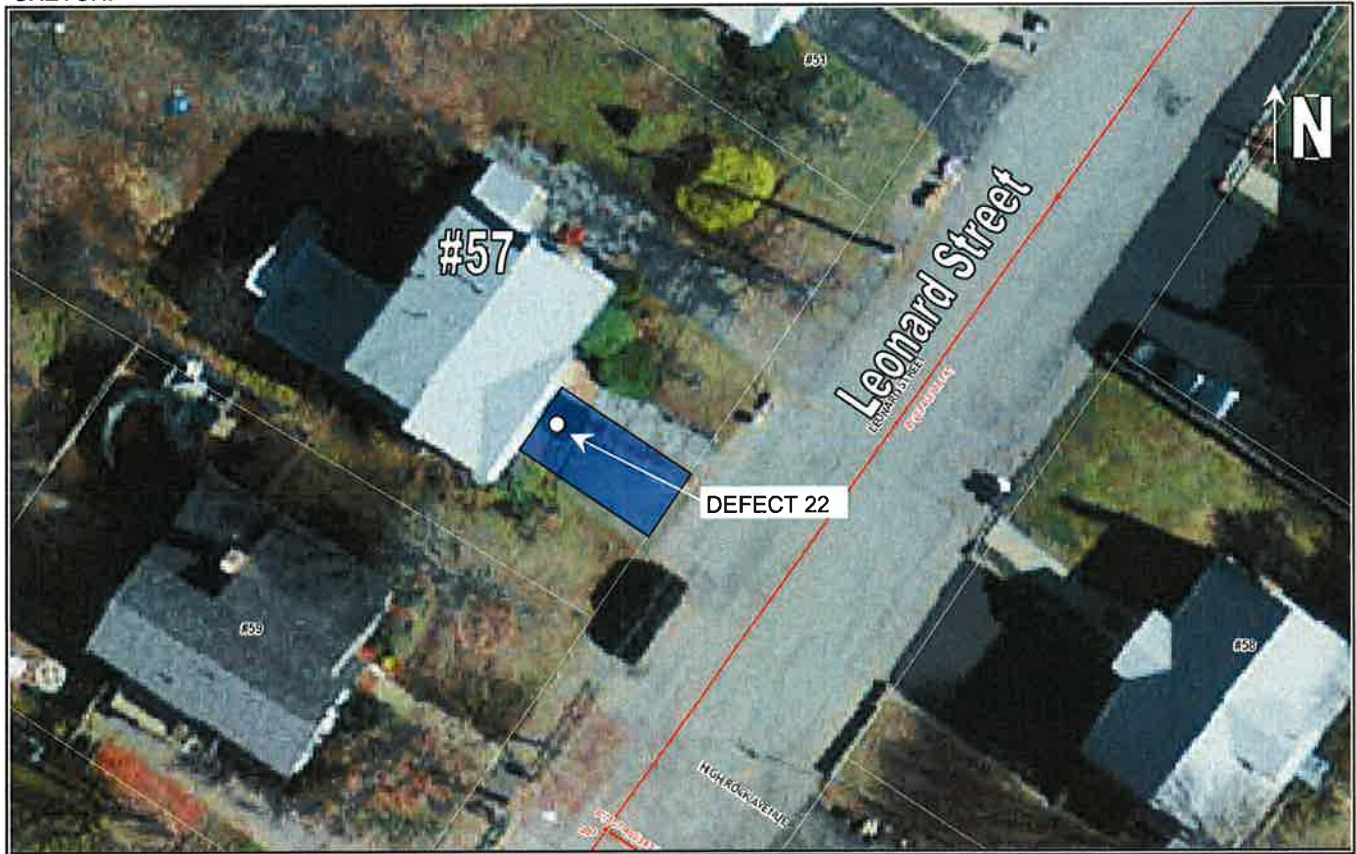
DEFECT: 22 thru 22

57 Leonard Street	KK	22	Driveway Drain	Private	x			Dye Observed in SMH KK-500	2,854	0	Redirect Driveway Drain at 57 Leonard Street
38 Leonard Street	KK	23	Driveway Drain	Private	x			Dye Observed in SMH KK-490	3,065	0	Redirect Driveway Drain at 38 Leonard Street
81 Berlin Street	KK	24	Driveway Drain	Private	x			Dye Observed in SMH KK-540	2,960	0	Redirect Driveway Drain at 81 Berlin Street
55 Thomas Street	KK	25	Open Cleanout Cap (below grade)	Private	x			No Dye Test Performed, Visual Confirmation	98	0	Install Cleanout Cap at 55 Thomas Street
99 Ware Street	KK	26	MWRA Drain Manhole with Holes in Cover	Public			x	N/A	0	0	
1 Newcourt Lane	GG	27	Catch Basin directly connected to sewer	Private			x	Dye Observed in SMH GG-1370 and SMH GG-1380	600	0	Redirect Catch Basin from SMH GG -1380
163 Central Avenue	OO	Suspect 1	Driveway Drain	Private			x	Negative	0	0	
155 Central Avenue	OO	Suspect 2	Driveway Drain	Private			x	Negative	0	0

DEFECT	DESCRIPTION	Drainage Area	Surface Type	Severity			Picture No.(s)
				Major	Mod	Minor	
22	Driveway Drain.	243	Asphalt	X			22

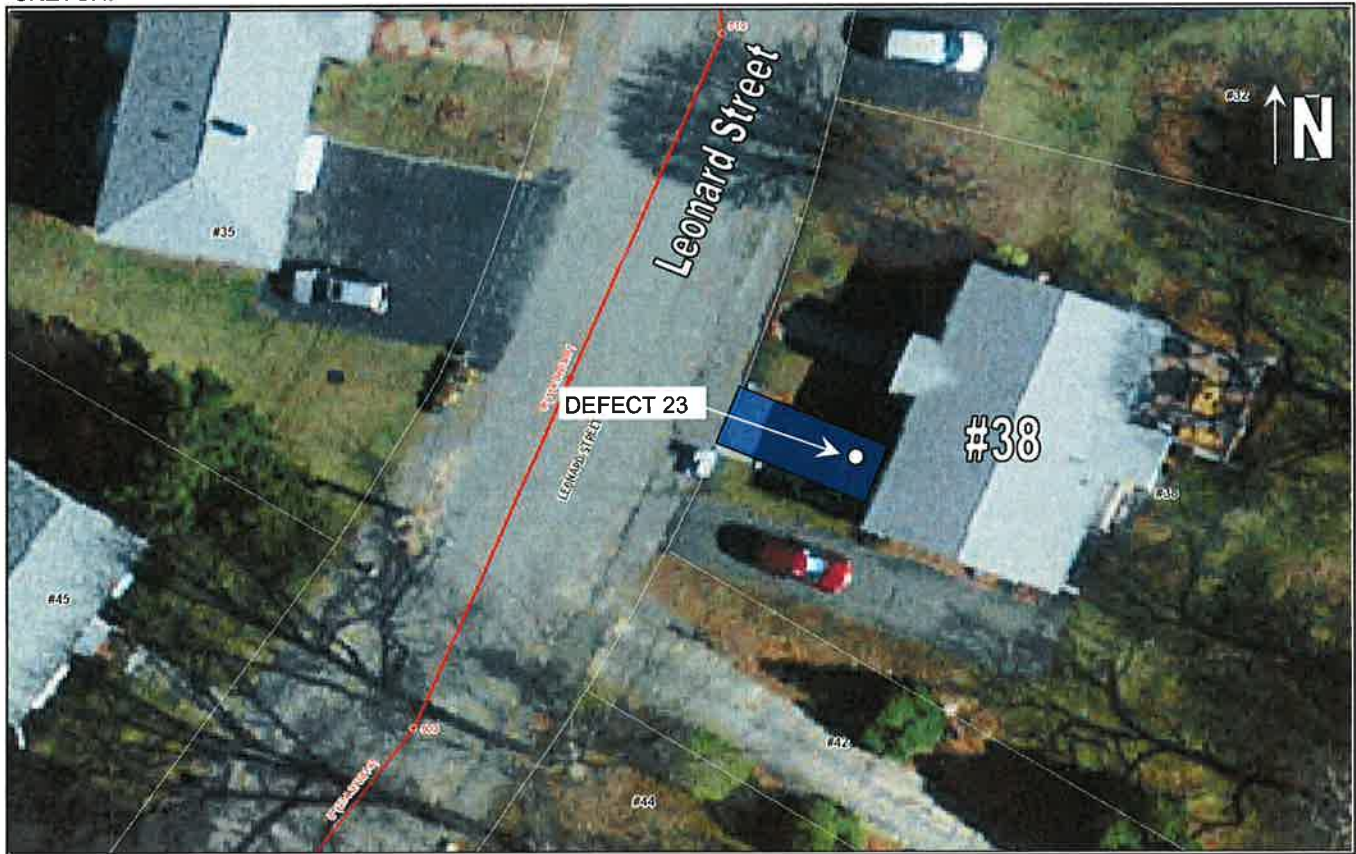
DEFECT: 23 thru 23

DEFECT	DESCRIPTION	Drainage Area	Surface Type	Severity			Picture No.(s)
				Major	Mod	Minor	
23	Driveway Drain.	261	Asphalt	X			23

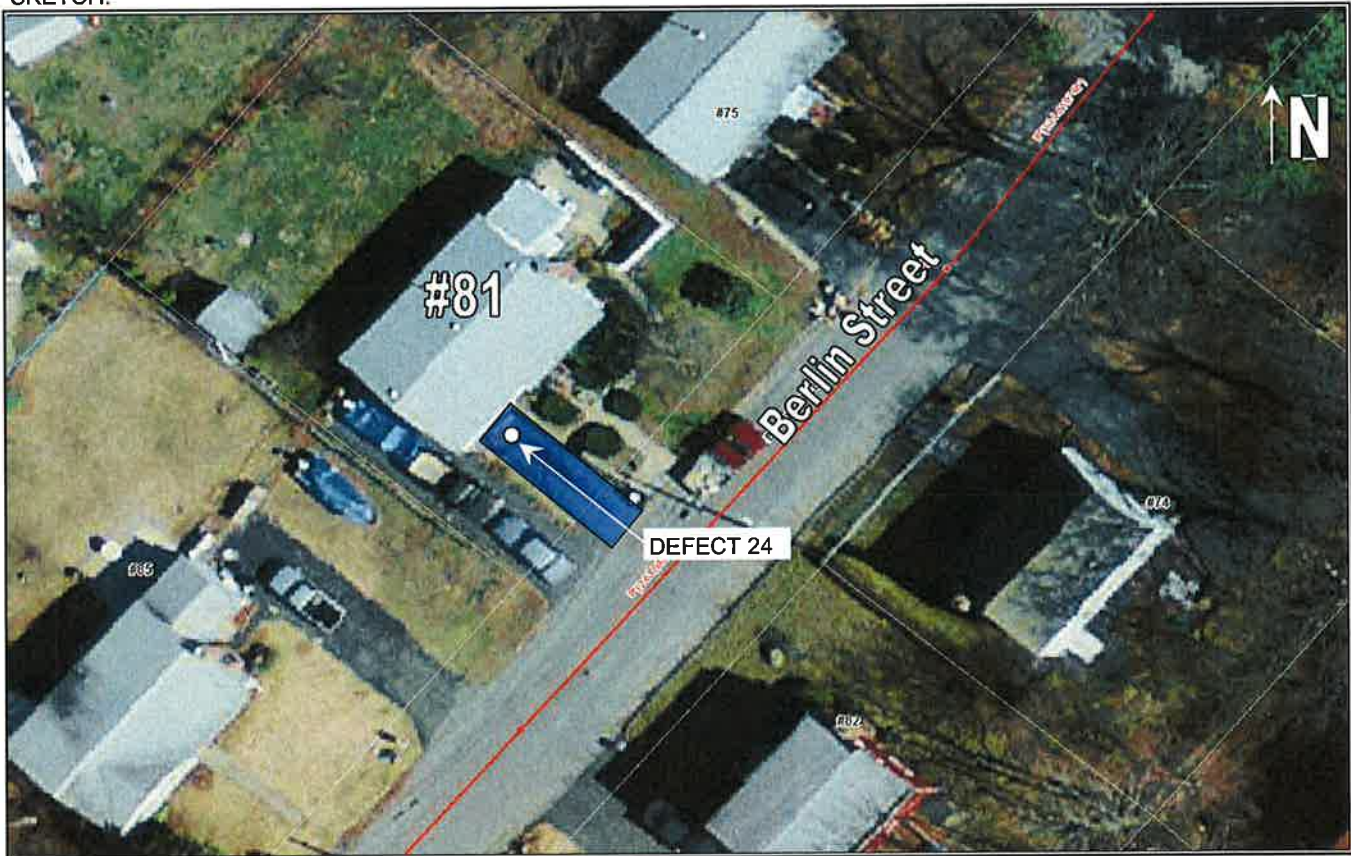
DEFECT: 24 thru 24

DEFECT	DESCRIPTION	Drainage Area	Surface Type	Severity			Picture No.(s)
				Major	Mod	Minor	
24	Driveway Drain.	252	Asphalt	X			24

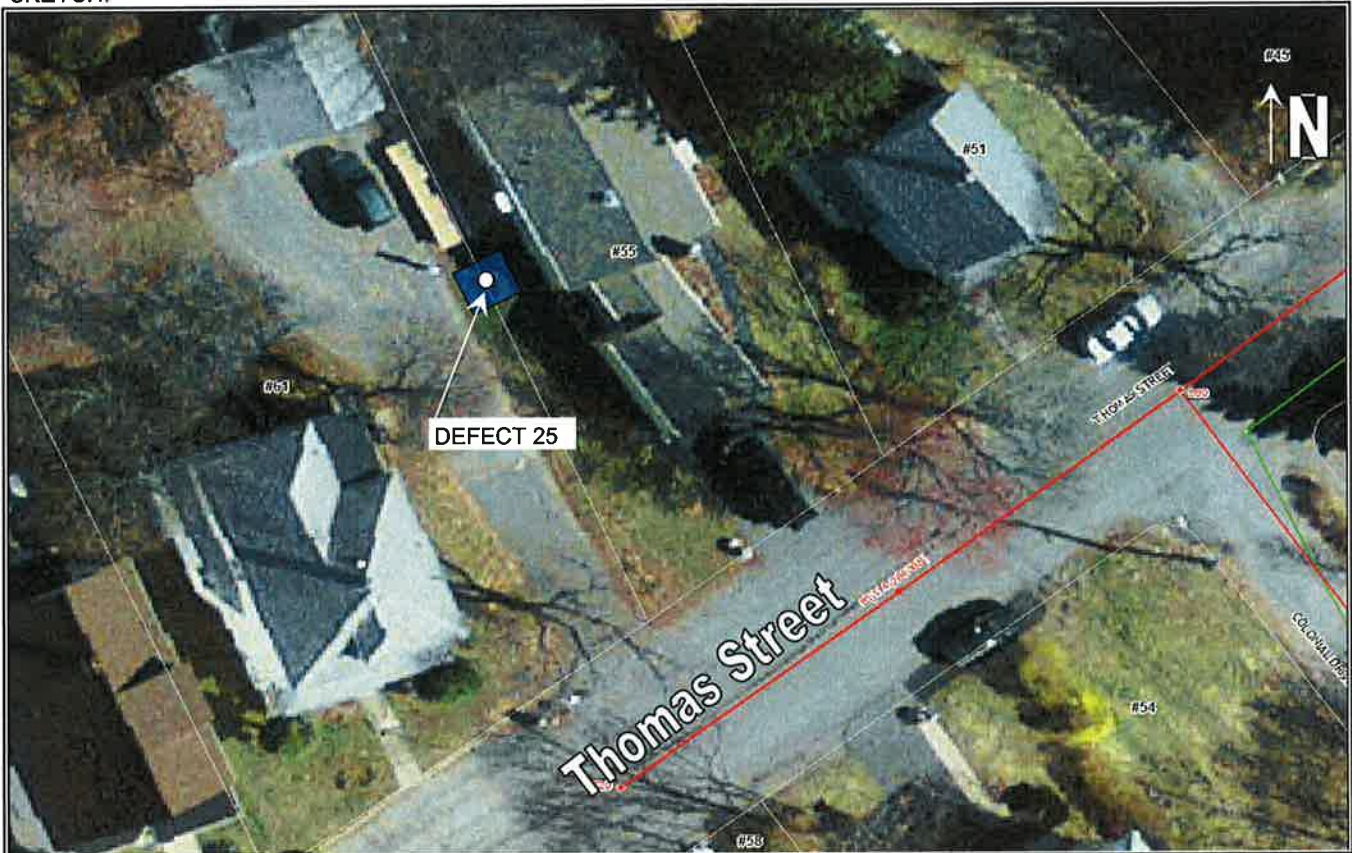
DEFECT: 25 thru 25

DEFECT	DESCRIPTION	Drainage Area	Surface Type	Severity			Picture No.(s)
				Major	Mod	Minor	
25	Missing Exterior Cleanout Cap.	25	Grass			X	25

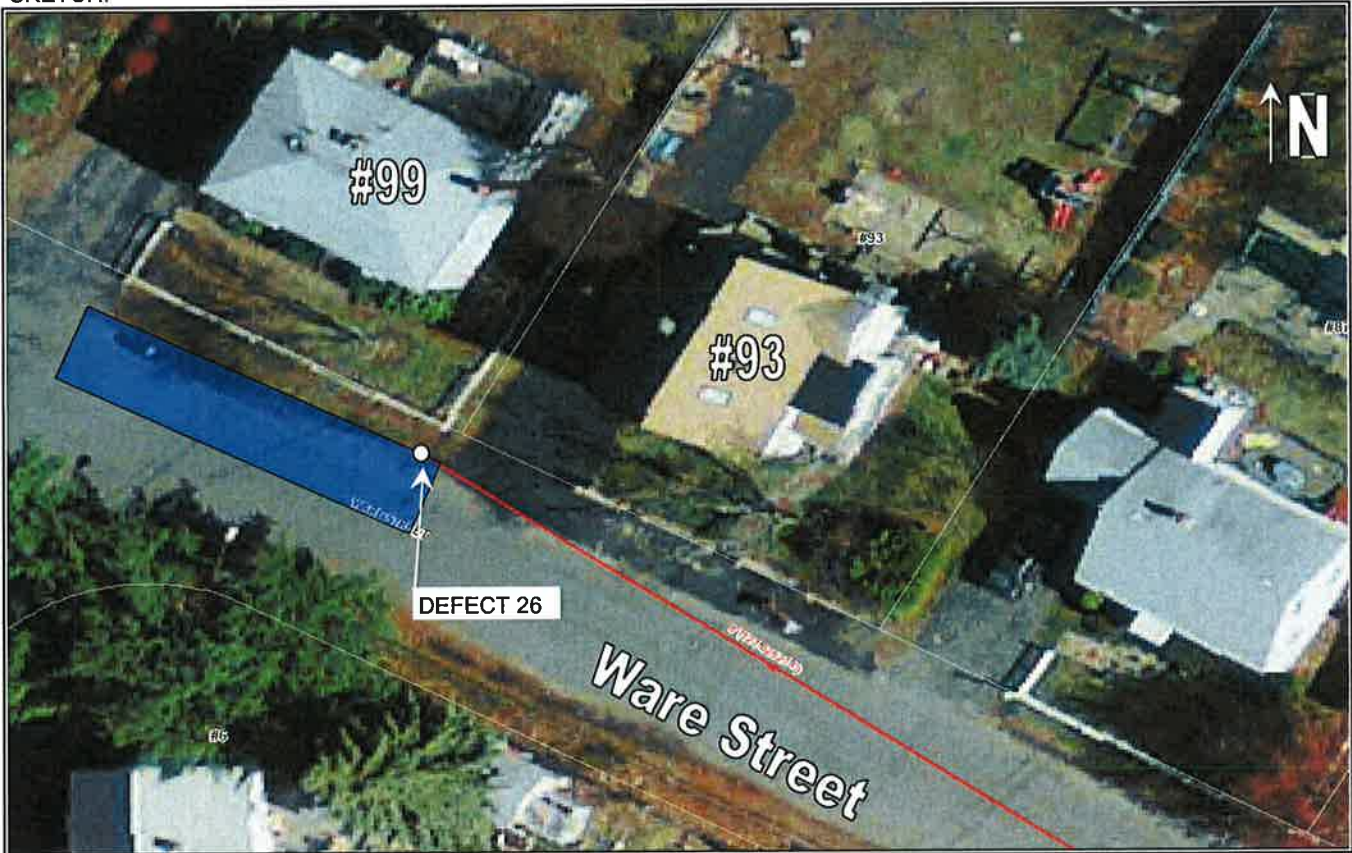
DEFECT: 26 thru 26

DEFECT	DESCRIPTION	Drainage Area	Surface Type	Severity			Picture No.(s)
				Major	Mod	Minor	
26	MWRA MH in Subarea KK with vent hole.	600	Asphalt	X			26

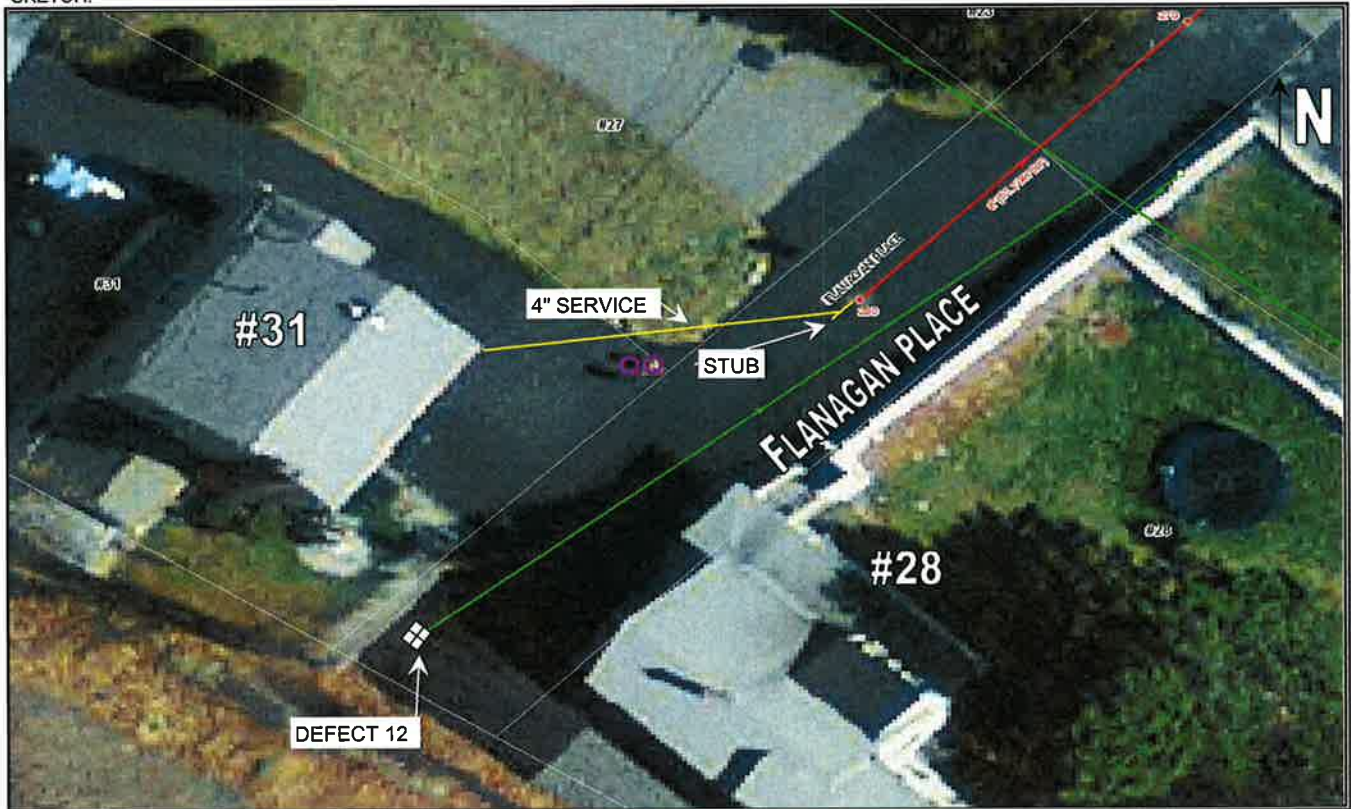
DEFECTS: 12 thru 12  
 SUBAREA: QQ  
 DYE FLOOD NO.: 1  
 CONTRACTOR: NEPCCO

Leak No.	Description of Smoke Testing Defects	Drainage Area	Surface Type	Date
12	Catch Basin with light smoke.	925	Asphalt	9/18/13

**Description of test:** Unable to dye flood drain line due to no access for plugging of downstream line. Unable to perform television inspection of drain line due to debris. Unable to perform television inspection of sewer service from manhole QQ-280 due to 4" pipe.

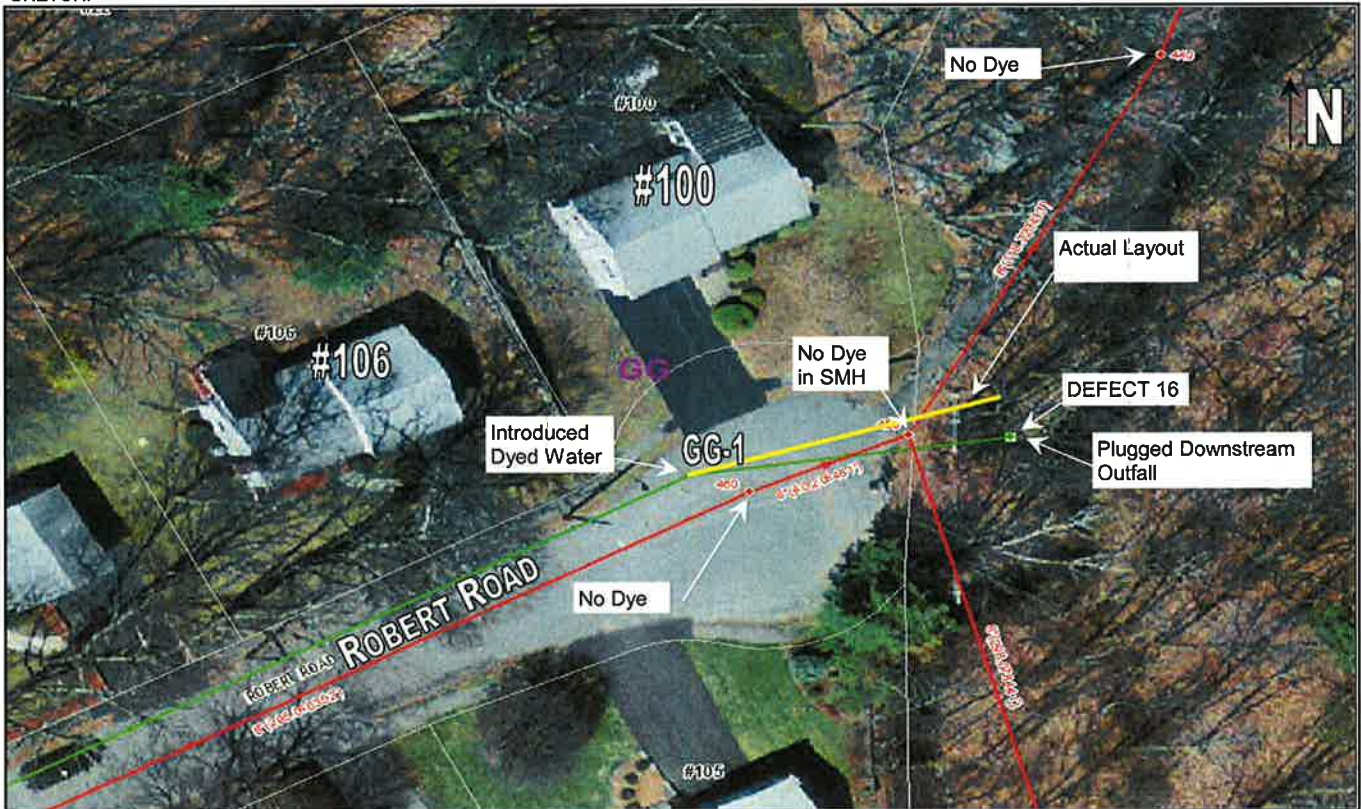
DEFECTS: 16 thru 16  
 SUBAREA: GG  
 DYE FLOOD NO.: 2  
 CONTRACTOR: NEPCCO

Defect No.	Description of Smoke Testing Defects	Drainage Area	Surface Type	Date
16	Drainage Outfall with Light Smoke.	0	-	9/20/13

**Description of test:** Upon plugging and flooding of drain line, dyed water was not observed in the surrounding sewer manholes. Television inspection from DMH GG-1 towards the drain outfall revealed moderately open joints throughout the drain line.

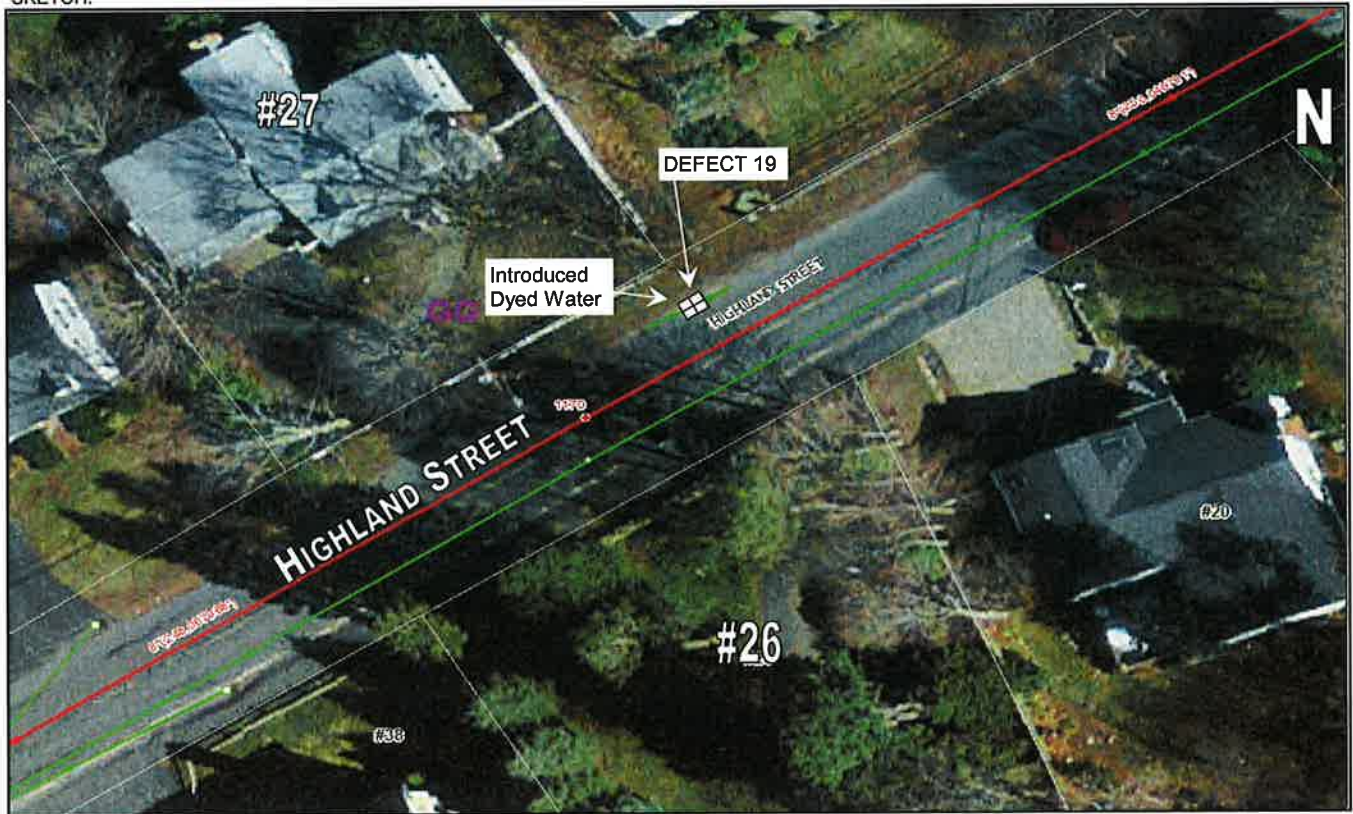
DEFECTS: 19 thru 19  
 SUBAREA: GG  
 DYE FLOOD NO.: 3  
 CONTRACTOR: NEPCCO

Leak No.	Description of Smoke Testing Defects	Drainage Area	Surface Type	Date
19	Moderate Smoke from Catch Basin Walls	480	Asphalt	9/20/13

<b>Date of Test:</b> 11/8/13	<b>Contractor:</b> New England Pipe Cleaning Co.	<b>Result(s):</b> Negative
<b>Description of test:</b> Plugged incoming and outgoing stubs. Flooded catch basin. No Dye observed. Television Inspection of sewer line between manhole GG-1170 and GG-1180 was performed revealing no defects.

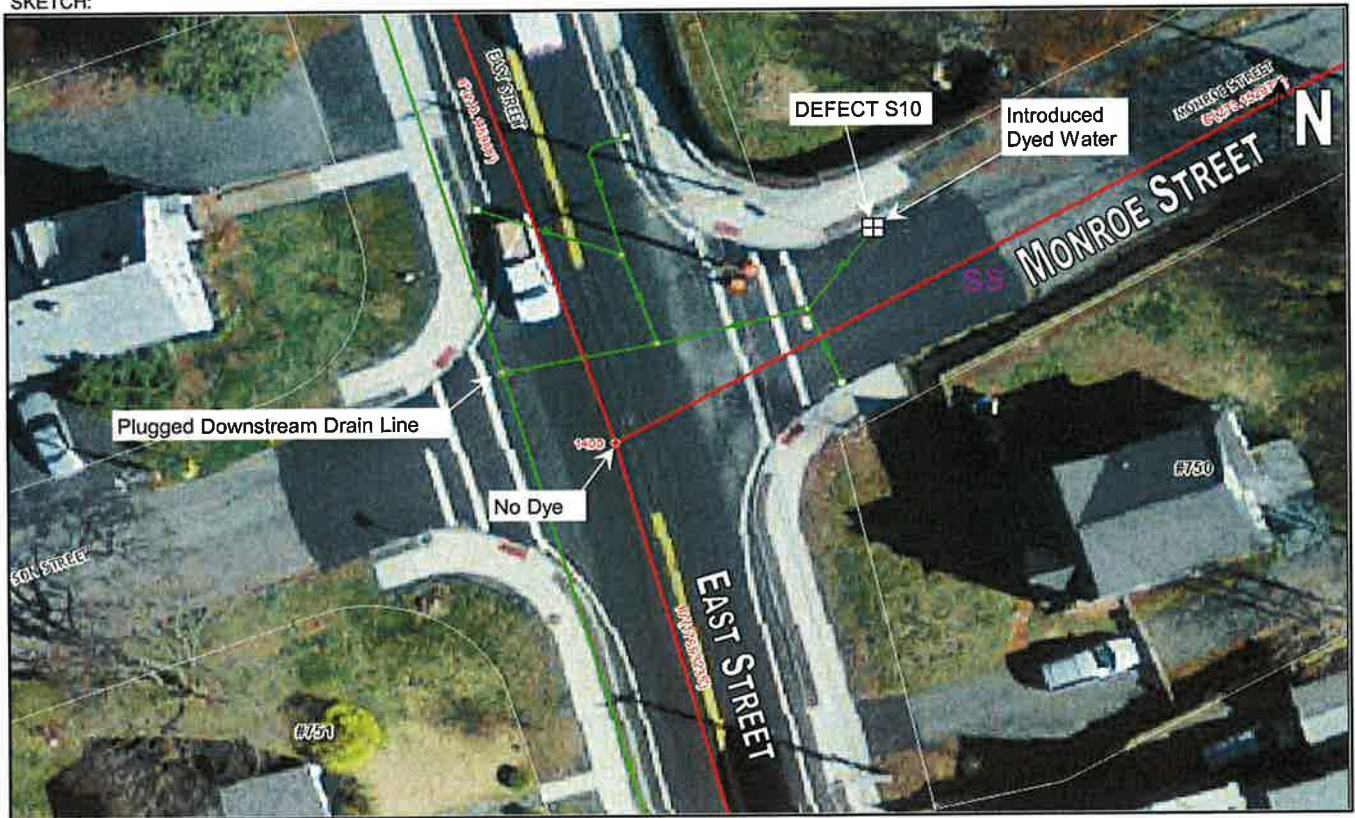
DEFECTS: S10 thru S10

Leak No.	Description of Smoke Testing Defects	Drainage Area	Surface Type	Date
S10	Catch Basin with Hood	1,500	Asphalt

**Description of test:** Upon flooding and plugging, no dyed water was observed.

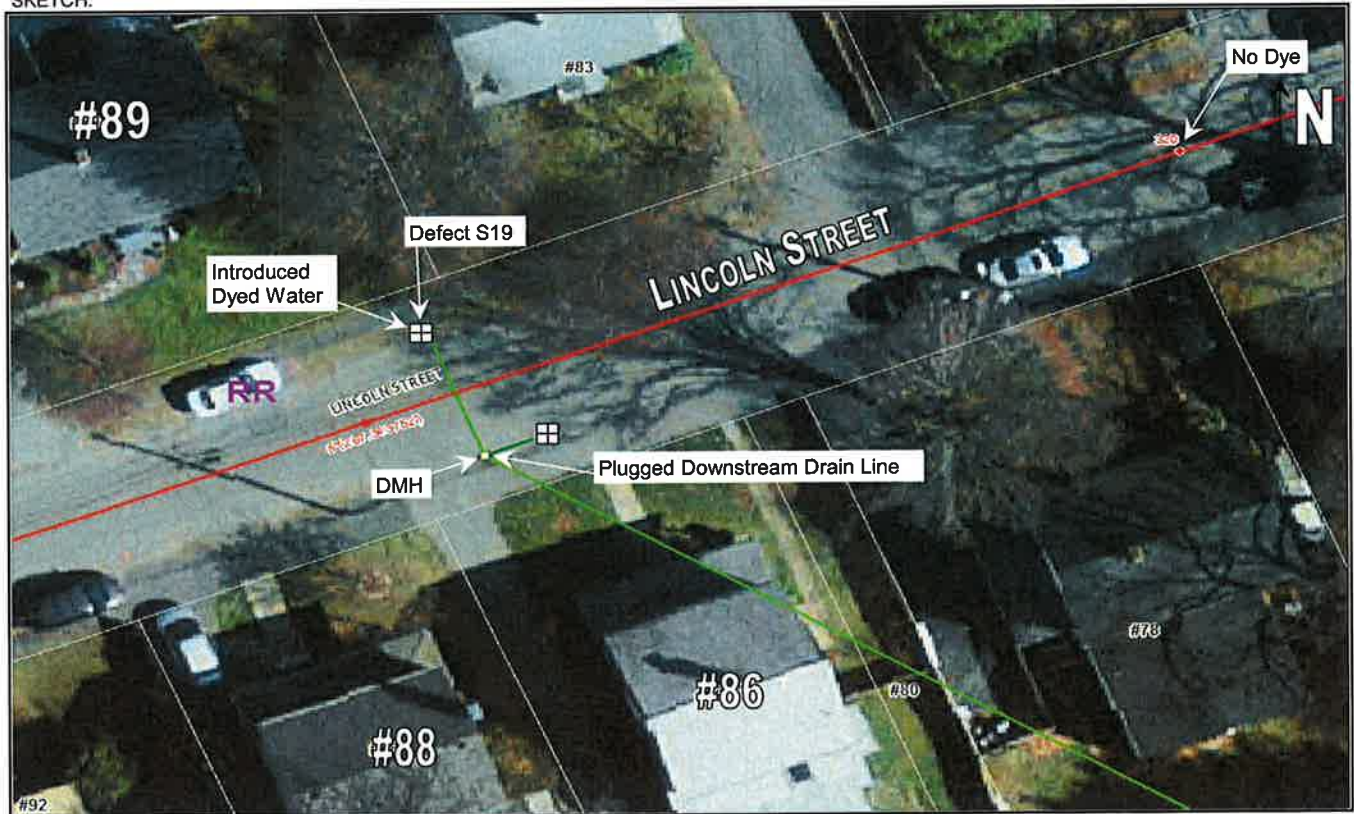
DEFECTS: S19 thru S19  
 SUBAREA: RR  
 DYE FLOOD NO.: 5  
 CONTRACTOR: NEPCCO

Leak No.	Description of Smoke Testing Defects	Drainage Area	Surface Type	Date
S19	Two (2) Catch Basins with Hoods	2,160	Asphalt

**Description of test:** Upon Flooding and plugging, no dyed water was observed at the downstream sewer manhole.

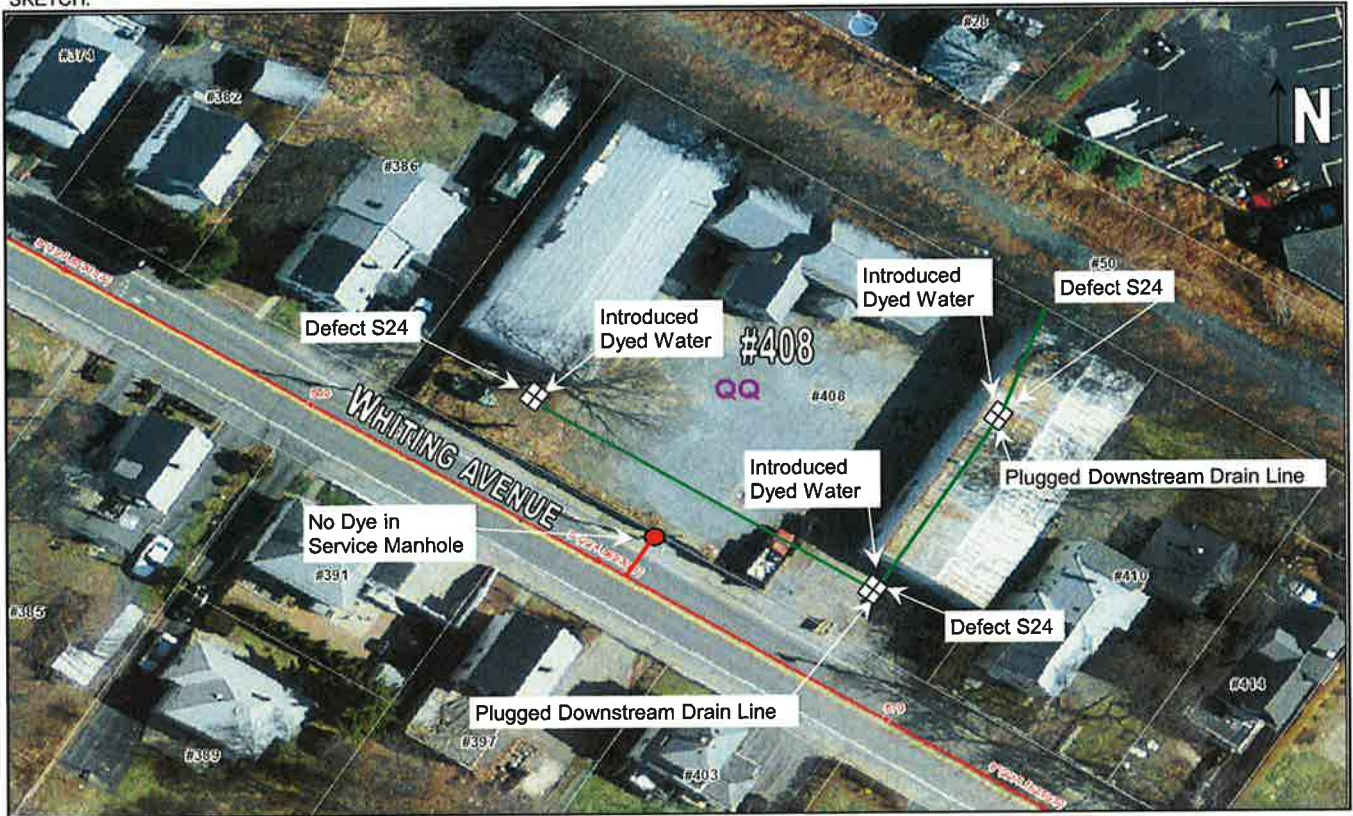
DEFECTS: S24 thru S24  
 SUBAREA: QQ  
 DYE FLOOD NO.: 6  
 CONTRACTOR: NEPCCO

Leak No.	Description of Smoke Testing Defects	Drainage Area	Surface Type	Date
S24	Three (3) Catch Basins	25,000	Asphalt

**Description of test:** Upon dye flooding and plugging, no dyed water was observed in the service manhole. Lot is under construction, shown buildings no longer exist. Was informed by owner catch basins flow to a leaching field behind the new building.
